CORNER RECORD FILE GUIDE (Rectangular Surveys)

1. T 1 S R 8 1/2 E No. A 28 Cor. 1/4 Mer. Will State Oregon (Rectangular) N. F. Mt. Hood Dist. Hood River

LAND CORNER RECORD

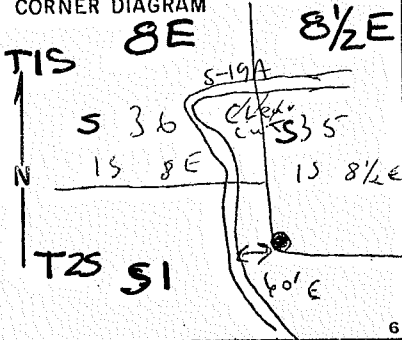
CORNER DIAGRAM

Iron Pipe 4" Diameter 12' Above ground Brass
cap mound of rocks.

10" Hemlock 5 stump from 5 stump to corner
Brs 1920 24 lks no scribing
24" hemlock 240° 38 lks scribing visible &
legible.

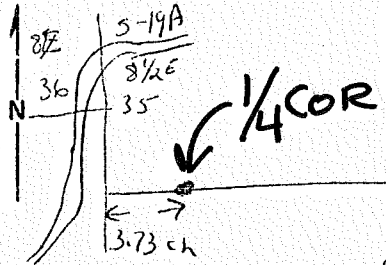
CORNER DIAGRAM

From pipe Brass cap 2" 12" Above ground mound of rocks

14" Hemlock sing 124° 131ks scribing visible & legible
14" Hemlock 220° 381ks no scribing-

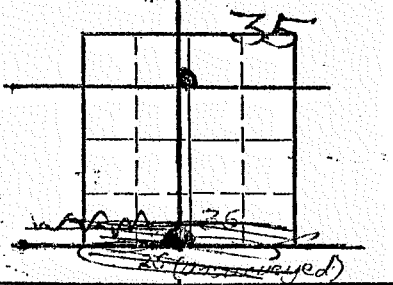
2. Corner Status

4. Description of Corners: *Corners may be reached from clear-cut logging area. Fire trail is 2ch W of corner.*
