SECTION OR SUBDIVISION $\frac{1}{4}$ COR 21 | 22

CORNER No. 313

TWP. 1N, RANGE 10E, W.M.

CORNER DESCRIPTION

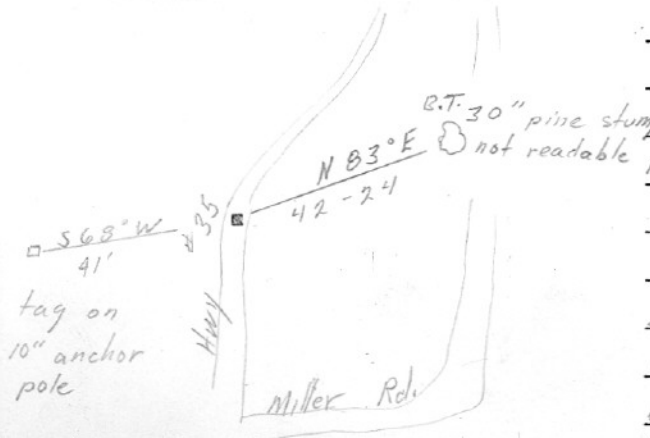
$\frac{3}{4}$ " pipe flush with pavement

an old i.p. @ ft. of stump

V.B.E. states that he set this cor. from orig. L.O. notes - checked by State Hwy. Engrs. signed - Van R. Embree Oct. 6, 1961

3/4" pipe has disappeared.

Reset corner Oct. 28, 1987

set RR spike

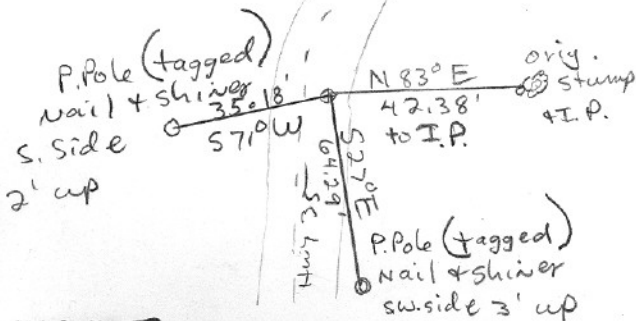
set RR spike w/punch mark
 approx 4' E. of Hwy 35

H.R.E.C. Pole #

000020

S71°W 35.18'

000000

S27°E 64.29'

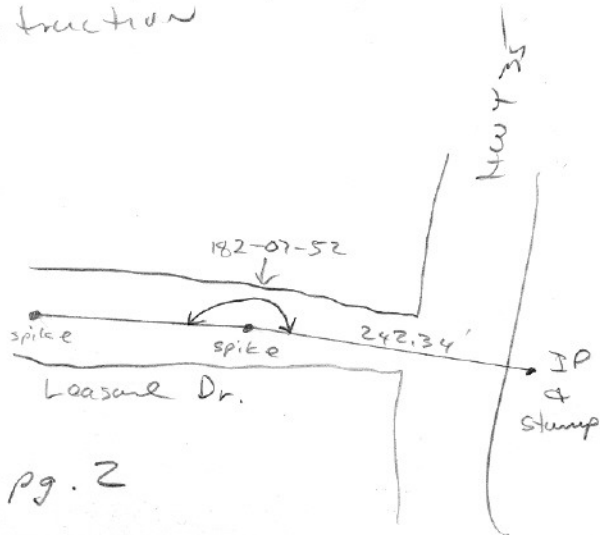
set 2 RR spikes ON & Leasure Dr.
Turned X to pipe at face of BT stamp.
1/4 cor gone. will reset upon
completion of construction
