SECTION OR SUBDIVISION

TWP. 1 N., RANGE 10 E, W.M.

CORNER No. 850

CORNER DESCRIPTION

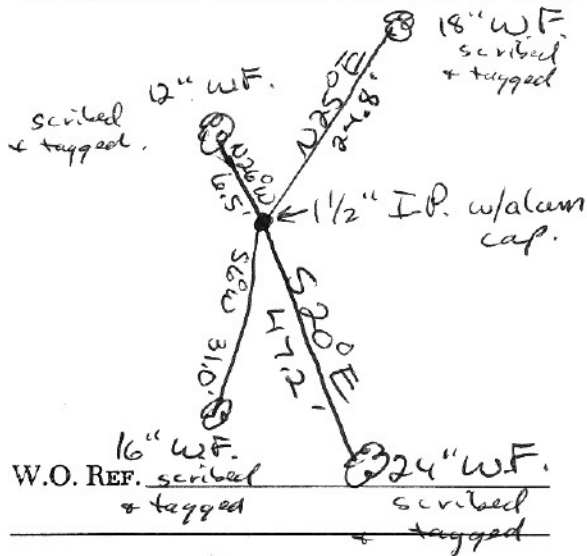
cor. is 1 1/2" I.P. w/ alum cap. Corner was reset by double proportion in 1994.

Trees were scibed in 1978. we changed distances & bearings on tags to fit new corner.

This corner had been set by double  
proportion in 1978. Due to the  
recovery of the original  $\frac{1}{4}$  corner  
between secs. 16/15 NW10E, the  
sec. cor. moved 16.80' north.

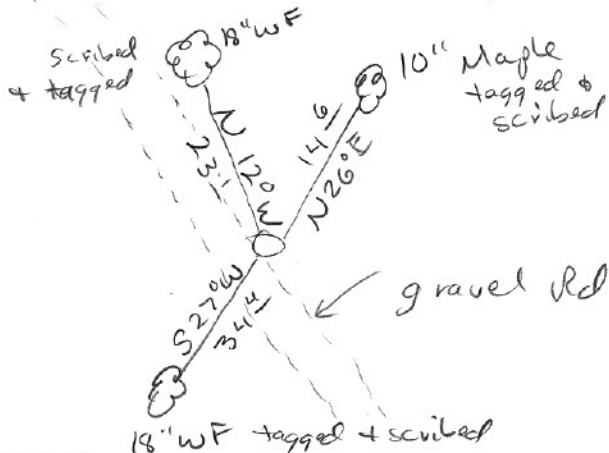
Drove 1 1/2" IP  
 w/ alum cap directly  
 over DLC  
 Iron rod. Corner  
 had been set  
 incorrectly in 1984.
