CEMETERY PLAT

UNITED CHURCH OF UPPER HOOD RIVER VALLEY
IN NW1/4 SW 1/4 SEC 33 T1 N R10 E WM
SURVY APRIL 1965
SCALE 1in = 40ft

Survey of Upper Valley Community Church Property Section 33, Township 1 North, Range 10 EWM.

Date of Survey: Completed August, 1969

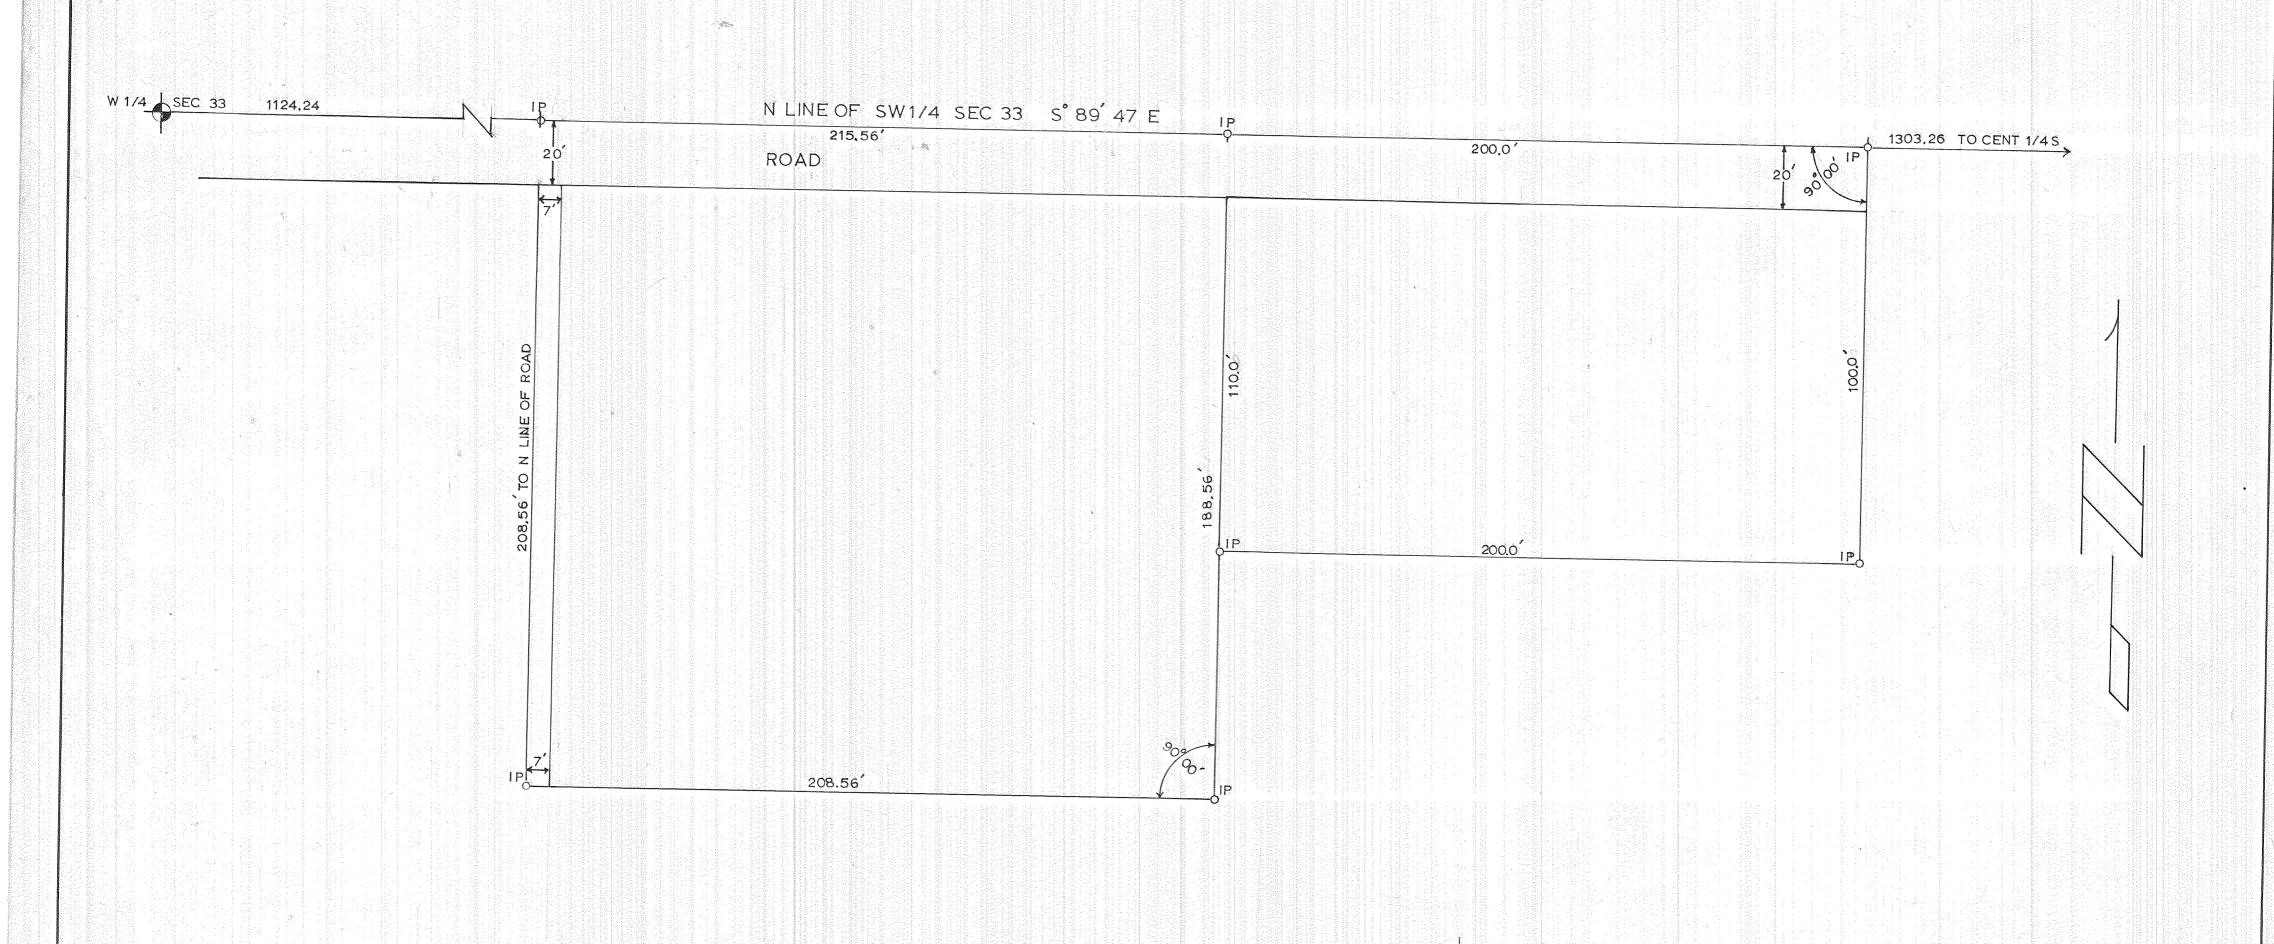
- 1. The 2 inch axle was not placed properly.
- 2. Had the 2 inch axle been placed properly the pipes placed in 1965, according to the Frey Plat, are not on line between the quarter corner and either the true center or the 2 inch axle that has been assumed to be the center quarter.

In conclusion, it is the opinion of this office, that to establish the cemetery, as the deed description calls it, at the present time, would be impossible and that an exchange of deeds between the concerned parties and to rewrite the description of the cemetery and adjoining lands would be in order.
