T 1N R 9E M WILL.

CORNER RECORD (SEARCH)

T 1 N 9 E R.D. Hood River County Hood River

Merid. Willamette N.F. Mt Hood State Oregon

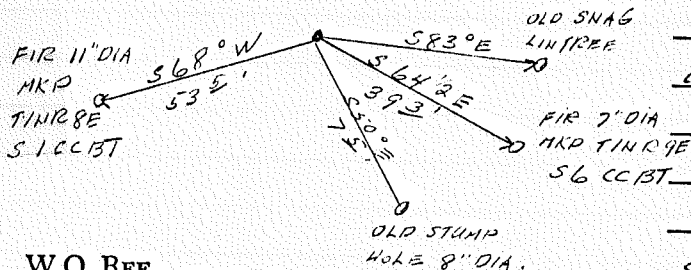
CC SEC 6 T4N R9E
SEC 1 T4N R9E
SET 2" I.P. IN GROUND
WITH STONE COLLAR
12' x 12' x 12' WITH BRASS
CAP MKD

T2N
CC 136
R9E 129E
NO. 625
FIN
SET 10-4-69
HOOD RIVER COUNTY

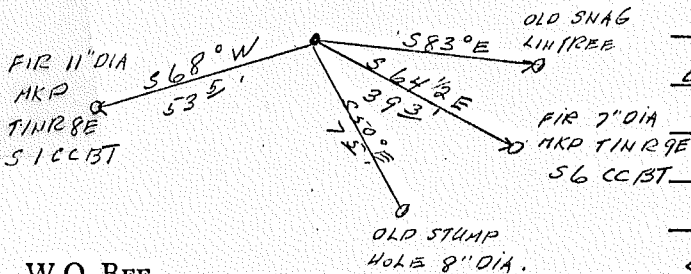
CC SEC 6 T1N R 9E
SECT 1 T1N R 8E
SET 2" T.P IN GRND
WITH STONE COLLAR
12" x 12" x 12" WITH BRASS
CAP MKD

T2N

CC T36
R8E R9E
N0.625
FIN

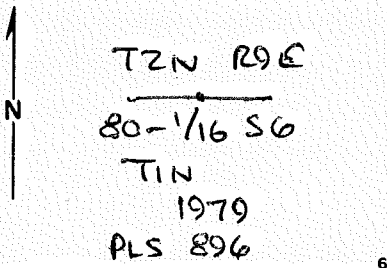
CORNER DIAGRAM

Found 2 inch iron pipe with brass cap stamped as shown (set in rock mound by "Bishop" in 1979).

Corner is on brushy, burned over ridge approximately 100 feet West of 5 acre "boulder patch". Go East 700 feet from Southwest 31 to corner.

Found witness post 4 feet East of monument.

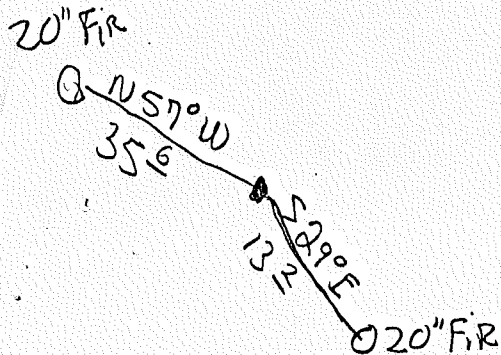
CORNER No. 806

BT's:

20" FIR N 57° W 35.6
20" FIR S 29° E 13.12

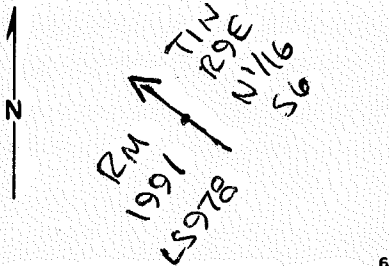
CORNER DIAGRAM

Grouted a 2 1/2 inch brass cap in a 4'X4' boulder as a reference monument to the 1/16 corner (cap is stamped as shown).

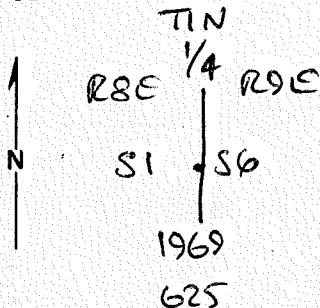
CORNER DIAGRAM

Found a 2 inch iron pipe with brass cap set by Hood River County in 1969 stamped as shown.

Found witness post 1.5 feet North of monument.

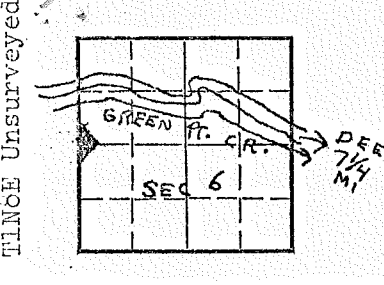
4. Description of Corners: Consists of 2 1/2" galv. iron pipe, 12" above ground, set in concrete/Brass cap marked by Hood River County Official. Loc. good. Not original

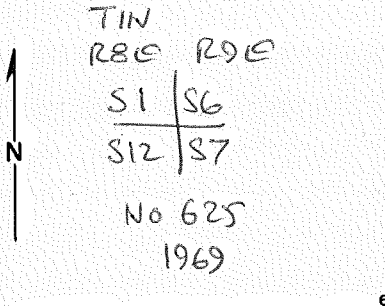
CORNER DIAGRAM

Found a 2 inch iron pipe with brass cap set by Hood River County in 1969 (by single proportion).

Found witness post 0.8 feet East of monument.

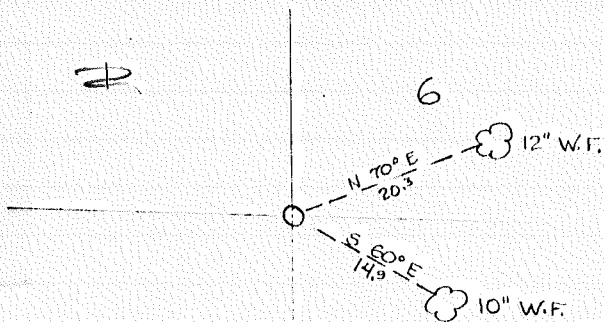
CORNER 15 2" I.P. WITH

BRASS CAP.

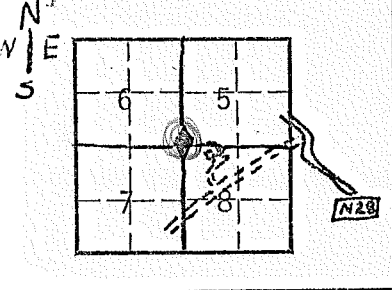
4. Description of Corners: Consists of a cement post 2" dia., 12" above ground with a ~~BLM~~ brass cap.
~~GENERAL RECORD~~

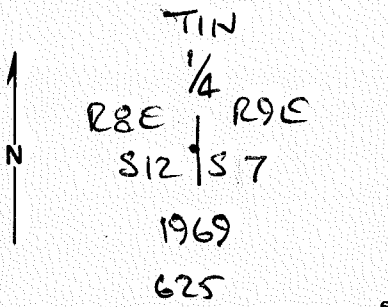
CORNER DIAGRAM

Found 2 inch iron pipe with brass cap set by Hood River County in 1969 stamped as shown.

Found witness post 1 foot East.

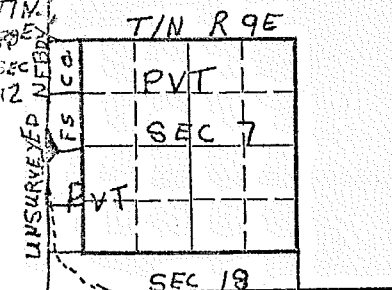
4. Description of Corners: 2" iron pipe. Brass cap, stamped: (10" above ground)

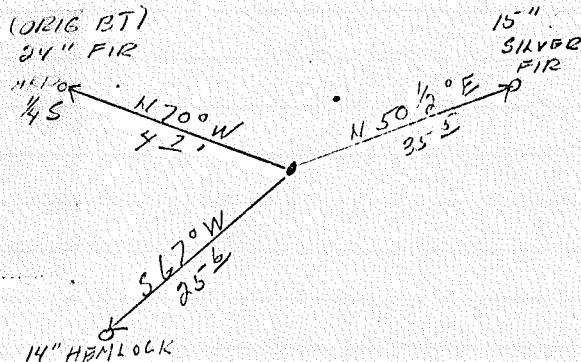
CORNER No.212.....

RESET FROM ORIG. 13T'
4 GLO NOTES
SET 2" GAL PIPE W/3PASS
CAP MKD
1/4
S12/S7
R9E/R9E

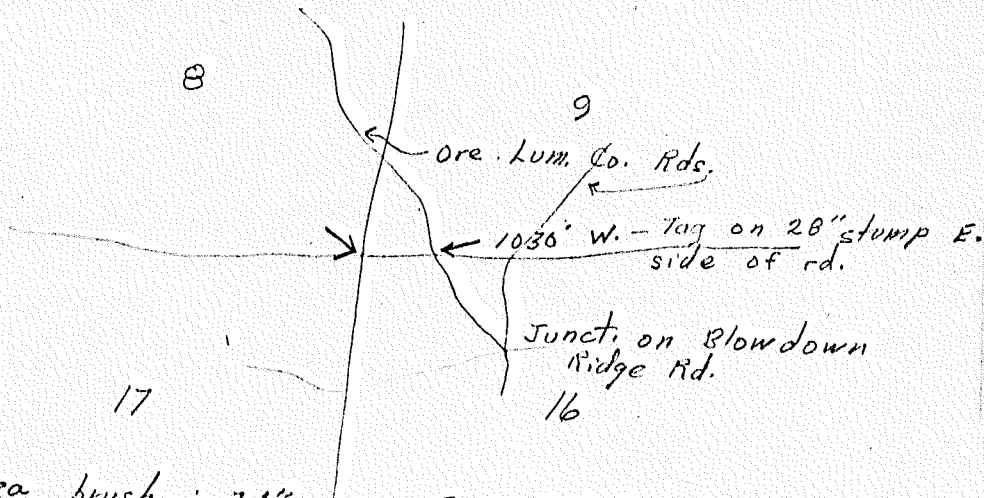
Area brush ; 34" green Fir, 50' from cor.
} other trees burnt snags

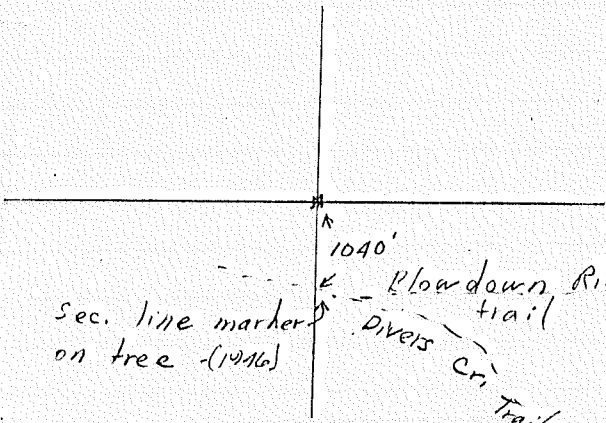
Sec. line marker on tree (1916)

1040'
Blowdown Ridge trail
Divers Cr Trail

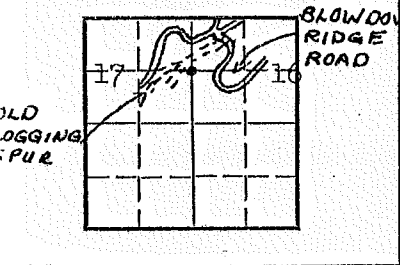
1. T 1N R 9E No. L9 Cor. 1/4 Mer. WM State Oregon (Rectangular) N. F. Mt. Hood Dist. Hood River

2. Corner Status
Common to 16 and 17

Broken	Tree	Stump
	B.T.	B.T.
Species	Hemlock	Hemlock
Diameter	20"	20"
Bearing	N50°E	S30°W
Distance	9'	12'

Believed to be a genuine Land Office Corner. The original corner is gone. An old road bed where corner should be. A pile of rocks & stake set where original corner should be. Metal Location Post is on a old D. Fir stub 16' high 36" diameter on the N.E. side from which this Corner bears 70° 20'. This 1/4 corner is in old logging between switchback on main road and old logging spur as shown on sketch. This corner is located in the lowest part of a slight ravine

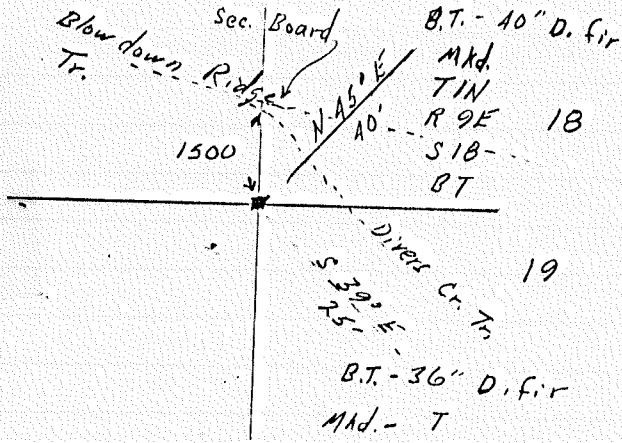
CORNER DESCRIPTION

B.T. - 40" D. fir
Mkd.
TIN
R 9E 18
S 18-
BT

Found by Geo. Frey
11-61. No Vent. P. 1011
given.
Rock
Ed. by V.P.E. - May 27, 1911

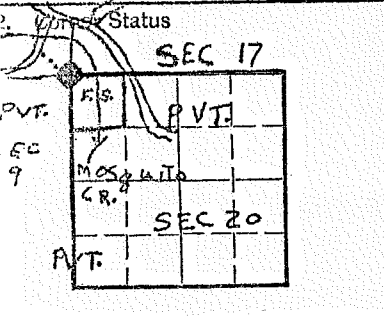
T IN R 9E No N-5 Cor. Sec Mer. W State Oregon (Rectangular) N. F. Mt. Hood Dist. Hood River

4. Description of Corners: Sec cor. 1 1/2" iron pipe, 20" above ground, aluminum cap marked: FIN R9E
1817
1920
2319 An iron fence post 3' above ground.

A silver fir 9" dbh, N60°W, 10' distant. Blaze partly overgrown, ~~iron~~ marks visible, Good condition.

A silver fir 8" dbh S27°W. Blaze partly overgrown, ~~iron~~ marks visible, good condition

A W Fir 9" dbh S 34°E, 21' distant, Blaze partly overgrown, ~~Iron~~ marks visible, good condition

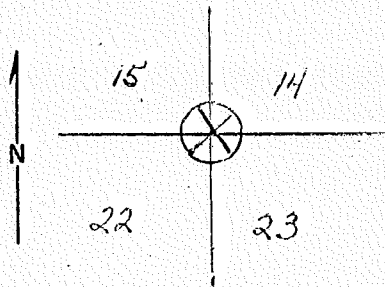
CORNER DIAGRAM

DESCRIBE BEARING TREES OR OTHER OFFICIAL ACCESSORIES FOUND ²
Rock-Iron bar in place, good condition, 1x1x6" above ground. No markings found. Mound of rock is located at base of bar. All bearing trees destroyed by fire. Believed to be genuine. Corner was found when the bearing trees were standing. Section line marker between Secs. 22 & 23 on a post on Lost Lake Road 250' S from sec. cor.

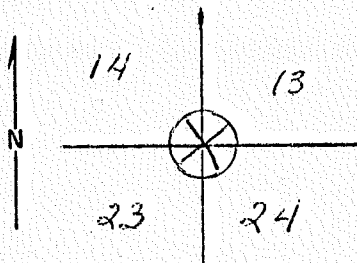
CORNER DIAGRAM

DESCRIBE BEARING TREES OR OTHER OFFICIAL ACCESSORIES FOUND ² Iron Pipe & Stake in place, good condition. Pipe 2"x20", stake 4x4x24" above ground. Card. position L 57 Diag. Position on NE side S 13. No bearing trees. Not genuine. Corner was established by Oregon Lbr.

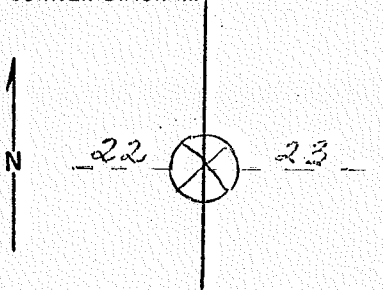
CORNER DIAGRAM

DESCRIBE BEARING TREES OR OTHER OFFICIAL ACCESSORIES FOUND Stake good condition
above ground 3x3x24" marked $\frac{1}{4}$ on W side. Scription overgrown -
D.F. 16" dia. bearing S21°30'E dist. 15'; D.F. 10" dia. 10" bearing
S23°W dist. 12'. Not genuine. Replacement. Staff compass - chain
from sec. cor. 40 ch. N.

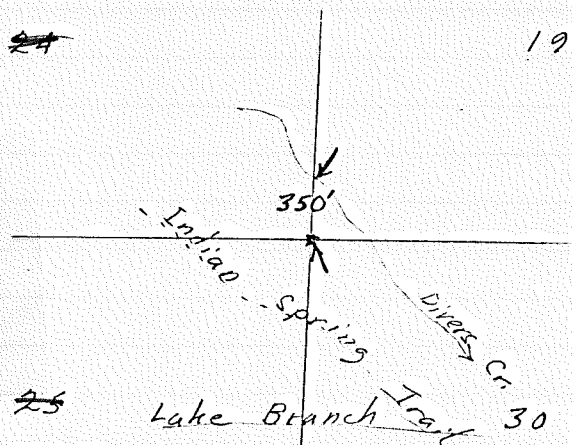
CORNER DESCRIPTION

Sec. Cor
 10" x 10" x 8" rock
 R.T.S - 24" D. Fir stump,
 N.W. 15' mhd. T.N. R.B.E.
 S 24 RT ; 20" down W.
 Fir SW 6' mhd. T-S-B.T.
 12" down W. Fir SE 10' mhd
 T.N. - R.B.E. - S. 30 - B.T.
 Ed. by V. B. E. 4/17/44

Follow Ore. Lum. Co. log rd. to boundary
line mark - follow marked line S. to cor.
BT's in bad condition

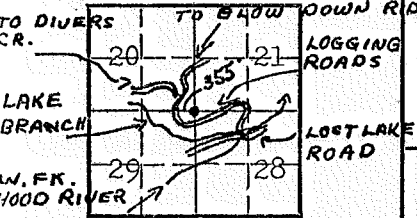
4. Description of Corners: Corner consists of a iron pipe in place. Good condition. Dimensions above ground 1 1/2"x8".

5. Investigation Notes: ALL MARKINGS BURNED OUT

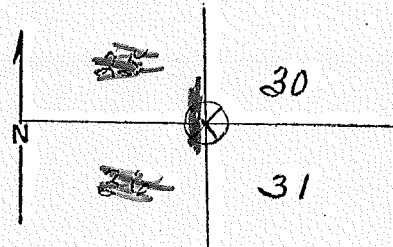
CORNER DIAGRAM

Pipe with brass cap.

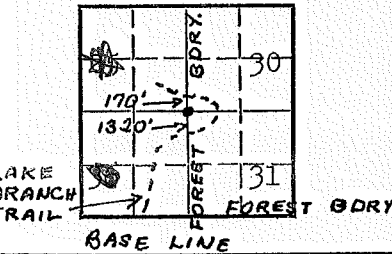
1. T. 1N R. 9E No. V-1 Cor. Sec Mer. WM State Oregon (Rectangular) N. F. Mt. Hood Dist. Hood River

2. Corner Status COMMON TO 30, 31, 25 & 36

4. Description of Corners: Corner consists of a rock in place. Good condition.

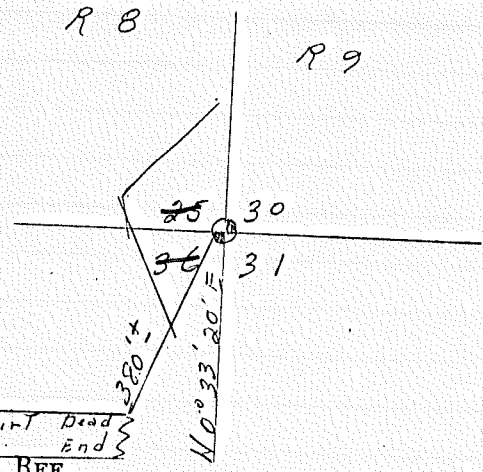
10' dirt Dead End Rd.

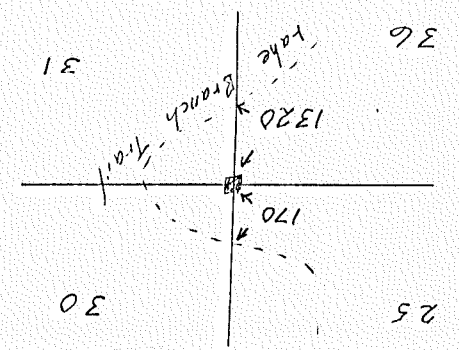
Sec. Cor.
 Rock - fd. by V.B.F. - 2/15/44
 R.T's
 16" D. fir snag
 TIN R9E S31
 R.G.S.
 11/11/55
 22" D. fir snag
 scribed on bark

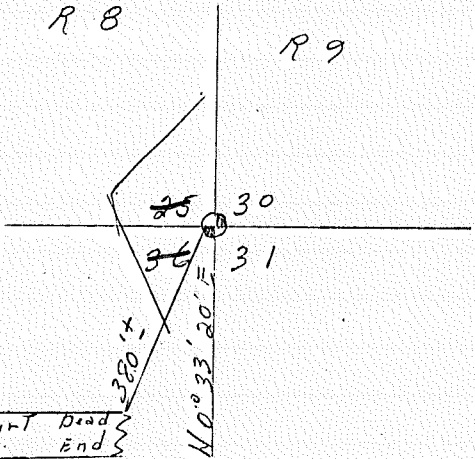
NW Cor Sec 31
fd 1 1/2" Pipe w/cap

Y = 683,619.03
X = 1,678,251.48

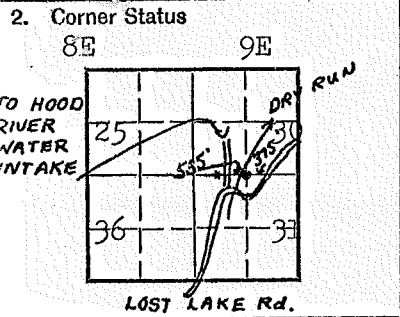
1. T 1N 8& R 9E No. V3 Cor. 1/4 Mer. WM State Oregon N. F. Mt. Hood Dist. Hood River

4. Description of Corners: Corner consists of an iron pipe. Dimensions above ground not none. Iron pipe seen by Eric S. Nance March of 1960. Documented on Field Map Sheet for H.R.Co. Forest Resource Inventory in Timber dept. Common to 30 & 31

5. Investigation Notes: No bearing trees. Not believed to be a genuine Land Office Corner. No iron pipes put in at time of survey. Evidently replacement. Location correct.

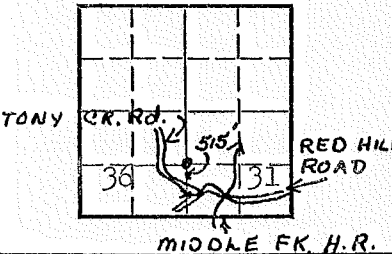
1. T 1N R 9-10E No. 125 Cor. 1/4 Mer. WM State Oregon N. F. Mt. Hood Dist. Hood River

4. Description of Corners: Corner consists of a stake in place. Good condition. Dimensions above ground 4x4".

5. Investigation Notes: Markings ? ?
Species
Not believed to be a genuine Land Office Corner. New stake evidently replacement. According to bearing trees location correct.

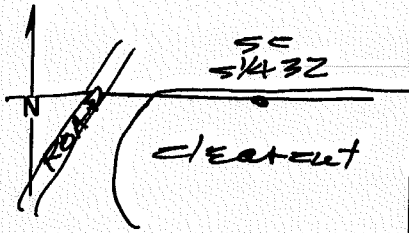
CORNER DIAGRAM

Found BLM Dress cap
Found

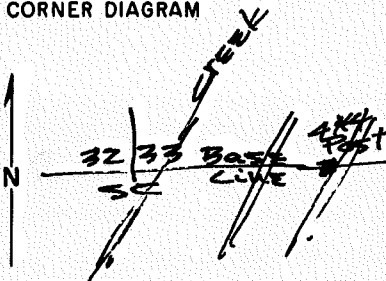
CORNER DIAGRAM

Found loose 2" IP with BLM stamped brass cap

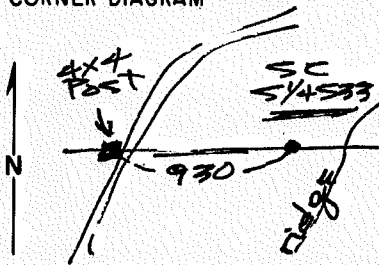
CORNER DIAGRAM

Found BLM stamped brass
cap on 1" I.P. -
Pipe loose

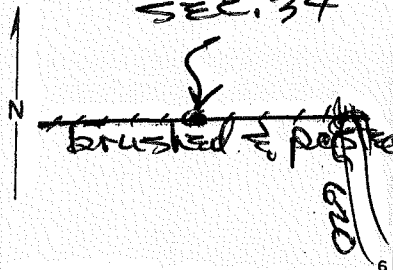
5/4 COR
SEC. 34

BLM 1940 stamped Brass Cap

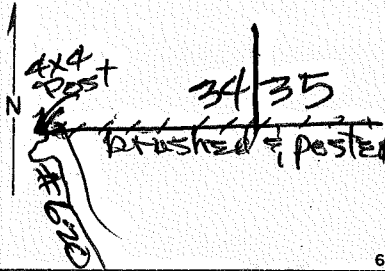
CORNER DIAGRAM

BLM 1940 stamped brass cap

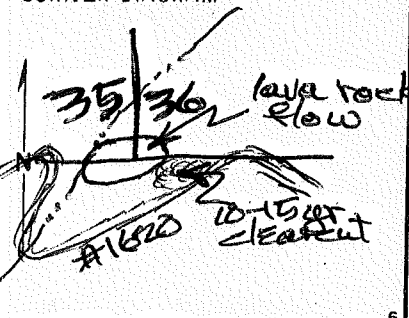
BL.M. 1940 stamped Brass Cap

4' stump of orig. 55" D.F. - N. 20° E. - 113.52'
Remains of orig. 22" Fir - S. 55° W. - 28.38'
20" D.F. 1940 BT (healed) - N. 06° E. - 125.4'
18" W.F. 1940 BT (healed) - N. 81° W. - 83.82'

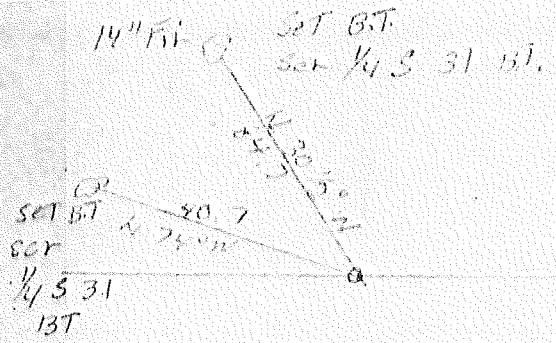
TWP. 1N, RANGE 10 E, W.M.

SET 1/4 S 31 BT
2" C.I. 1 P. 100
TIN RICE
1/4 S 31
1966
Remains of corner of
sec 1
y 671 105 7/2
x 715 08 24
