T 1S R 10E M WILL.

LAND CORNER RECORD  
(Rectangular)

1. T 1S R 10E No. A-1 25 Cor. Sec. Mer. Will. State Oregon N. F. Mt. Hood Dist. Hood River

T 10 R. 10E R.D. \_\_\_\_\_ County Hood river  
Merid. Willamette N.F. Mt. Hood State Oregon

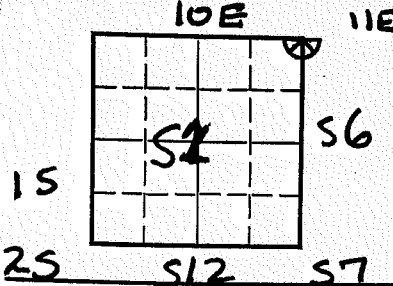
4. Description of Corners: Cor. est. Nov. 1882. Int. B.L. 857 lks. E. old Cor. S31 & S32 TLN, R11E, a post 1" sq. mkd. TLN, B.L.; new Cor. S31 & S32, TLN, R11E, bears W, 90 lks. a basalt stone 10x10x7, mkd. 5 notch. E & 1 notch W. w/B.L.N. face; set a basalt stone 11x12x7, 10" in grd. mkd. CC w/6 notch. on S, E, & W edge 20" fir bears S61° E, 62 lks. mkd. T1S, R11E, S6, BT; 12" fir bears S53° W, 113 lks. mkd. T1S, R10E, S7, BT.

Corner consists of rock & stake, 12x16x3, above grd 12x12x3, poor condition, no marks. DF 6' stump 32" S 64° E 41' T1S, R11E, S6, BT. Put Form 448 on it. WF 2 1/2" Face down S 53° W 7 1/2'. Think this is the other BT. Metal tag on WF 6" S 50° E 15'. Best way to cor is from logging rd into Unit #1 Wasco Sale. Take old rd SE in old Unit app 1 mi or from main rd, go to end of rd then follow fire trail East on South side of old Unit to cor. Old Unit is #2 Stecco Sale.

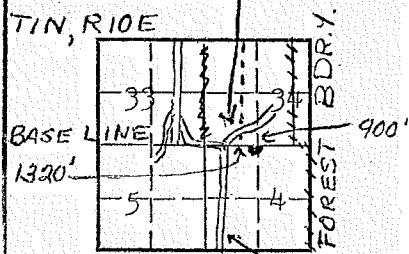
1. T 1S R 10E No. A11 Cor. 1/4 Mer. WM State Oregon N. F. Mt. Hood Dist. Hood River

4. Description of Corners: Corner consists of a stake and rock in place. Good condition. Dimensions above ground stake 3x3x24, rock 8x8x10". Mound of rock is located around corner.

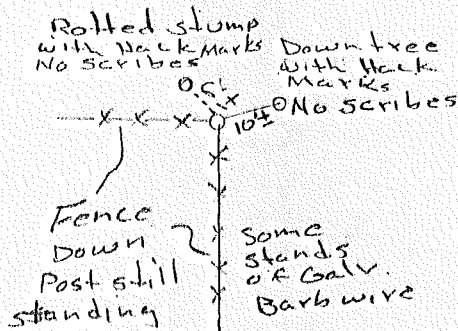
ED Old Fence  
Cor. (cedar pole 6'  
out of ground).

Fence Cor is best  
evidence of  $\frac{1}{4}$   
Cor but does not  
fit 60' <sup>calls</sup> from the  
South by 40' & from  
the North by 16'  
ACK Mar 1977

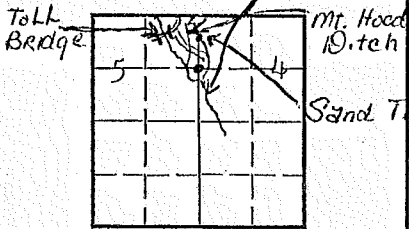
2. Corner Status EAST FORK Hood River

4. Description of Corners: Corner consists of a ..... No Corner found.

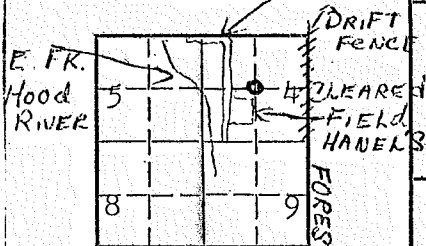
2. Corner Status Smullin Rd.

4. Description of Corners: Corner consists of a stake. Dimensions above ground 3x3x12".

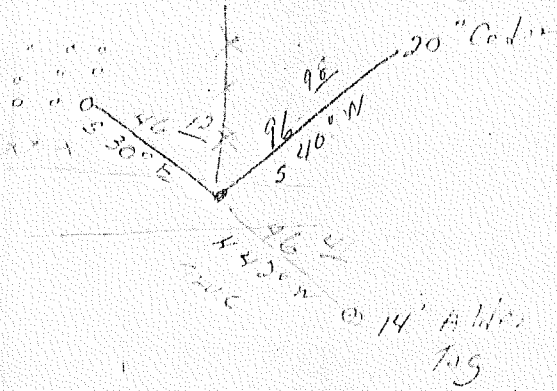
CORNER No. .... 31 .....

Re-estimated  
 Destroyed by wind  
 Const.

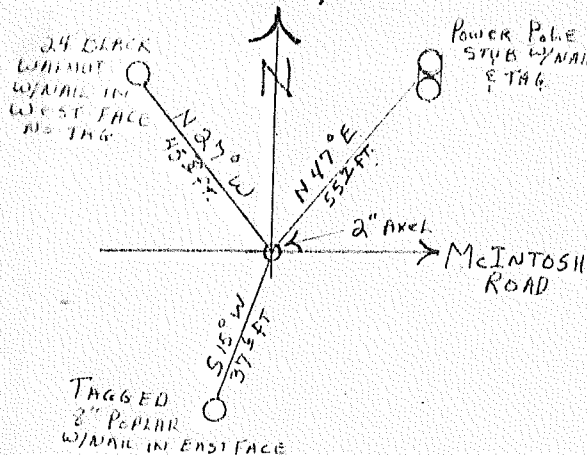
CORNER No. 195

FOUND 2" AXEL, SET FLUSH  
IN ROCK GARDEN. (CINDERS)  
NEAR WEST END OF McINTOSH  
ROAD @ BRANSON RANCH.  
11-2-71

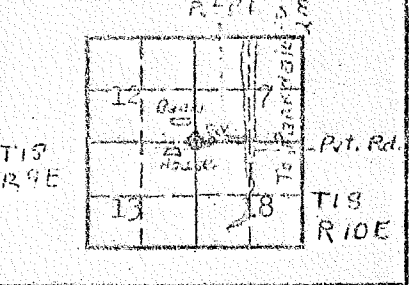
1. T. 18 S. R. 9-10E No. 31 Cor. Sec. Mer. WM State Oregon N. F. Mt. Hood Dist. Hood River

4. Description of Corners: Corner consists of a drive shaft. Good condition. Dimensions above ground 2x30".

5. Investigation Notes: No markings found. Ground all cleared. The corner was set by County surveyor Perkins. Location probably correct. Metal Location Poster is on a Corner Post 8" diameter on the South side of Private Road from which this Corner bears N.E. 46'. Drive south of Parkdale 2 miles on County Road. Then west on private road 1/2 mile. Old Macintosh Place. This is not believed to be a genuine Land Office Corner.

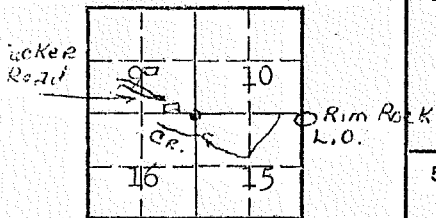
1. T 1S R 10E No. J13 Cor. Sec Mer. WM State Oregon (Rectangular) N. F. Mt. Hood Dist. Hood River

4. Description of Corners: Corner consists of a rock in place. Good condition. Dimensions above ground 4x8x10". Mound of rock is located around corner. Cardinal Position

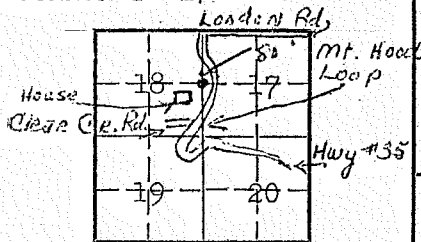
1. T LS R 10E No. L5 Cor.  $\frac{1}{4}$  Mer. WM State Oregon (Rectangular) N. F. Mt. Hood Dist. Hood River

4. Description of Corners: Corner consists of a rock (not) in place. Good condition. Dimensions above ground 8x8x7". **CARDINAL POSITION**

5. Investigation Notes: This is not believed to be a genuine Land Office Corner. Evidently replacement. Accepted by land owners and probably correct. Metal Location Poster is on a power pole 10" diameter on the West side of Pole at corner. This corner is 80' west of Loop Highway and at foot of small power pole west side.

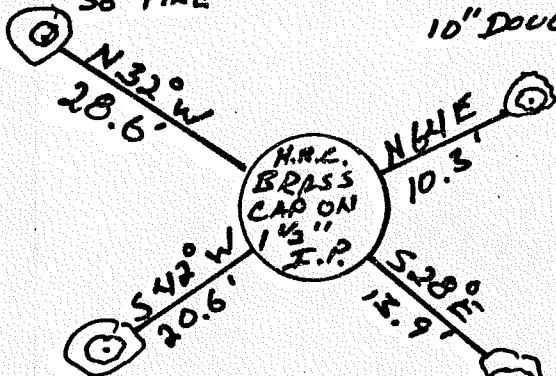
1 1/2" B.P. WITH  
B.C. (H.R.C.)  
MARKED 4 B.T.'S  
AS NOTED.

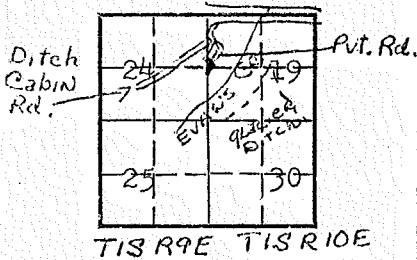
1. T T1S R 10E No. 19 Cor.  $\frac{1}{4}$  Mer. WM State Oregon (Rectangular) N. F. Mt. Hood Dist. Hood River

4. Description of Corners: Corner consists of a iron pipe in place. Good condition. Dimensions above ground 1x10".

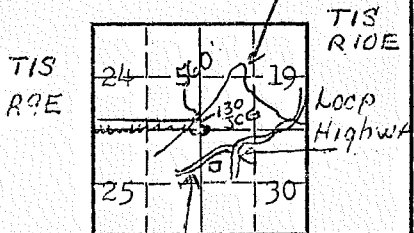
1. T. 1S R. 10E No. R1 Cor. Sec. Mer. WM State Oregon N. F. Mt. Hood Dist. Hood River

4. Description of Corners: Corner consists of a mound of rocks, 1½" iron pipe (not) in place.

5. Investigation Notes: No markings found. Not original corner but accepted by Land Owners and checks o.k. Metal Location Poster is on a Fir tree ? inches diameter on the North side of Glacier Ditch from which this corner bears South 560'.

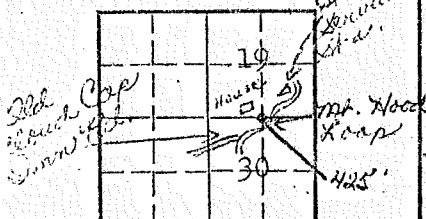
4. Description of Corners: Corner consists of a iron pipe in place. Good condition. Dimensions above ground 1"x12".

5. Investigation Notes: This is not believed to be a genuine Land Office Corner. At time of survey no pipes were put in. Evidently a replacement. Near East end of dwelling house.

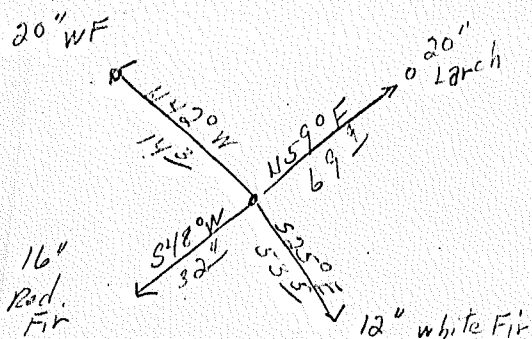
CORNER No. ....77.....

1/4 Cor. description  
Gen. E. 141.2  
CORNER PIN 1 1/2" dia  
WITH 2" LEAD CAP PLAIN  
BT'S check - CO. SURV  
5-1-70

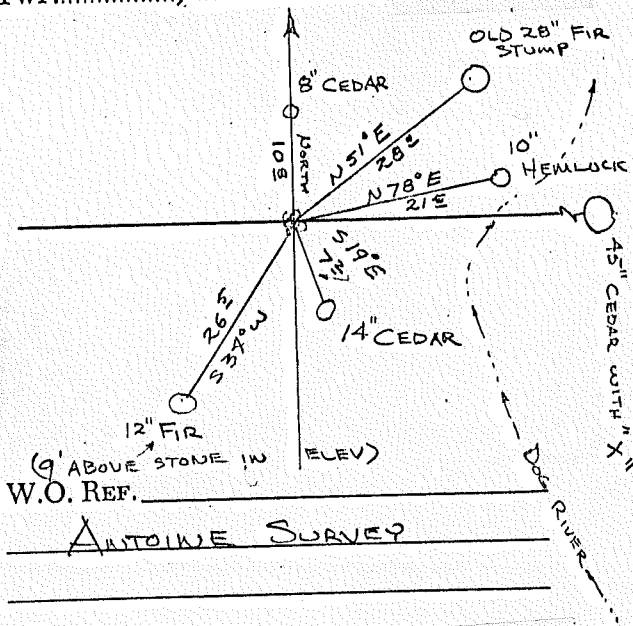
CORNER NO. ... 1.4 .....

FD. 4" x 6" x ?" STONE  
 AT BOTTOM OF STEEP HILL  
 NEAR CREEK. FD. ONE  
 OLD SCRIBED TREE. SET  
 A NEW B.T.'s SCRIBED.

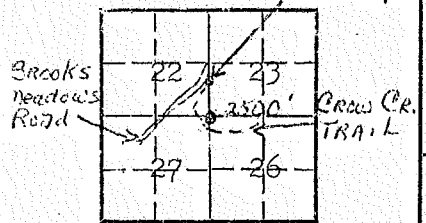
4. Description of Corners: Corner consists of a stake and rocks.

This is not believed to be a genuine Land Office Corner. New stake Evidently replacement. Location probably correct. This corner is directly on the Crow Creek Trail.

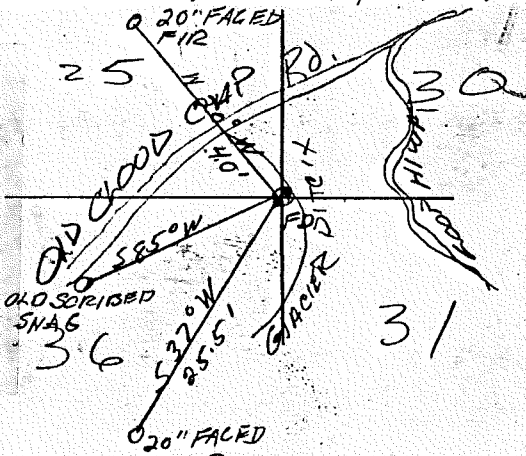
IP W/ BRASS CAP MOUND of  
Rock W of COR  
DF 6" S 85° W 5' DEAD  
WF 14" S 40° W 35' X  
DF 14" S 70° E 5'  
W.F.R 12" N 35° E 18' X  
P.F 14" N 12° W 19' X  
FOUND V.R.E. 46"  
9/29/66 ESN  
FD GLO BRASS CAP 9 MO OF STONE  
TENNESON 6-69  
 CARD..... OF .....

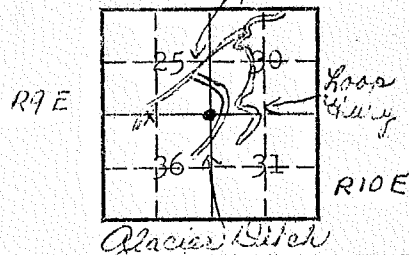
4. Description of Corners: Corner consists of a iron pipe in place. Good condition. Dimensions above ground 2"x12". Mound of rock is located West of corner.

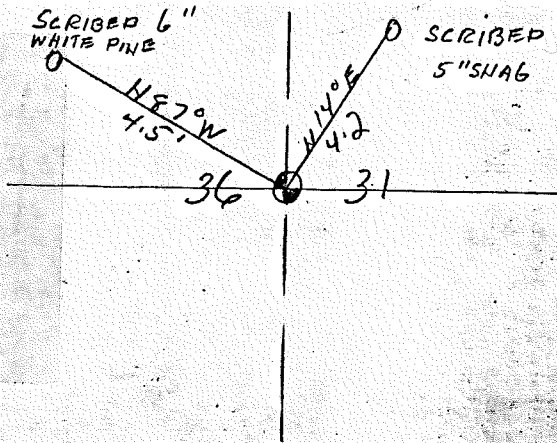
3/4 I.P. W/BRASS CAP  
 USGLO 1940  
 L.P. PINE 6" DBH. N25°E 4' (200)  
 " 7" " N87°W 5'  
 9/27/66 ESN  
 REVISITED BY TENNESON 6-59  
 DRAWING FROM TENNESON NOTES  
 GLO BRASS CAP ON 1" PIPE

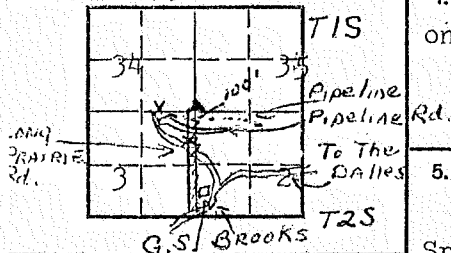
1. T. 1S R. 10E No. 217 Cor. Sec Mer. WM State Oregon N. F. Mt. Hood Dist. Hood River

4. Description of Corners: Corner consists of a stone in place. Good condition. Dimensions above ground 13x3x10".

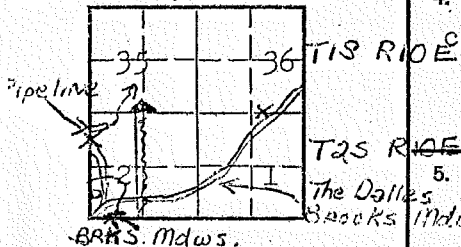
1. T 1S R 10E No. 219 Cor. 1/4 Mer. WM State Oregon N. F. Mt. Hood Dist. Hood River

4. Description of Corners: Corner consists of a Basalt stone in place. Good condition. Dimensions above ground 18x15x10".
