CORNER RECORD FILE GUIDE (Rectangular Surveys)

T 1S R 9E No. A5' Cor. Sec. Mer. WM State Oregon (Rectangular) N. F. Mt. Hood Dist. Hood River

CORNER RECORD (SEARCH)

LAND CORNER RECORD

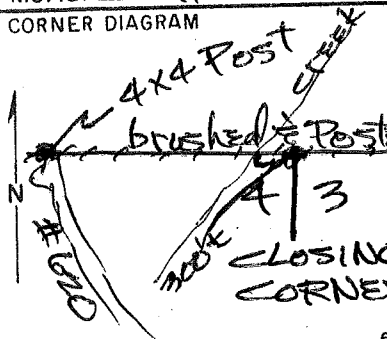
CORNER DIAGRAM

BLM 1940 stamped brass cap

22" D.F. 1940 BT (healed) S.10°E. - 105.6'
17" D.F. 1940 BT (healed) S.48°W - 97.02'

Find 4x4 post at end of rd # 620 -
walk East 2100 ± along posted line
to corner - corner sets N 300' East
of creek in rock slide on steep
slope

set polymer post with 54-4 sign attached
" " " " " " " "

Attached B.T. tags to 54-4 (Att signs) to BT's found -

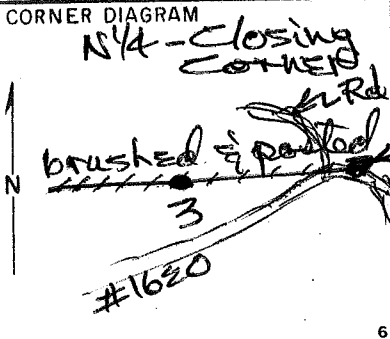
BLM. 1940 stamped brass cap

14" D.F. 1940 BT (healed) S. 22° E. - 38.94'

19" D.F. 1940 BT (healed) S. 29° W. - 51.48'

Get in vicinity by way of rd. #1620 - find 4x4 wood post where base line cuts road - follow posted line WEST 1000'± to corner

set polymer post with 54-4 sign attached
" " " " 54-2a " on Base line

Attached B.T. tags # 54-4 (ATT signs) to BTs found -

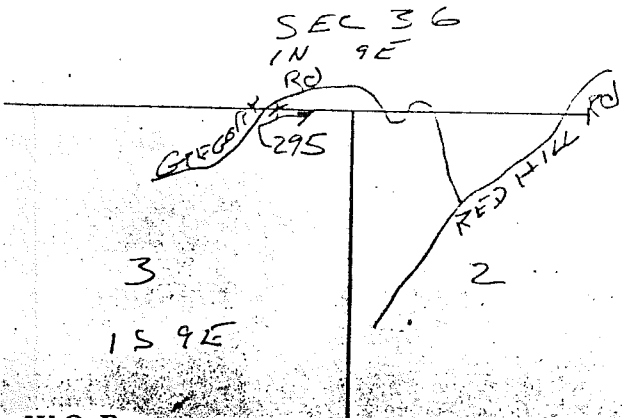
CORNER DESCRIPTION

I.P.W.I.P.A.S.S. C&P
D.F. 8" S.W. 60'
" 6" S.E. 10'
FOUND C. WELTY 1942

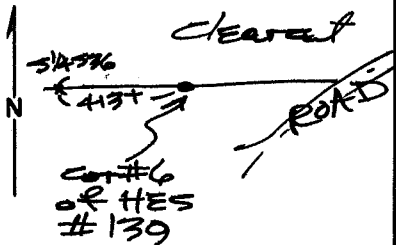
CORNER DIAGRAM

disturbed marked GLO Stone,
marking as per GLO.

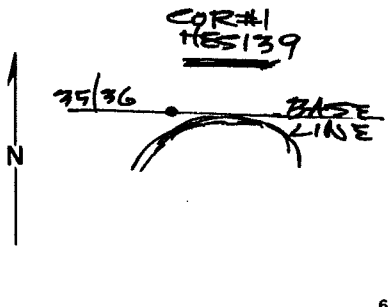
CORNER DIAGRAM

Found stone marked as per GLO

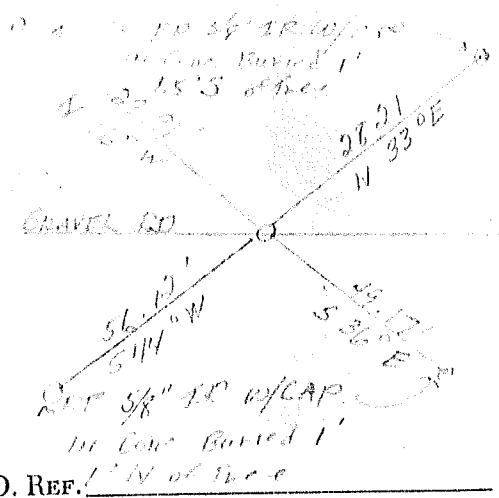
CORNER DESCRIPTION

N 1/4 CORNER
BRASS CAP MKD
T 15 R 9 E
S 31
N 4 S 1
T 15 R 9 E

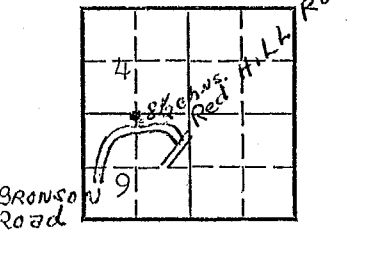
1. T 1S R 9E No. E11 Cor. 1/4 Mer. WM State Oregon (Rectangular) N. F. Mt. Hood Dist. Hood River

4. Description of Corners: Corner consists of a 3/4" iron pipe, brass cap in place. Good condition. Dimensions above ground 3/4"x12". Mound of rock is located W side of pipe.

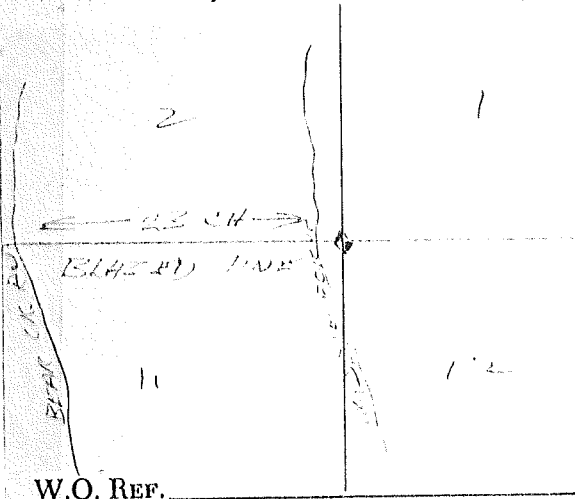
CORNER DESCRIPTION

1. BLAZED LINE 23.54
 N. 10.1'
 E. 70' 10° 25'
 S. 70' 240° 12'
 W. 35.28'
 6" 24° 14' CORNER
 FOUND BY SURVEYOR JULY 4, 1958

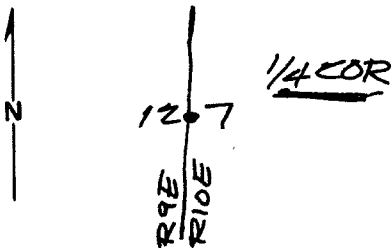
CORNER DIAGRAM

Found Perkins 1959 Survey I.P.s to North as per D.L.C. 7/10/85 survey

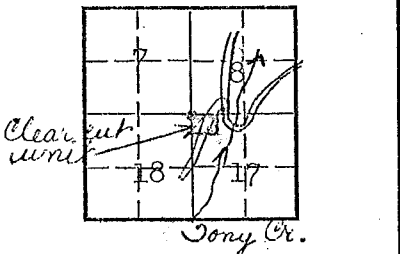
COMMON TO 7, 8, 17, 18

4. Description of Corners: Corner consists of a pipe w/brass cap in place. Excellent condition. Dimensions above ground 14". Mound of rock is located around pipe.

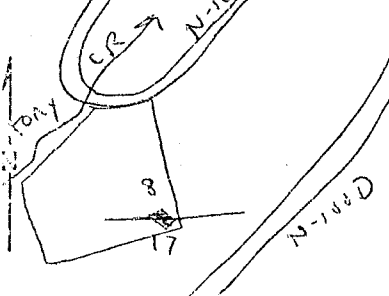
CORNER DIAGRAM

Iron Pipe 2" GLD Brass Cap. mound of Rocks -
12" ht. above ground. Corner is in excellent
condition -

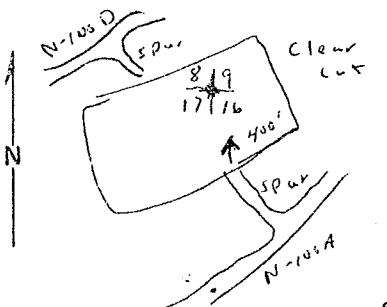
CORNER DIAGRAM

Iron Pipe with 2" G10 Brass cap. mound of rocks.
monument is in excellent condition.

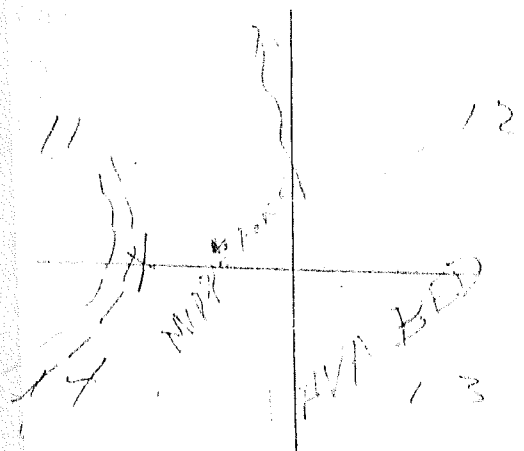
CORNER DESCRIPTION

T.P. W/ERAS CAP IN HOOD OF
ROCK

BE. 28° S 47° W 50'

FOUND VIR. E. JUNE 6, 45

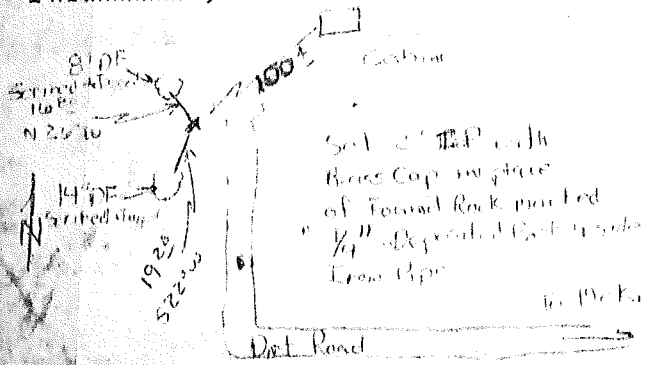
CORNER DESCRIPTION

Set 2" L.P. with Brass
Cap marked $\frac{1}{4}$ Cor S12
S13

Deposited Rock marked " $\frac{1}{4}$ "
beside Pipe

Marked two B.T.'s BT $\frac{1}{4}$
14" DF S22⁰W 1920
8" DF N26⁰W 116⁰C
B.H. trees were found 4-4-77

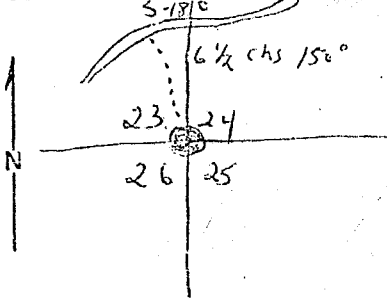
CORNER DIAGRAM

1940
Iron Pipe with GLD BRASS cap 2" 1' above ground
Excellent condition. Rock next to pipe - 18" X 12" X 12" WITH
2 NOTCHES ON SIDE AND ONE NOTCH COUNTERCLOCKWISE
ADJACENT SIDE (ROCK IS LYING ON ITS SIDE.) 2

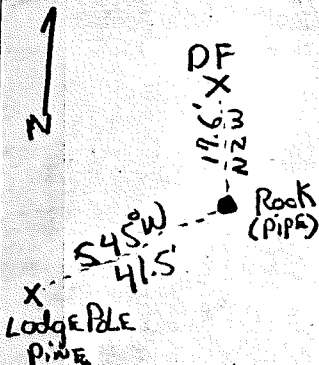
CORNER DESCRIPTION

Found orig. Rock w/x on top
 scribed on side. SET 1 1/2" PIPE
 w/NUM. CAP, SET NEXT TO ROCK.
 A 10" DF BEARS N 2° W 17.6'
 18" LP BEARS S 45° W 41.5'
 SET BY HRC. OCT. 24, 1979

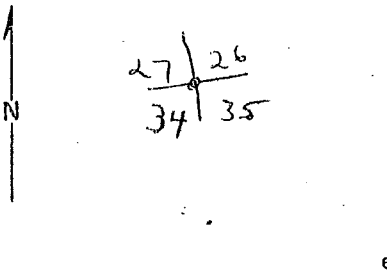
CORNER DIAGRAM

None

Corner was searched for by following N-S blaze line. No corner was found. There has been quite a lot of logging in the area. Assume corner has been destroyed -

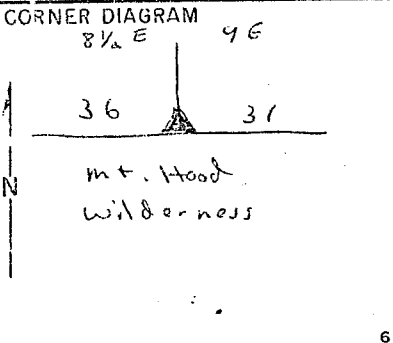
DESCRIBE CORNER MONUMENT FOUND
 Iron Pipe, 4" GLO Brass Cap. 6" ht. above ground.
 Rock next to pipe - Excellent condition -

DESCRIBE BEARING TREES OR OTHER OFFICIAL ACCESSORIES FOUND
 MH 21" DBH 350° 35' scribing visible & legible
 MH 12" DBH 64° 30' no scribing -
