**CORNER RECORD (SEARCH)**

T 2S R. 10E

R.D. Hood River County Hood River

1. T2S R 10E No. A1 Cor. Mer. WM State Oregon (Rectangular) N. F. Mt. Hood Dist. Hood River

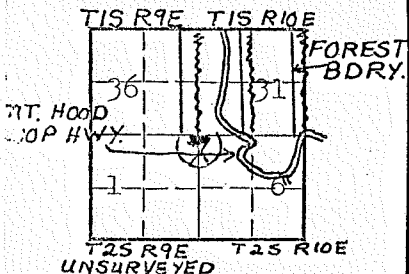
4. Description of Corners: Corner consists of a basalt stone in place. Good condition. Dimensions above ground 12x8x4".

Grown Over	T2S
	R10E
	S 6
	B.T.

Species	Hemlock	D. Fir Stump
Diameter	30"	36"
Bearing	S41°E	S24°W
Distance	16'	4'

Believed to be a genuine Land Office Corner. This corner is approximately 2000' West of entrance marker on the Loop Highway.

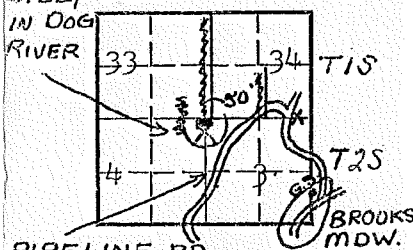
4. Description of Corners: Corner consists of a Basalt Stone in place. Good condition. Dimensions above ground 14x10x6".

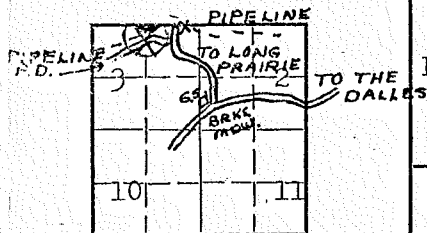
4. Description of Corners: Corner consists of a stone in place. Good condition

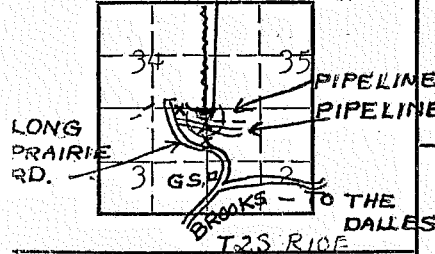
4. Description of Corners: Corner consists of a stone in place. Good condition. Dimensions above ground 10x6x5".

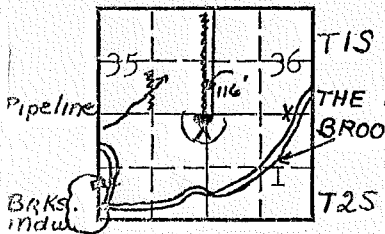
4. Description of Corners: Corner consists of a stone in place. Good condition. Dimensions above ground 20x12x6".

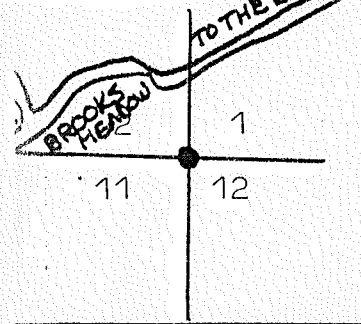
CORNER DIAGRAM

Rock- 11 x 6"- 4" above ground- in good condition but loose- Marked with X on top and 5 slashes on South face.

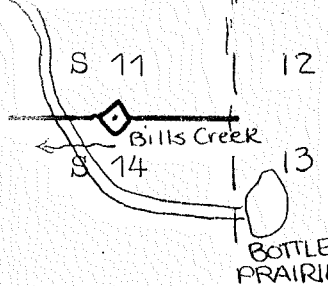
FIELD DIAGRAM

Rock- 10"x6"x7" above ground in good condition with X marked on top and 1/4 on North face.

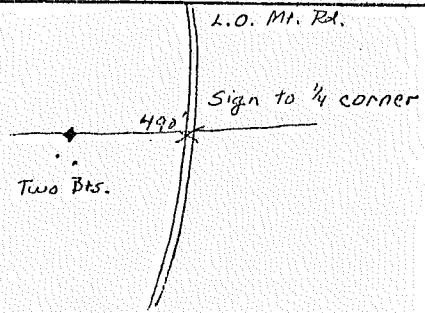
4. Description of Corners: N.B. 2 witness trees in Sec. 34. None seen in Sec. 27. This corner is inside a proposed logging unit #6, Horkelia Meadow Sale. Trees marked for high stumpage.

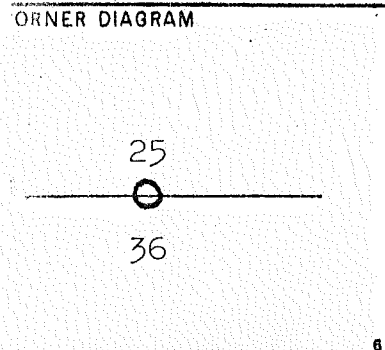
DESCRIBE CORNER MONUMENT FOUND  
No evidence of corner

DESCRIBE BEARING TREES OR OTHER OFFICIAL ACCESSORIES FOUND  
Timber not as described  
Survey calls in 1878 survey are not possible
