HOOD RIVER COUNTY RESTORATION FORM

Section: 5 Township: 1S Range: 9E DATE: 3/5/2012

CORNER DESIGNATION
WEST QUARTER CORNER

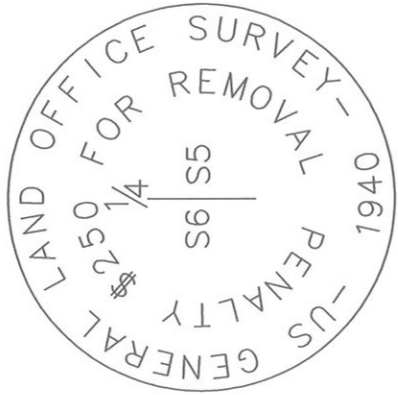
Monument Detail

FOUND AND HELD 2.5" GLO BRASS CAP STAMPED AS SHOWN EXPOSED 0.4' AS DESCRIBED IN THE GLO FIELD NOTES.
EXISTING REFERENCES:
(OBT) BADLY DECAYED FIR STUMP N 64° E 89 LINKS, NO MARKS VISIBLE, UNABLE TO ATTACH TAG
(OBT) BADLY DECAYED FIR STUMP S 78° W 47 LINKS, NO MARKS VISIBLE, UNABLE TO ATTACH TAG

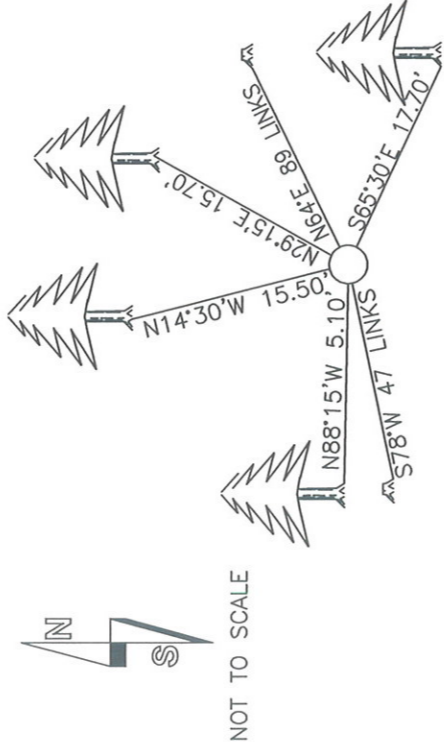
Sketch

NEW ACCESSORIES WERE TIED FROM CONTROL TRAVERSE AND BEARING ARE REPORTED TO THE NEAREST DEGREE DISTANCES WERE MEASURED TO A SPIKE AT SIDE CENTER WITH A STEEL BUCKERS TAPE

- 13" PACIFIC SILVER FIR SCRIBED "1/4 S5 RP" N 29°15' E 15.70' SIDE CENTER
- 10" PACIFIC SILVER FIR SCRIBED "1/4 S5 RP" S 65°30' E 17.70' SIDE CENTER
- 14" PACIFIC SILVER FIR SCRIBED "1/4 S6 RP" N 88°15' W 5.10' SIDE CENTER
- 12" PACIFIC SILVER FIR SCRIBED "1/4 S6 RP" N 14°30' W 15.50' SIDE CENTER
