FIELD NOTES

CS1367

FOR: Richard, Bill and W. W. Cannon W.O. 1003, Survey of Descriptive parcels in Lots 4, 5, and 6 Albee Tract in the E $\frac{1}{2}$ N $\frac{3}{4}$ Section 4, T2N R10E, W.M., Hood River County, Oregon.

DATE COMPLETED: November 19, 1971.

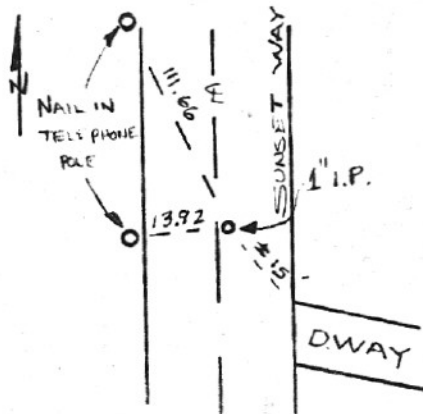
CORNER No. 2

CORNER DESCRIPTION
C¹/₄ COR.
1" IRON PIPE IN
ROADWAY - SUNSET WAY
F.S. LOCATION TAG
NAILED ON TELEPHONE
POLE 14' W OF COR.

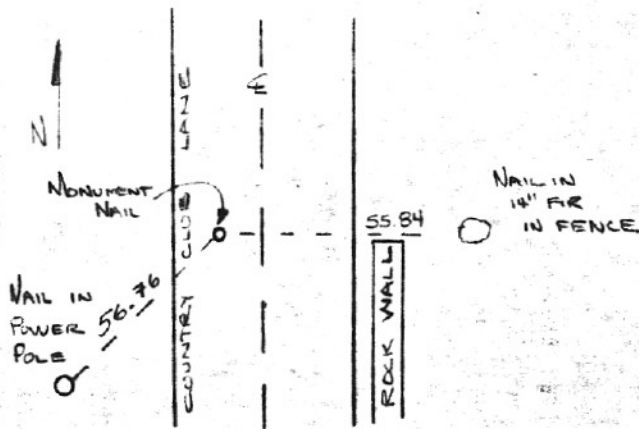
CORNER No. 1

CORNER DESCRIPTION
CENTER EAST ¹/₁₆ COR.
MONUMENT NAIL SET
IN ASPHALT 7' WEST
OF E STRIPE, COUNTRY
CLUB LANE

Upon re-establishing the center-East one-sixteenth section corner (being the Southwest corner of Albee Tract) a discrepancy of approximately 7.4 feet was noted along the West boundary of Albee Tract between platted distance of ± 2674.4 and measured distance of 2667.04. A field check was made to determine how this discrepancy would agree with the location of old existing fences in Albee Tract if prorated throughout all eight lots. It was found that if this procedure were used nearly all fences would fall considerably out of position. Usually in instances such as this where excess or deficiency exists in blocks adjoining a subdivision boundary, it is prorated only as a last resort. In this particular situation, in view of the more or less distances shown on the original plat of Albee Tract and the location of existing fence lines throughout the area, inference is that the original boundary line was erroneously established and later moved to the true location. For these reasons, it was decided to place all the deficiency in the last lot.

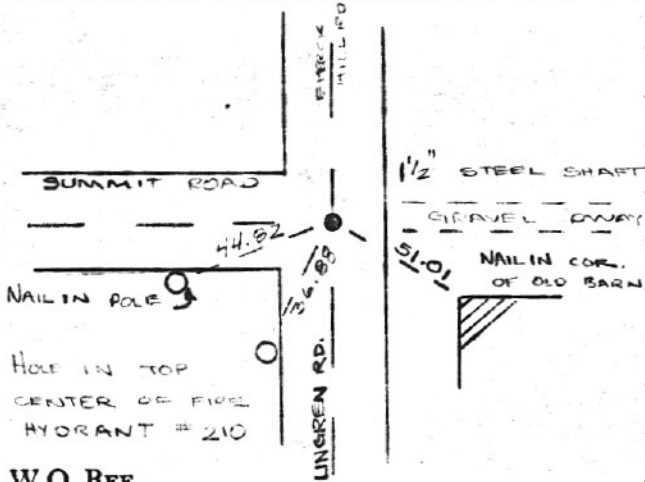
CORNER No. 4

CORNER DESCRIPTION
1/2" STEEL SHAFT AT
INTERSECTION OF SUMMIT
ROAD & LINGREN ROAD

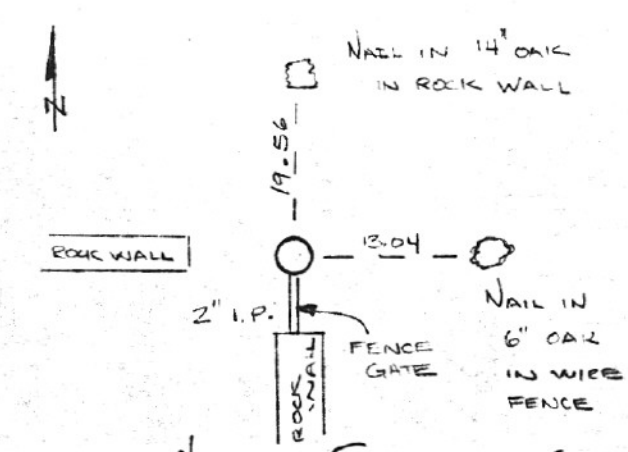
CORNER No. 3

CORNER DESCRIPTION
REPLACED LEAD PLUG
& HUB TACK WITH
BRASS CAP.

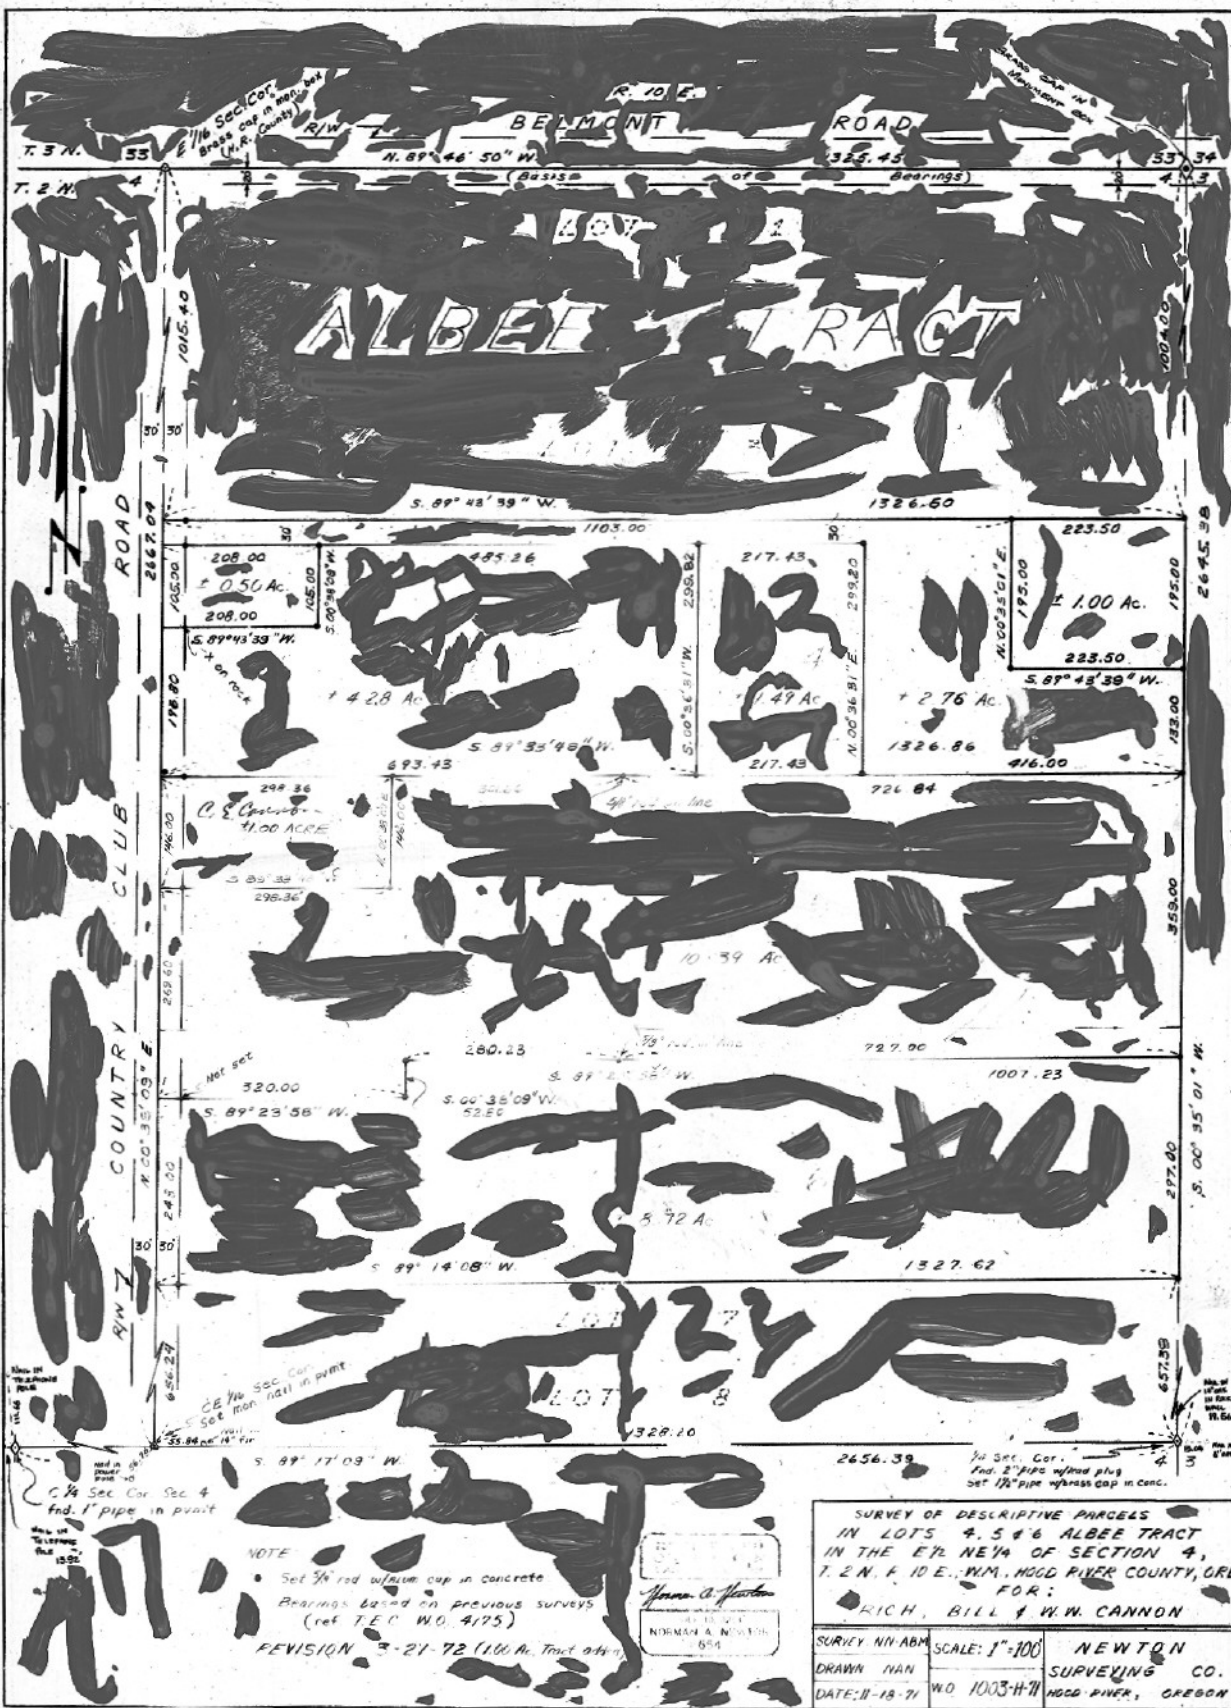
All corners found and established in the course of this survey, together with measured distances and angles are shown on the attached maps, which by reference is made a part hereof.
