Date	No.	Revisions	By	App.
		Survey		
For Chas. E. Krumbach				
In the N.W. 1/4 of the S.E. 1/4 Sec. 33,				
T. 3 N., R. 10 E., W.M.				
Hood River County, Ore.				
Design	TENNESON ENGINEERING CORP.			Scale
Survey	Consulting Engineers			1" = 500'
Drawn	412 West Second Place			Date
Checked	The Dalles Oregon			10-23-70
Approved	Work Order No.			Sheet
	4125			1 of 1

FIELD NOTES

FOR: Charles E. Krumbah, W.O. #4175. Survey of South line of his property in the N.W. 1/4 of the S.E. 1/4 of Section 33, T. 3 N., R. 10 E., W.M., Hood River County, Oregon.

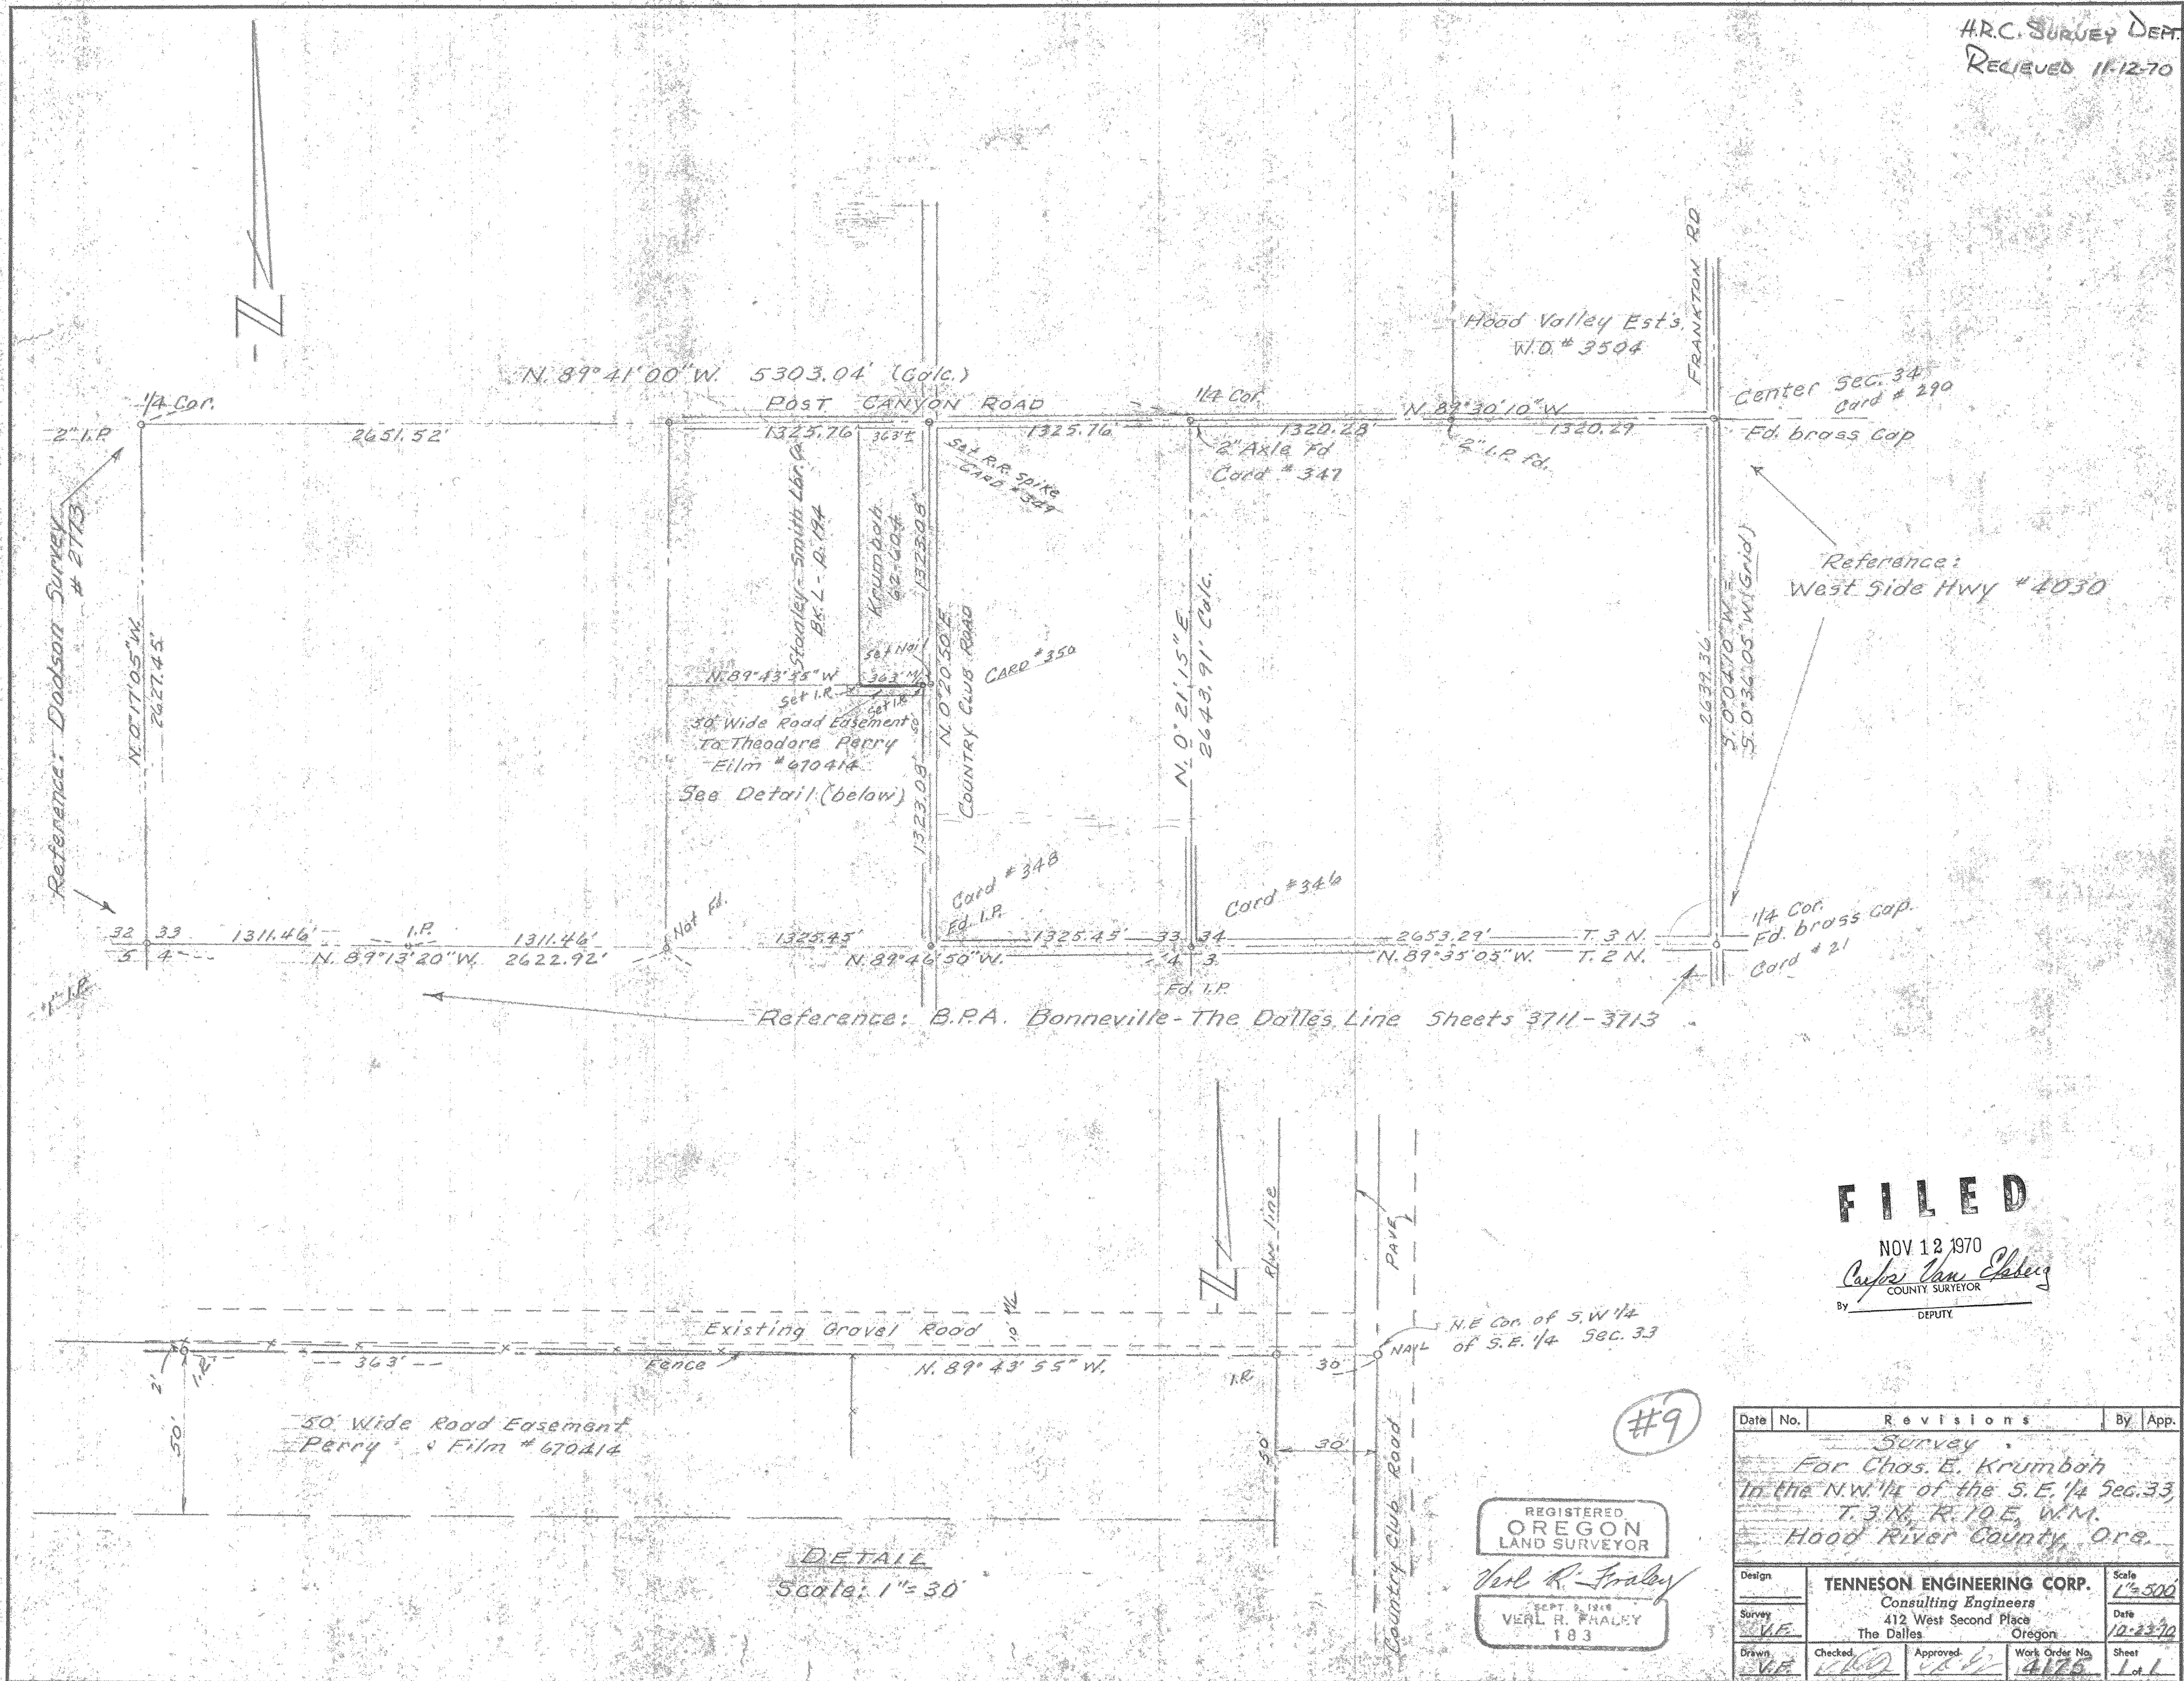
**DETAIL**  
Scale: 1" = 30'

Monuments found and set on this survey are shown on the attached map, W.O. #4175, which by reference is made a part of these notes.
