SURVEY OF DESCRIPTIVE PARCEL IN THE NW 1/4 SW 1/4 SECTION 35 T3N R10E WILL. MER. PROPERTY OF PAUL WORTHEN		
SURVEY: NN 3M	SCALE: 1" = 30'	NEWTON SURVEYING COMPANY HOOD RIVER, OREGON
DRAWN: BM	N.O. 1008-H-71	
DATE: 11-15-71

NARRATIVE FIELD NOTES

FOR: W.O. 1008-H-71 - Paul Worthen. Survey of a descriptive parcel in the NW $\frac{1}{2}$ SW $\frac{1}{2}$ Section 35, T.3N., R.10E. W.M., Hood River County, Oregon.

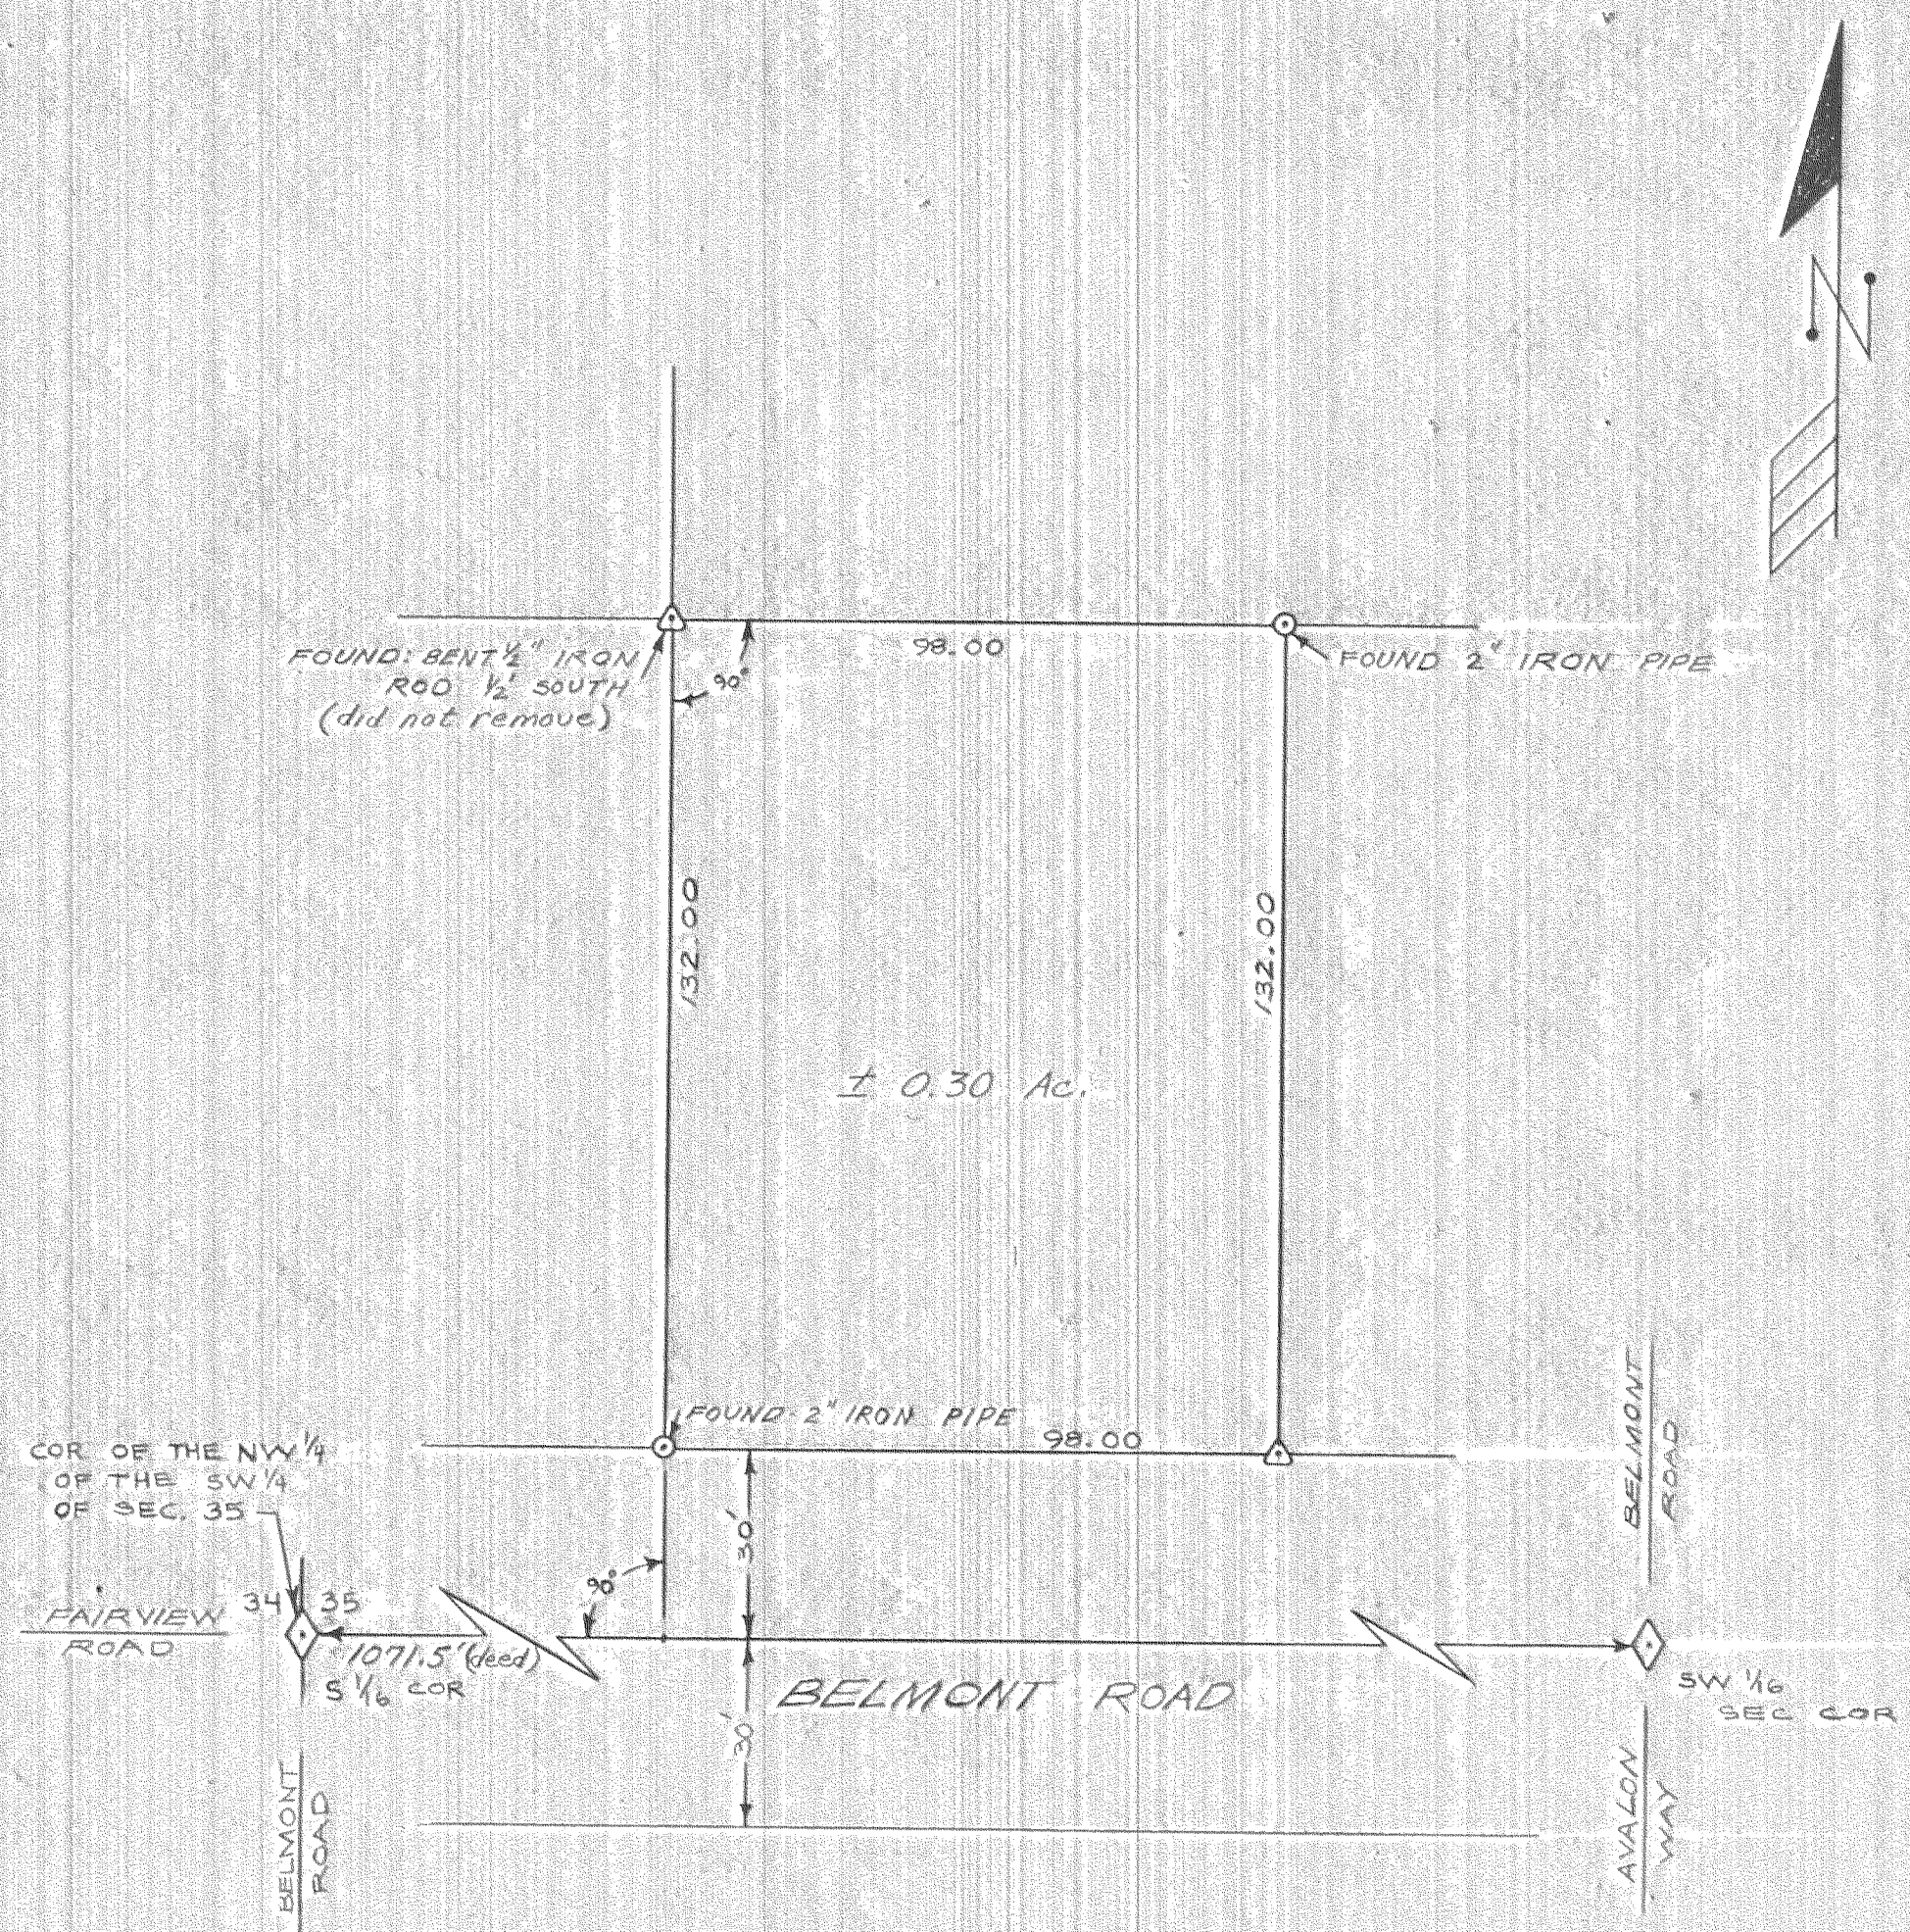
- △ SET 3/8" ROD W/ALUM CAP IN CONCRETE
- SET 2" PIPE W/ALUM CAP IN CONCRETE
- ◇ FOUND 1/2" IRON PIPE WITH TACK

A similar 2" pipe was recovered at the Northeast property corner. Record distances were intersected from the found pipes to the remaining two corner positions and a bent $\frac{1}{2}$ " iron rod was found 0.5 below ground at the Northwest property corner location and approximately 0.5 feet South of the intersected position. This rod was left in place and a new corner was established. The Southeast property corner was established on the North line of Belmont Road at record distance from the recovered 2" pipes.

All corners found and established in the course of this survey, together with measured distances and angles are shown on the attached maps, which by reference is made a part hereof.
