Survey
Lot 6, Division No. 1
in Sections 6 & 7
T. 2 N.; R. 8 E., W.M.
Hood River County, Ore.

CONSULTING
Engineers — TENNESON ENGINEERING CORPORATION

FOR: Work Order #3706 - Survey for Ray Yoder and Bud Rushton, Lot 6,
 Division No. 1 in Sections 6 & 7, Township 2 North Range 8 East, Willamette
 Meridian, Hood River, County, Oregon

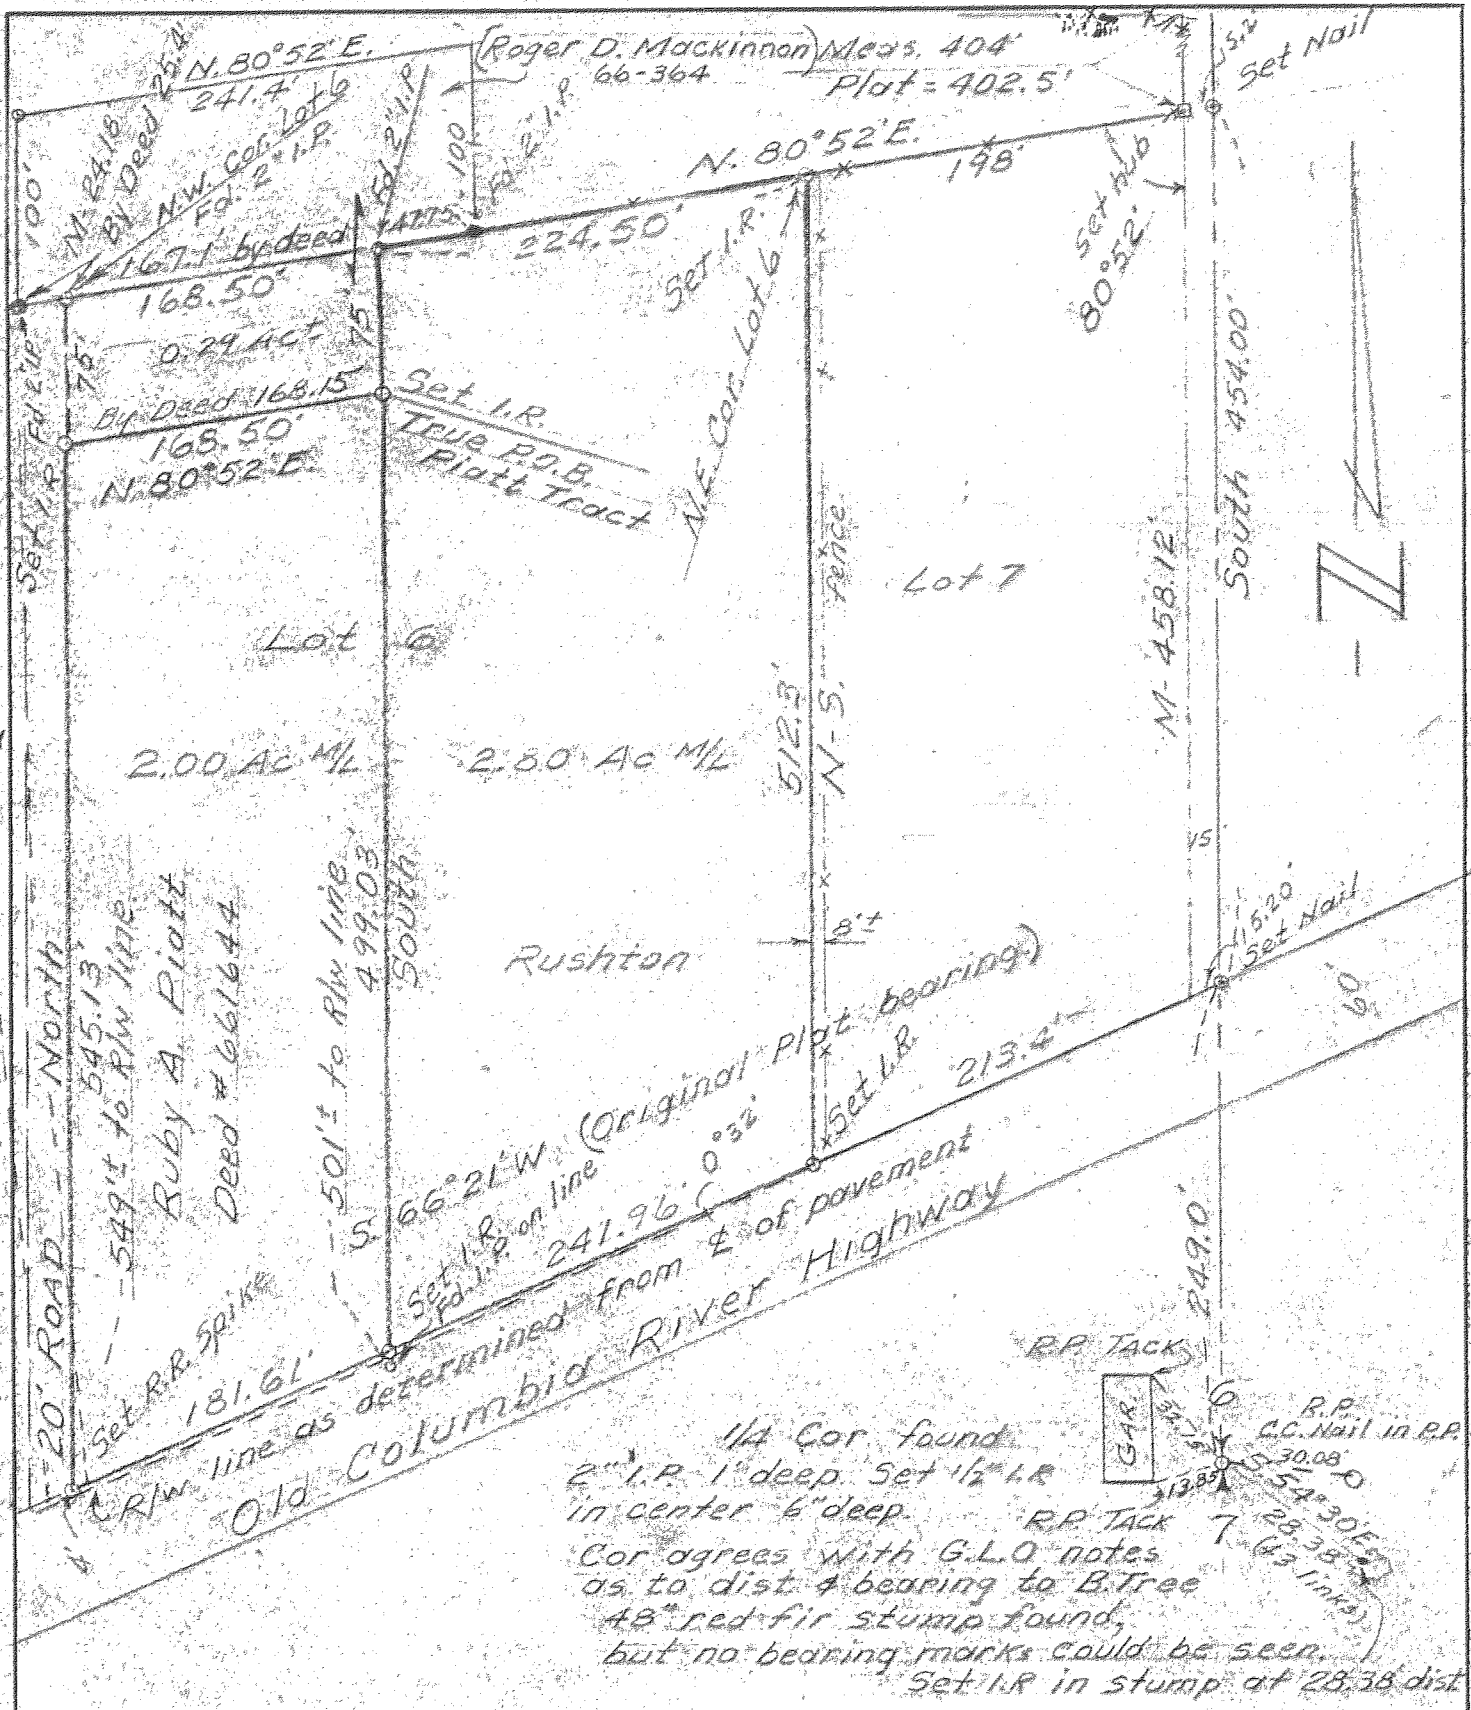
Date	No.	Revisions	By	App.
Design		Scale 1"=100'		
Survey	V.F.	Date 3-9-67		
Drawn	V.F.	Sheet 1 of 1		
App'd	Ckd.	Wk. Or. No. 3706

On the official map of Division No. 1, the East-West distance of 388 feet shown in Lot 6 fits the 393 feet shown along the North line of Lot 6. Calculations indicate that, if the geometric condition established by the bearings, angles and distances which do agree upon the face of the plat that the distance along South line of Lot 6 should be 423.57 when the plat bearing of South $66^{\circ} 21'$ West is used. The plat called for 422.4 feet, discrepancy = 1.17 feet. Therefore we calculated the frontage distance for the Rushton Tract should be 241.96 feet in order to be consistent with the measured distance of 224.49 feet along the Rushton North line. Our calculations for the Piatt tract was done in the same manner.

The found 2" iron pipe, we accepted as the true Northwest corner of Lot 6. It is consistent as to distance and bearing from the Northeast corner of Lot 7 and using the calculated frontage along the South lines of Lots 6 and 7 as above described to set the Southwest corner of Lot 6, makes the West line of Lot 6 parallel with the East line of Lot 7.

The South line of Lots 6 and 7 which we established from plat calls does not fit too well with the pavement as constructed. The North right-of-way line as established from the pavement hits the Southeast corner of Lot 6, but at the Southwest corner of Lot 6, this right-of-way line is 4 feet South of our established corner. No points could be found to establish a true right-of-way line.
