FIELD NOTES

CS1367

FOR: Richard, Bill and W. W. Cannon W.O. 1003, Survey of Descriptive parcels in Lots 4, 5, and 6 Albee Tract in the E $\frac{1}{2}$ N $\frac{3}{4}$ Section 4, T2N R10E, W.M., Hood River County, Oregon.

DATE COMPLETED: November 19, 1971.

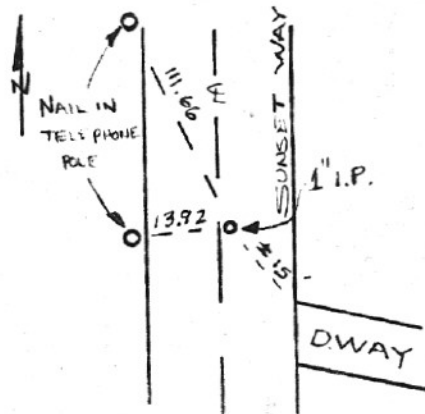
CORNER No. 2

CORNER DESCRIPTION
C¹/₄ COR.
1" IRON PIPE IN
ROADWAY - SUNSET WAY
F.S. LOCATION TAG
NAILED ON TELEPHONE
POLE 14' W OF COR.

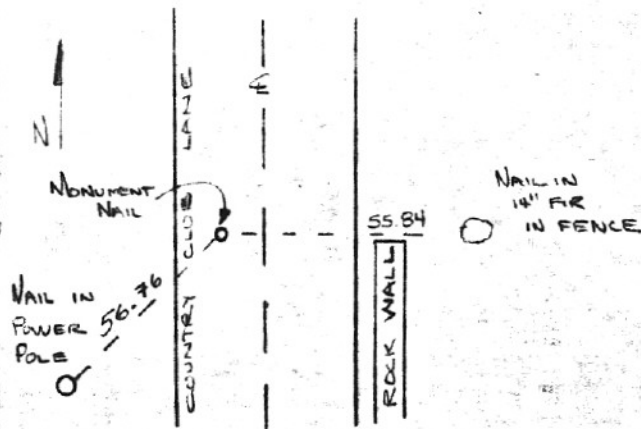
CORNER No. 1

CORNER DESCRIPTION
CENTER EAST ¹/₁₆ COR.
MONUMENT NAIL SET
IN ASPHALT 7' WEST
OF E STRIPE, COUNTRY
CLUB LANE
