TWP. 2N, RANGE 8E, W.M.

CORNER No. 452

CORNER DESCRIPTION

HOOD RIVER COUNTY

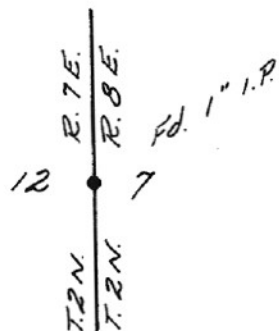
CARD 1 OF 34

WEST 1/4 CORNER
FOUND 1" IRON PIPE
NO B.T.S., NO REFERENCES
FOUND BY MARSHALL BROS.
IN NOV. 1937
FOUND BY B.P.A. IN
1939
FOUND BY M&C IN 1969,
CHECKS B.P.A. & STATE
HWY. COORDS.

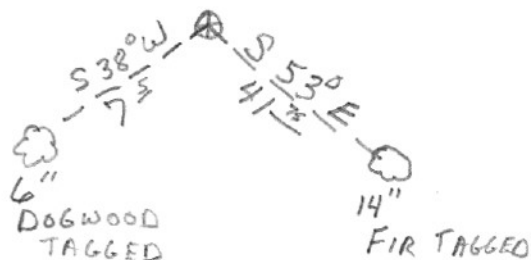
CARD 2 OF 34

SET 2" I.P. WITH
BRASS CAP.
6-73 HRCO.

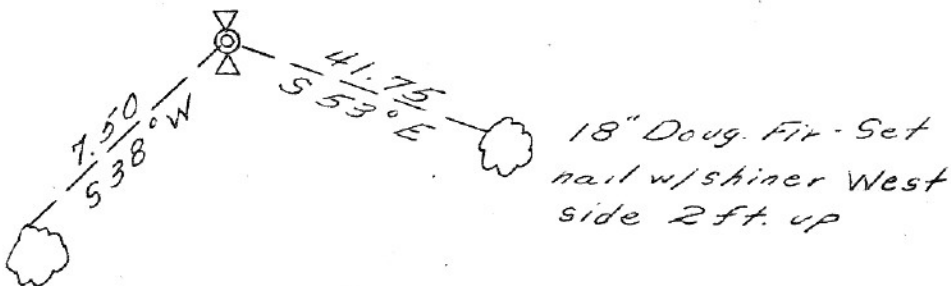
NAME OF STATION W 1/4 Cor. Sec. 7 T2N, R8EWM

STATION MARK	SURVEY POINTS AND PROMINENT OBJECTS WHICH CAN BE SEEN FROM GROUND STATION	DISTANCE	BEARING
A-A	1" iron pipe with yellow plastic cap marked H.R.C. NOTE: All bearings and distances are Oregon State Plane Coordinates, North Zone	180.90	N60°52'10"E

6" Dogwood - Set nail / shiner North side 2 ft. up
