OREGON CORNER RESTORATION FORM

Section 6 Township 1 N Range 9 E

County Hood River Date September 13, 2013

Center 1/4 Corner Section 6, T1N, R9E

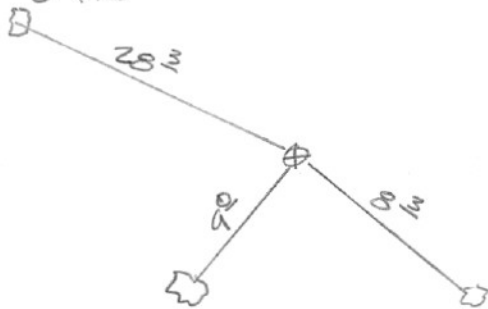
CORNER DESCRIPTION

NEW TAG
8" FIR

NEW B.T.
10" FIR

NEW TAG
6" FIR

SET 2" IRON PIPE
WITH BRASS CAP
SET IN CONCRETE

1 SEPT 1971
SET BY H.R. Co
CARD..... OF

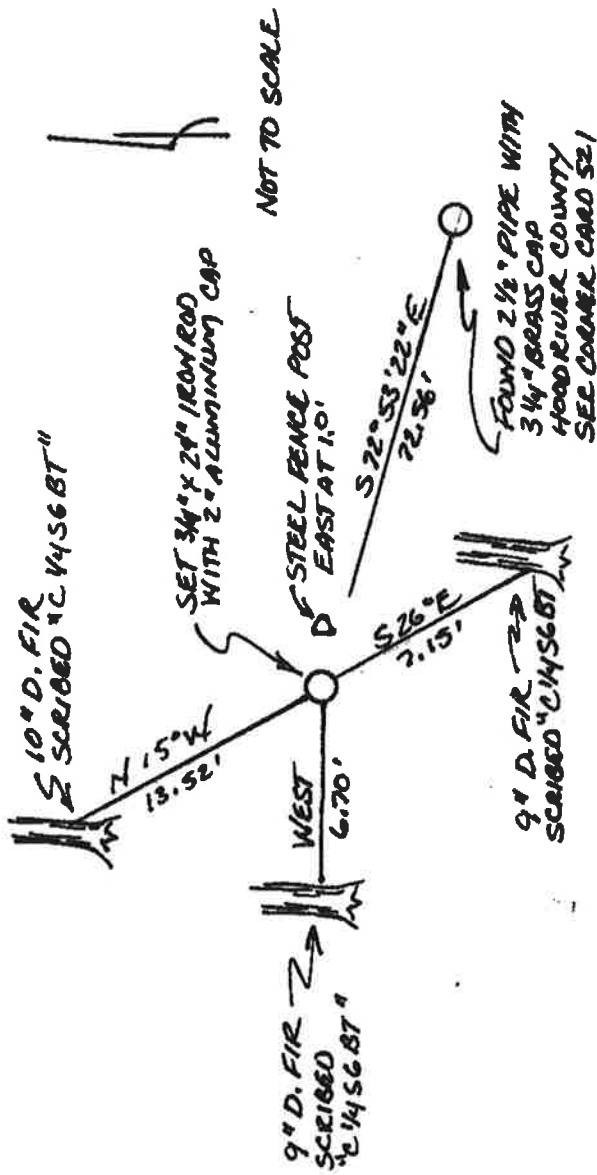
Sketch

Monument(s) & Accessories Found: (Condition and Source)
Found 2-1/2" Pipe with 3-1/4" brass cap.

Set 3/4" x 24" Iron Rod with 2" Aluminum cap at intersection of the north-south and east-west centerlines. The east and west 1/4 corners were found. The north and south 1/4 corners were calculated at single proportion position.

Referenced 10" D. Fir N15°W at 13.52' scribed [C1/4 S6 BT; 9" D. Fir West at 6.70' scribed [C1/4 S6 BT]; 9" D. Fir S26°E at 7.15' scribed [C 1/4 S6 BT]; steel fence post east at 1.0'
