T 1 S R 8 E M WILL.

CORNER RECORD (SEARCH)

T 15 R. 3E

LAND CORNER RECORD

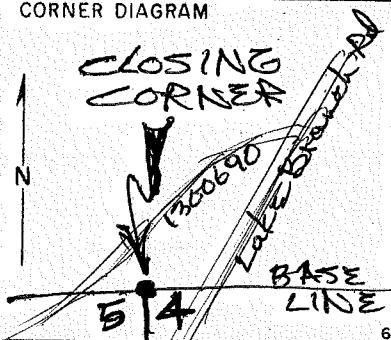
CORNER DIAGRAM

1940 BLM Stamped Brass Cap -

stump of 27" D.F. - B.T. - S 69° W. - 46.86'

Going up Lake Branch Rd - Turn Rt. onto F.S. Rd # 1300690 - go a 3/8 mile to Base Line - will see 5/4 of 32 - Park - walk East N 1/2 to corner - Visible from Rd. in thick reprod.

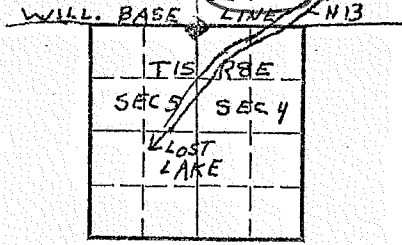
1. T 13 R 8E No. A-9 Cor. Sec Mer. State Oregon N. F. Mt. Hood Dist. Hood River

4. Description of Corners:
2" galv. pipe, iron. Firmly set, 6" above ground with a mound of rock. Has a brass cap stamped

5. Investigation Notes:
A W Hem stump 16" dbh, S35° E, 21' distant. stump is 6' high. Faced. Not grown over. No iron marks visible.
No other witnessing found. Corner is surrounded by a clear-cut ~~Believed to be genuine.~~
~~Ribbon at boundary on road. Hike 550' west along ribboned line to corner.~~

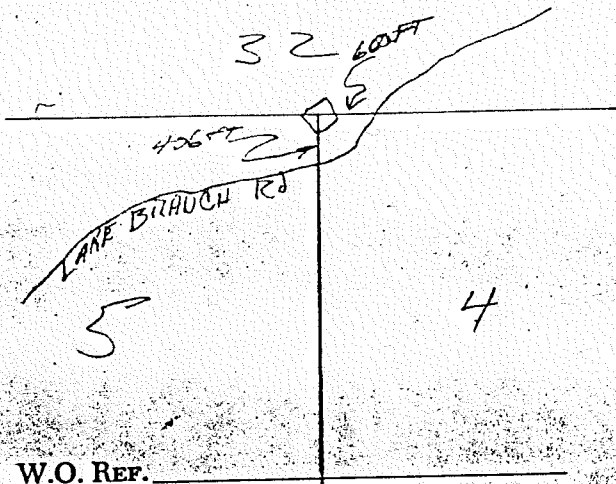
TWP. 15....., RANGE 8..... E, W.M.

FOUND R. WARD 8/19/61

5. Investigation Notes:
 BRASS CAP ON IRON PIPE IN good CONDITION, ABOVE GROUND 18", 2" PIPE
 HIGH ROCK CAIRN by PIPE, ON METAL CAP "U.S. GENERAL LAND OFFICE SURVEY 1940"

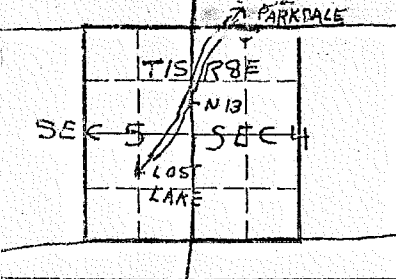
1. T¹ IS R^{8E} No. A-10 Cor. 1/16 Mer. W State Oregon (Rectangular) N. F. Mt. Hood Dist. Hood River

4. Description of Corners:
 No corner marker found here. Location is known by:
 A W Hem stump, 4' high, SE side was blazed, witnessed, grown over and subsequently chopped out.

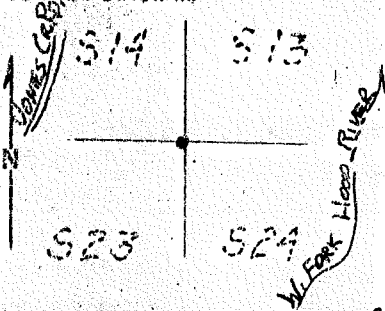
CORNER DIAGRAM

GLD BRASS CAP ON GALVANIZED IRON PIPE, 1 1/2" BLK IRON PIPE ALONGSIDE, BOTH IN 2' HIGH MOUND OF STONE. (SEE REMARKS (2))

NONE

17" D FIR, N 34-30' E, 11.2 FT, SCRIBED "S13 BT" TREES HAVE 54-2
 12" D FIR, S 28-45' E, 7.0 FT, " " "S24 BT" 54-2 TAGS, RED PAINT
 20" D FIR, S 87-15' W, 43.1 FT, " " "S23 BT" BANDS AND BRASS
 12" D FIR, N 21-30' N, 29.0 FT, " " "S14 BT" "PLD 1815" WASHERS;
 SET CARBONITE GUARD POST WITH 54-2 & 54-9 DECALS NEAR MONUMENT.

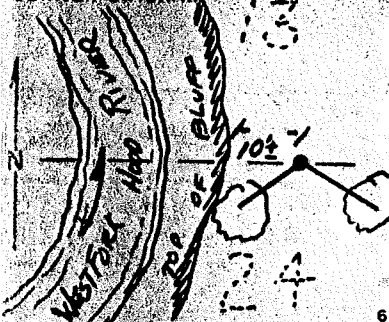
CORNER DIAGRAM

NONE

SOUTH ON 18 rd TO FOREST SERVICE LOCATION POST/TAG; N78°W, 700 FT. to 1/4 1/2 THEN 1220' WEST to W 1/2 @ EAST OF BANK HOOD RIVER

SET 2 1/2" x 30" STANDARD FOREST SERVICE ALUMINUM MONUMENT 24" IN THE GROUND IN RING OF STONES

11" HEMLOCK, S 54° 15' W, 5.5 FT., SCRIBED "524 1/16 BT"

8" D. FIR, S 83° 15' E, 42.54 FT., " "524 1/16 BT"

TREES HAVE 54-9 & 54-2 TAGS CARVED 'X' AT BREAST HEIGHT, RED PAINTED BANDS, & BRASS "PLS 1815" WASHERS, SET CARSONITE GUARD POST WITH 54-2 & 54-9 DECALS NEAR MONUMENT.

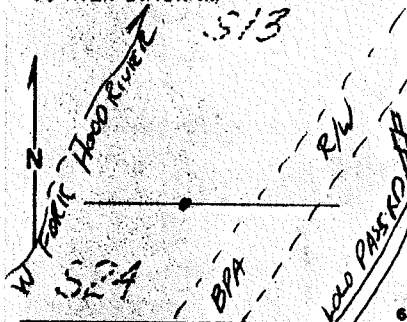
CORNER DIAGRAM

960 BRASS CAP WITH MOUND OF STONE ALONGSIDE

FOUND 1940 960 TREES to BE LIVE & DOMINANT 5" D. FIR (NOW 19"), N 69° E, 34 IKS. (23.2 FT MEASURED) 5" D. FIR (NOW 19"), S 33° W, 70 IKS. (45.7 FT MEASURED)

SOUTHWEST ON LOLO PASS Rd [18] APPROX 2 1/4 MILES FROM ITS JUNCTION WITH [16] to A LOCATION Post/FOREST SERVICE TAG. THEN N 82° W 700 FT to CORNER. COR IS APPROX 330 FT WEST OF W. BPA R/W.

PAINTED FACES & BRANDS ON GLO TREES; ADDED 54-9 & 54-2
TAGS. SET CARSONITE GUARD POST NEAR MONUMENT.

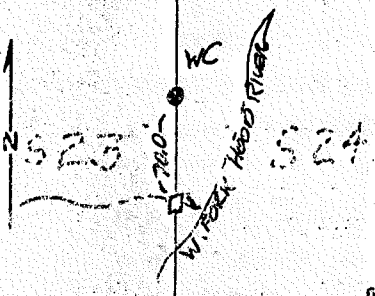
CORNER DIAGRAM

NONE

FOREST ROAD (12) TO ROCK PIT JUST SOUTH OF OLD LADD CREEK CAMPGROUND; THEN SW ON, NEW LOGGING ROAD OUT OF PIT, TO ITS PRESENT END, APPROX. 400 FT N OF LADD CREEK; THEN W ACROSS THE RIVER TO POSTED LINE, & NORTH APPROX 200 FT TO WITNESS CORNER;

SET 2 1/2" x 30" STANDARD FOREST SERVICE ALUMINUM MONUMENT 24" IN THE GROUND ON ROCK LEDGE OF STEEP SIDE HILL, IN 36" x 30" x 18" ROCK MOUND FOR WITNESS CORNER.

13" D. FIR, N 19° 15' E, 22.0 FT., SCRIBED "S 24 1/4 BT"
 17" D. FIR, S 63° 30' W, 15.0 FT., " " "S 23 1/4 BT"

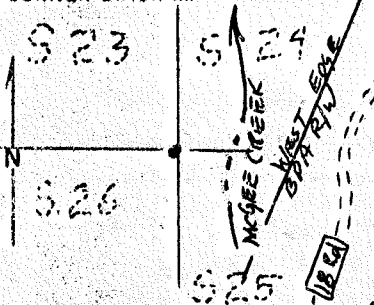
CORNER DIAGRAM

3/4" IP DRIVEN OVER 1/2" I.P. WITH STONE MARKED 'X' ALONGSIDE. ALSO FOUND NOTCHES ON STONE.

FOUND STONE W/ NOTCHES & 'X'
FOUND ROTTED GLO STUMP, ROTTED FACE, NO VISIBLE SCRIBING, @ S 30° W, 6.6 FT.

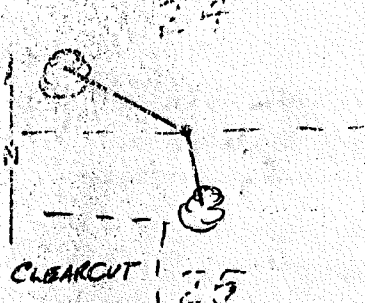
CORNER DIAGRAM

NONE FOUND

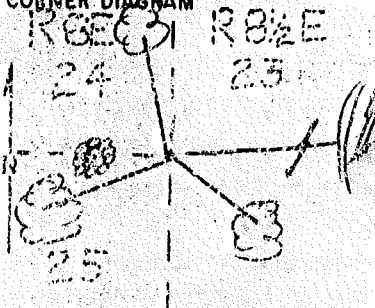
CORNER DIAGRAM

2 1/2" BRASS CAP ON A 2" GALVANIZED PIPE

FOUND 5 FT HIGH BY 4 FT BASE STONE MOUND, 5 FT WEST OF CORNER

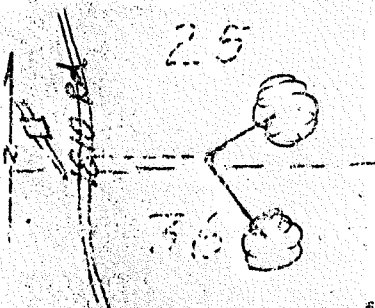
CORNER DIAGRAM

FD 1" IRON PIPE WITH ORIGINAL GLO STONE MARKED "1/4" ALONGSIDE

FOUND 30" x 6' HIGH W.R. CEDAR STUMP @ N50W, 8';
VISIBLE SCRIBING IN BURNED CHOPPED FACE
FOUND 25" x 3' HIGH W.R. CEDAR STUMP @ S55W, 22';
VISIBLE SCRIBING

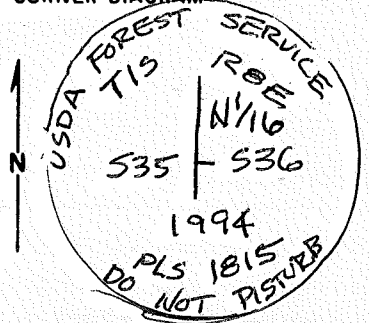
CORNER DIAGRAM

NONE

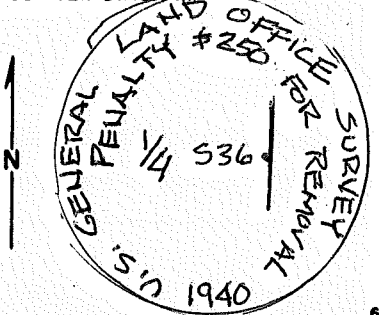
CORNER DIAGRAM

FOUND 2 1/2" BRASS CAP ON GALVANIZED PIPE SET BY RESURVEY DATED 2-1952

Found 14" Noble Fir - Now 16" - North 76 West @ 34 LINKS - BLAZE visible but scribbing over-grown.
Found 12" Noble Fir - Now 13" - S 62 W @ 15 LINKS. BLAZE visible but scribbing overgrown.
Both Original trees healthy.

Constructed Mound of Rock East of
 Corner. Cleared out brush and noted a 42" Doug Fir
 N 20 E @ 4' from corner. The bark was probably too
 thick & hard to scribe for a bearing tree. as object.
 Painted red ring around each tree and BT signs.

Placed 54-4 sign on NW tree & 54-9 sign on the SW tree.
 Built a stone mound, as indicated above & noted the
 Doug Fir tree. Placed a fiber glass post with a
 54-9 sign at corner & brass washers on each
 of the BTs

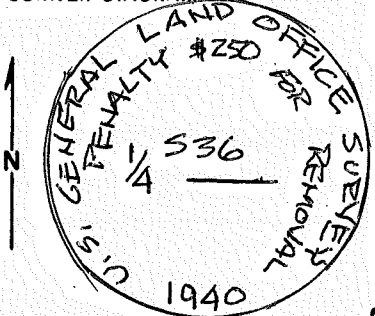
CORNER DIAGRAM

FOUND 2 1/2" BRASS CAP ON GALVANIZED PIPE SET BY RESURVEY DATED 2-1952

Found original 41" Hemlock - Now 52" Hemlock with visible scribbling BEARS N57W @ 22 LINKS, ORIGINAL 22" Hemlock - Now 42" Hemlock - No visible scribbling BEARS N. 27E @ 37 LINKS. Both trees healthy.
