USDA-FOREST SERVICE

CORNER RECORD (SEARCH)

T 2N R. 8E

N.F. MT HOOD State OREGON

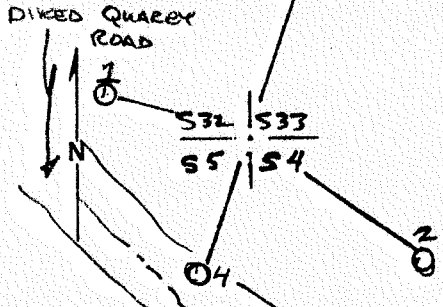
CORNER DIAGRAM ③

"LOST"

NO EVIDENCE FOUND.

SET A 2 1/2" Alum. USDA MON, 36" long with a 3 1/4" Alum Cap STAMPED:

1. 20" HARDWOOD, WITH 5 STEMS, SCRIBED "T3N RBE S32 BT" BEARS N25-00W, 28.04';
2. 12" ALDER SCRIBED "T2N RBE S4 BT" BEARS S55-00E 65.30; T3N RBE
3. SET RM & 2 1/2" x 36" USDA MON CAP 3/4" BEARS N12-49E 22.0" STAMPED: RM 534
4. SET RM & 3 1/4" ALUM. PEDASTAL MON, USDA BEARS S12-44W 38.6' STAMPED: T2N RBE 1992
SS N 306 LS2209

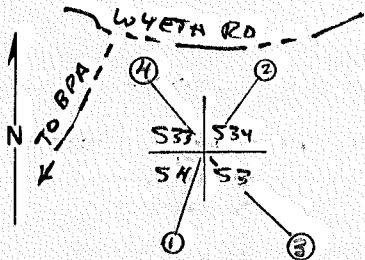
CORNER DIAGRAM

A 14" x 14" x 14" BASALT STONE WITH AN "X" SCRIBED ON TOP.

1. 49" FIR, SLIGHT FACE, LATH NAILED TO FACE BEARS S15-00W 25.3';
2. 20" FIR, HEALED "X" ON FACE BEARS N42-00E 30.7'

BURIED STONE SOUTH OF MONUMENT.

SET A 2 1/2" X 36" USDA ALUM. MON WITH A 3 1/4" ALUM CAP

3. A 10" FIR SCRIBED "T2N R2E S3 BT" BEARS 54E-00E 35.92';

4. A 35" FIR SCRIBED "T3N R2E S33 BT" BEARS N1E-00W 64.65'

PAINTED TREES RED; PLACED 54-99 54-3; PLACED BRASS SHANK "LS 2209" BETWEEN "BT".

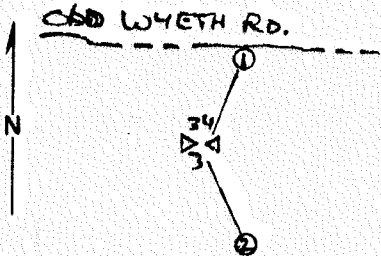
CORNER DIAGRAM

A 3" BRASS CAP ID A 8" X 8" CONCRETE
MON. STAMPED: US ARMY CORP
T3N24 REE
1/4 #
3

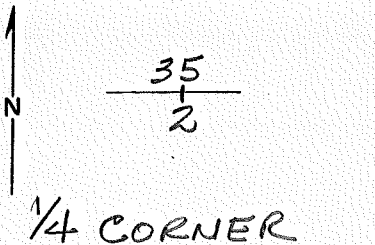
CORNER DIAGRAM

FD. U.S.E.D. CONC. MON.

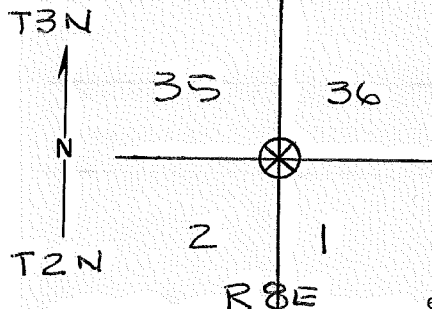
CORNER DIAGRAM

3 1/2" BRASS CAP SET 3" BELOW GROUND IN GOOD CONDITION.

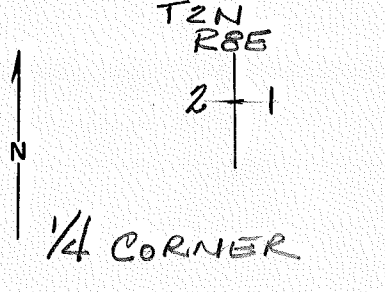
CORNER DIAGRAM

FD. STAKE IN MOUND OF ROCK

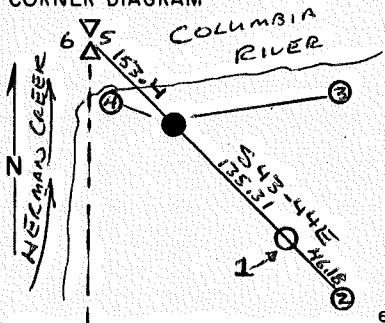
CORNER DIAGRAM

Original corner and US Army Corp remonumentation are now submerged by the Columbia River Due to the construction of the Bonneville Dam.

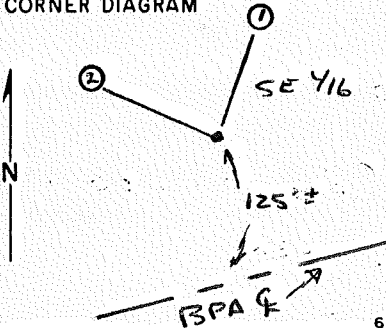
CORNER DIAGRAM

Found a 3/4" Iron Pipe set by US Army Corp

Remonumented found pipe with a 2½"x36" USDA Alum Mon with ¾" Alum Cap stamped:
Placed 6' Carsonite post alongside mon and built stone mound around mon.

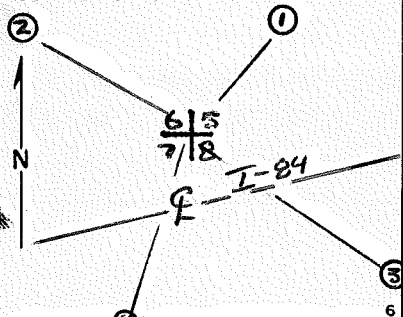
CORNER DIAGRAM

Found a 3" Brass Cap on a 2" Iron Pipe.

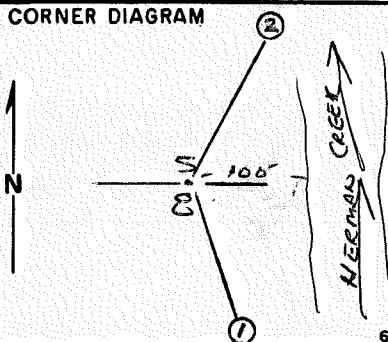
CORNER DIAGRAM

Found a 3/4" USDA Brass cap on a 2" Iron Pipe in a stone mound 1 1/2' x 1' high stamped:

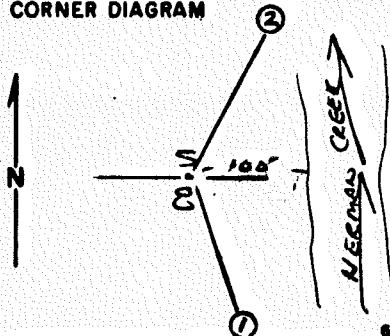
CORNER DIAGRAM

Found a 3/4" USDA Brass cap on a 2" Iron Pipe in a stone mound 1 1/2' x 1' high stamped:

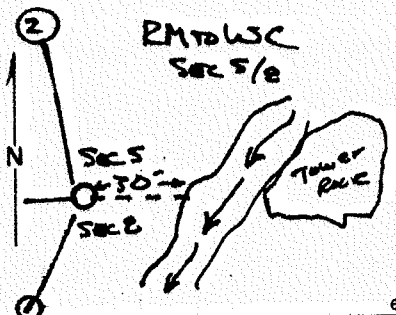
CORNER DIAGRAM

SEARCHED FOR BUT DID NOT FIND ORIGINAL WITNESS CORNER TO SEC. 5 & 8, RECENT CHANGES (SCOUR) IN THE RIGHT BANK PROBABLY WIPEd CORNER OUT.

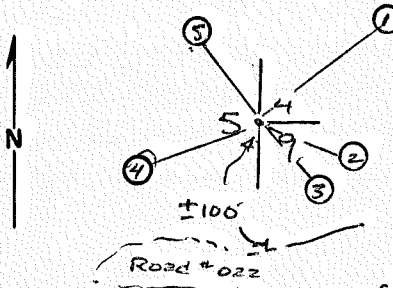
CORNER DIAGRAM

Found original GLO stone 22"x12"x8" with "X" on top and 5 notches on the South face and 4 notches on the East face.

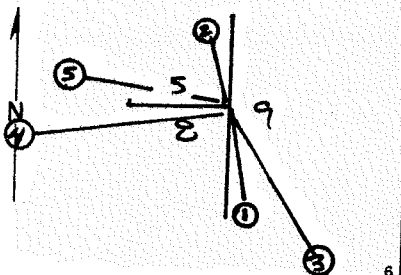
CORNER DIAGRAM

SEARCHED BUT COULD NOT FIND ORIGINAL STONE. SET CORNER FROM INTERSECTION FROM FOUND ORIGINAL MONUMENT REFERENCE AND THE SECTION SECTION LINE OF SECTION 9.

1. Found GLD STONE MONUMENT 3' x 1 1/2' x 1' high WHICH BEARS S11-40-53E 4.99 (GLD: 542-00E 7.26')

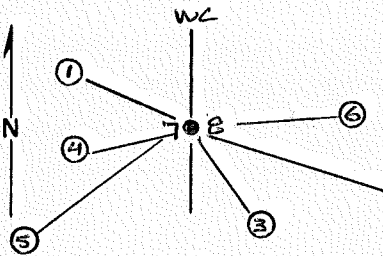
CORNER DIAGRAM

Found a 3 1/4" Alum Cap on 2" Alum Pipe in stone mound 2' in diameter and 1' high stamped:

1. An old stump hole bears N40-00W 14.0', possible original;
2. An 8" burned fir stump with ax marks bears S56-00E 55.2, possible original;
3. A 30" Fir with healed face bears S35-00E 12.5', original BT;
4. A 24" Fir with healed face bears S64-00W 12.7' original BT;
5. An 18" Fir with healed face bears S47-00W 23.8';
6. A 24" Fir with healed face bears N86-00E 15.1'.

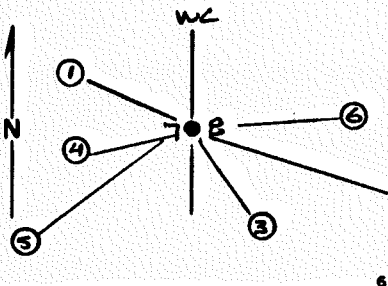
CORNER DIAGRAM

Found a 3 1/4" Alum Cap on 2" Alum Pipe in stone mound 2' in diameter and 1' high stamped:

1. An old stump hole bears N40-00W 14.0', possible original;
2. An 8" burned fir stump with ax marks bears S56-00E 55.2, possible original;
3. A 30" Fir with healed face bears S35-00E 12.5', original BT;
4. A 24" Fir with healed face bears S64-00W 12.7' original BT;
5. An 18" Fir with healed face bears S47-00W 23.8';
6. A 24" Fir with healed face bears N86-00E 15.1'.

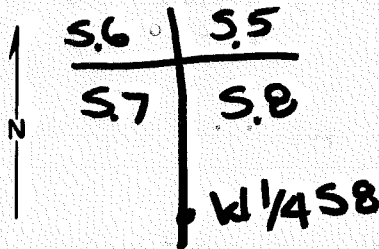
CORNER DIAGRAM

NONE

Found Fir stump with blaze 6" above ground and still open. Scribing visable but not legable.

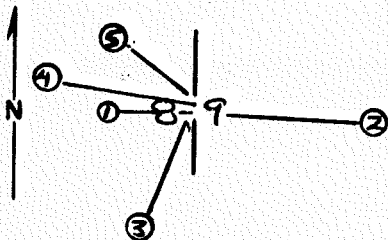
CORNER DIAGRAM

Found original GLO Stone a 15"x12"x8" Stone 10" in the ground with "X" on top and "1/4" on West face.

1. Found a 3'x1½' High Stone Mound Bears West 3'.

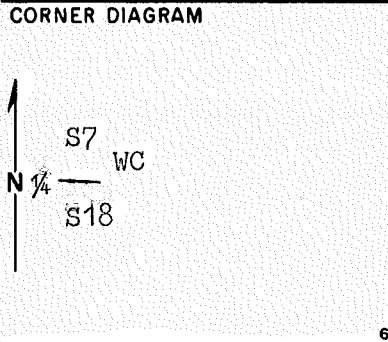
DESCRIBE CORNER MONUMENT FOUND 10.20
Stone 15x12x5 firmly set 10" in ground marked WC 80
on North-Mound of stone 2' base 1½' high North.

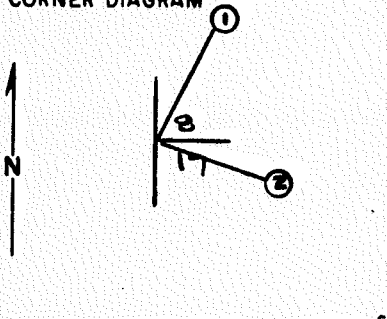
CORNER DIAGRAM

Found a $2\frac{1}{2}$ " USDA Alum Mon with 3" Alum Cap stamped: T2N R8E

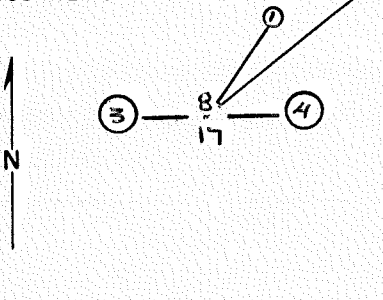
CORNER DIAGRAM

Searched but did not find any original evidence, set corner based on single proportionate measure.

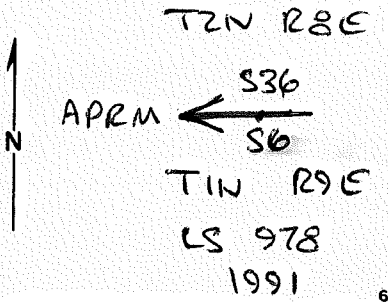
CORNER DIAGRAM

Found a 24 inch fir stub of line tree with partial notch (and overgrowth) on West side (called as being 4.80 chains West of Southeast 36).
