CORNER RECORD (SEARCH)  
(Ref. FSM 7151.4)

T 2N R. 9E

R.D. \_\_\_\_\_ County HOOD RIVER

N.F. MT. HOOD State OREGON

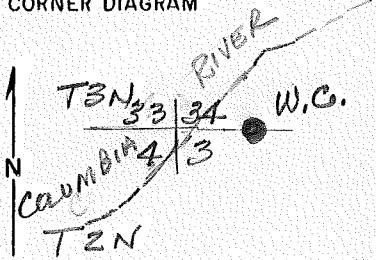
CORNER DIAGRAM

U.S.E.D. MONUMENT

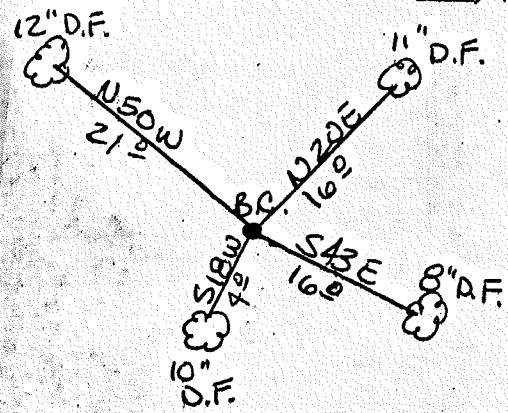
CORNER No. 871

T2N R9 E	<del>1979</del>
$\frac{2}{11} \frac{1}{12}$	HRC 1979
HRC

FROM WHICH A 11" D.F.  
 BEARS N20°E @ 16', 8" D.F.  
 BEARS S43°E @ 16', 10" D.F.  
 BEARS S18°W @ 4' SCRIBED  
 "SC" AND A 12" D.F.  
 CS BEARS N50°W - 21'  
 ALL HAVE YELLOW TAGS  
 CARD.....1..... OF .....1.....

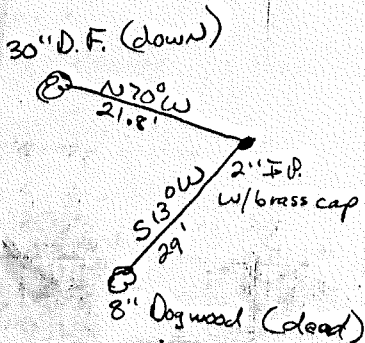
CORNER No. 376

Fd. both orig.  
 B.T.'s + set  
 2" I.P. w/brass  
 cap. - Aug. 1980

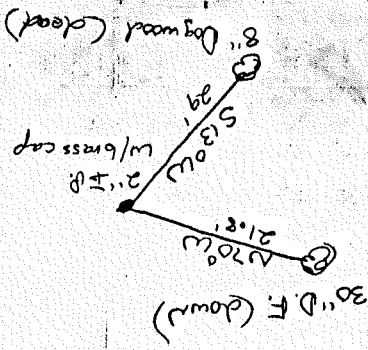
CORNER NO. 376

Fd. both orig.  
B.T.'s + set  
2" I.P. w/brass  
cap. - Aug. 1980

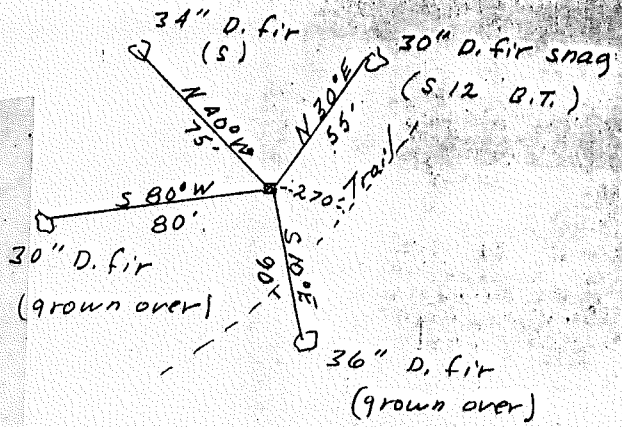
CORNER DESCRIPTION

Sec. Cor.  
Squared tree  
Fell by V.B.F. 1946

set 2" I.P. w/brass  
cap - Aug. 1979

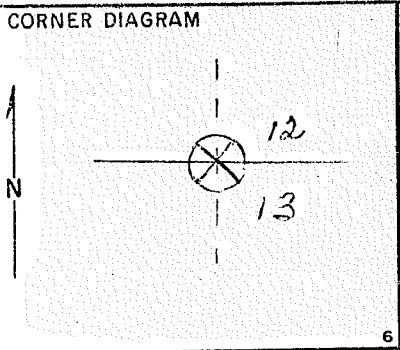
DESCRIBE CORNER MONUMENT FOUND  
White stake,  $\frac{1}{2}$ " iron pipe in place. Good condition. Stake 2x2x12 inches above ground.  $\frac{1}{4}$  S 12 on North side.

DESCRIBE BEARING TREES OR OTHER OFFICIAL ACCESSORIES FOUND  
Scribing grown over on D.F. 8" diameter bearing N44°W distance 5'. Scribing grown over on D.F. 28" diameter bearing S5°E distance of 14ft. Believed to be a genuine corner.

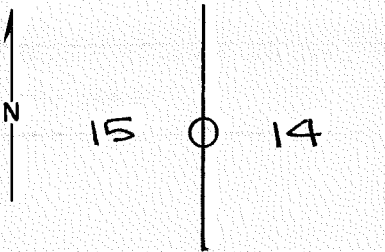
CORNER DIAGRAM

NONE

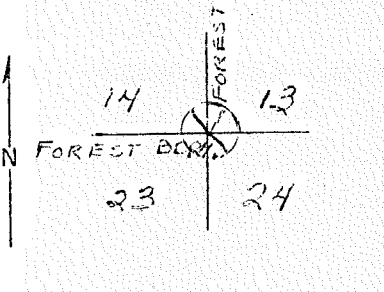
CORNER DIAGRAM

DESCRIBE CORNER MONUMENT FOUND  
 3/4" Iron pipe and old stake in place. Poor condition. Stake 2x2x12" above ground. Mound of rock around pipe.

DESCRIBE BEARING TREES OR OTHER OFFICIAL ACCESSORIES FOUND  
 Scribed S 14 B.T. on a D.F.(stub) 24" diameter bearing N65°W distance of 10'. Believed to be a genuine corner.

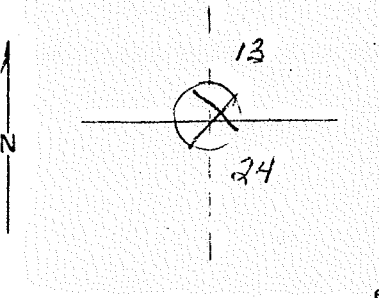
CORNER DIAGRAM

Iron pipe & old stake in place. Pipe good condition stake poor.  $\frac{3}{4}$ "x6" above ground.  $\frac{1}{4}$  marked on N side of stake. Mound of rock is located around pipe.

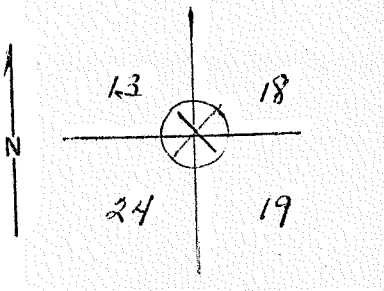
CORNER DIAGRAM

DESCRIBE CORNER MONUMENT FOUND  
Rock in place, good condition. Marked  $\begin{matrix} \text{H} \\ \text{N} \end{matrix} \begin{matrix} \text{E} \\ \text{S} \end{matrix} + \text{ON TOP.}$

DESCRIBE BEARING TREES OR OTHER OFFICIAL ACCESSORIES FOUND  
Scribing burned out on D.F. (stump) diameter 30" bearing N20°W, distance 15 ft. Believed to be a genuine corner.

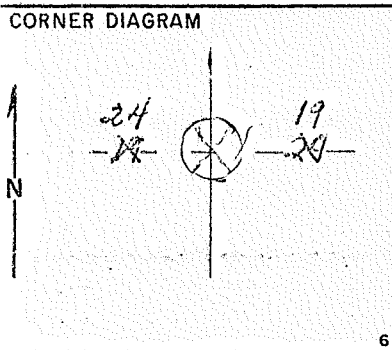
$\frac{1}{4}$  Corner

DESCRIBE CORNER MONUMENT FOUND  
 Stake in place. good (new) condition, 3x4x48" above ground.  
 FS tag  $\frac{1}{4}$  cor. 24- 1 chain South.

DESCRIBE BEARING TREES OR OTHER OFFICIAL ACCESSORIES FOUND  
 Down  $\frac{1}{4}$  CSI scribed on W. Fir 24" diameter. Is believed tree scri  
 by County surveyor. **SCRIBED**

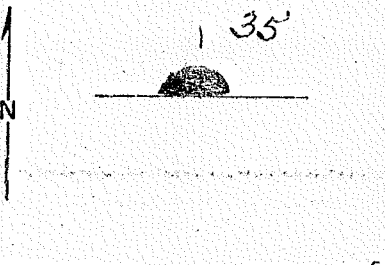
CORNER DIAGRAM

Iron pipe with brass cap in place.

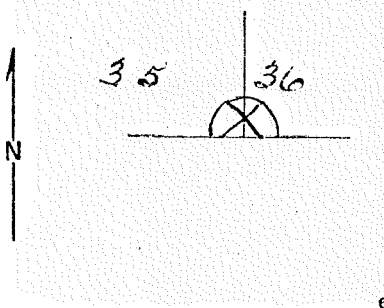
CORNER DIAGRAM

DESCRIBE CORNER MONUMENT FOUND  
 Iron pipe in place. Good condition, 3/4x6" above ground. Mound of stone around pipe.

DESCRIBE BEARING TREES OR OTHER OFFICIAL ACCESSORIES FOUND  
 Scribed T2N,R9E,S35,B.T. on D.F. 34" diameter bearing N28°W Distance 20ft.; Scribing rotted out on Oak 16" diameter bearing S60°30'E distance 33'. Believed to be a genuine corner.

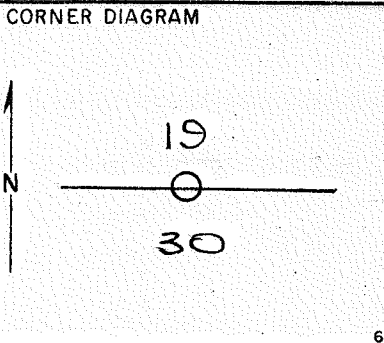
DESCRIBE CORNER MONUMENT FOUND  
NONE

DESCRIBE BEARING TREES OR OTHER OFFICIAL ACCESSORIES FOUND  
NONE  
SEARCHED FOR ON KINGSLEY CADASTRAL  
CONTRACT #530467-9-00200. TENNESON  
ENGINEERING, THE DALLES

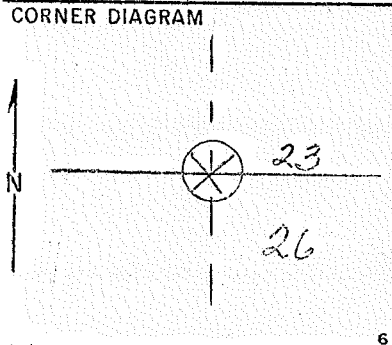
DESCRIBE CORNER MONUMENT FOUND  
3/4" Iron pipe 18'.

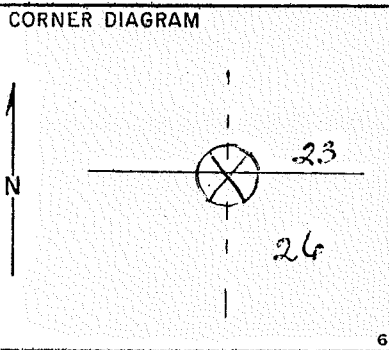
$\frac{1}{4}$  Corner  
Cor. 23, 26  
No. \_\_\_\_\_

DESCRIBE CORNER MONUMENT FOUND  
3/4" iron pipe and stake in place. Good condition. No marks found  
3/4" x 18" above ground.

DESCRIBE BEARING TREES OR OTHER OFFICIAL ACCESSORIES FOUND  
No bearing trees found. Not believed to be a genuine corner. No  
proof found but location probably correct. Established by private  
survey.

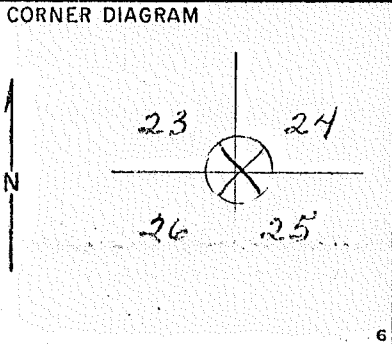
DESCRIBE CORNER MONUMENT FOUND  
Rock and stake ~~(3/4" x 1/2" x 1/2" pipe)~~ in place. Good condition 12" above ground. No pipe found. *Rock = - X ON TOP.*  
F.S. wooden tag 2N9E Sec. Corner 40 ft. W. Mound of rock around main rock.

DESCRIBE BEARING TREES OR OTHER OFFICIAL ACCESSORIES FOUND  
D.F. 20" diameter bearing N35° E 5ft. distance; D.F. (stump) 24" diameter bearing S80° E 15 ft. distance. Believed to be a genuine corner.

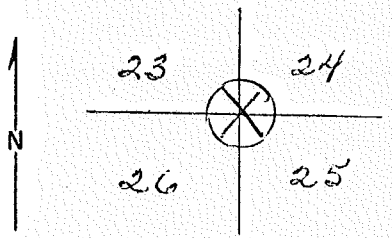
CORNER DIAGRAM

DESCRIBE CORNER MONUMENT FOUND  
 Rock and iron pipe in place, good condition, rock 12x9x8" above ground. Marked  $\ominus$  -  $\oplus$  ON TOP  
 S E

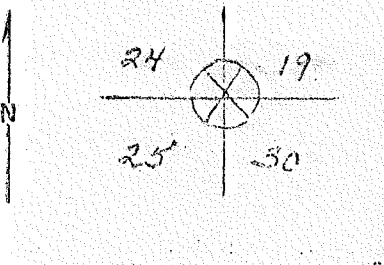
CORNER DIAGRAM

1 DESCRIBE CORNER MONUMENT FOUND  
Stake in place. Good condition, 3x4x48" above ground.  
O.S. Forest, 24"D.F., Sec. 24-2N 9,10E, 21ft. S52°E 10/30/58 on metal.

2 DESCRIBE BEARING TREES OR OTHER OFFICIAL ACCESSORIES FOUND  
Doug Fir 24" diameter bearing N52°W distance 21 ft.

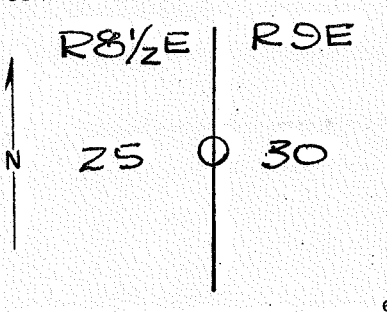
CORNER DIAGRAM

NONE

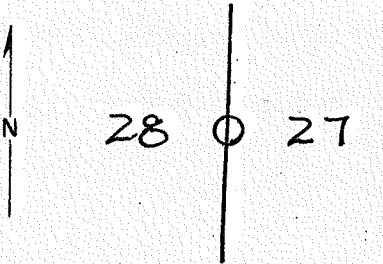
CORNER DIAGRAM

NONE

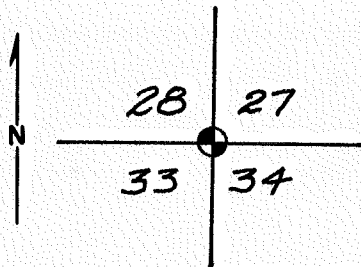
## CORNER DIAGRAM

A rock with an "X" chiseled on top, 10" above ground and mound of stone. Rotted 2"x2" post.

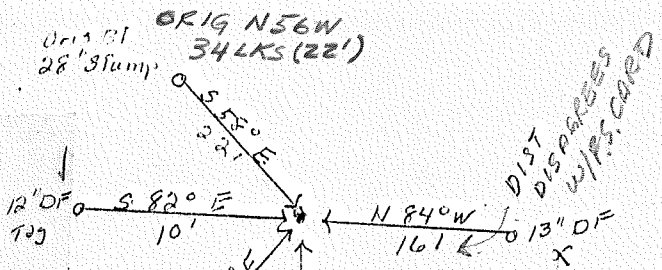
CORNER DESCRIPTION

Corner 28/21  
2x2 16" above ground  
beer can Rect. w/ X  
Found 4-24-68 A. Hutison

ORIG BT  
 30" Stamp  
 ORIG S28W  
 14 LKS (9')  
 W.O. REF.

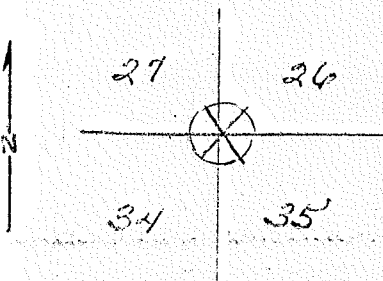
CORNER DIAGRAM

Wooden stake by rock pile in place. Poor condition. Old rock has X on it. Approximately 3x3x36" above ground. F.S. tag marked SC 17ft. N10E by Co. Survey 9/18/58

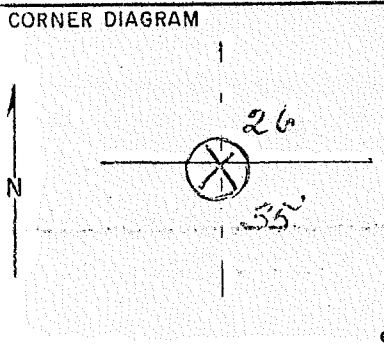
$\frac{1}{4}$  Corner  
Cor. No. 35, 26

DESCRIBE CORNER MONUMENT FOUND  
Iron pipe  $\frac{3}{4}$ ", rock pile in place. Good condition, 12" above ground. Mound of rock around pipe.

DESCRIBE BEARING TREES OR OTHER OFFICIAL ACCESSORIES FOUND  
Faced D.F. 4" diameter bearing  $S65^{\circ}W$  distance 21.8ft.; faced D.F. 6" diameter bearing  $N23^{\circ}E$  distance 21 ft. Not believed to be genuine corner. Placed by County Survey crew.

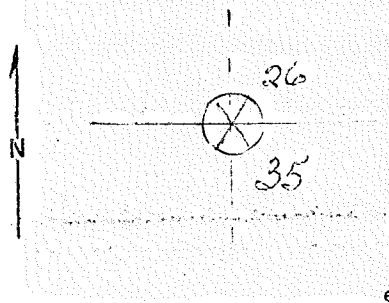
CORNER DIAGRAM

Iron pipe.

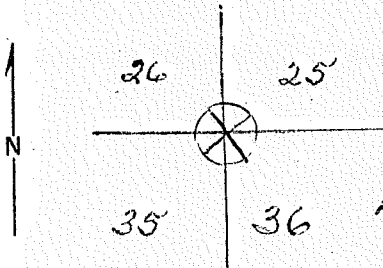
CORNER DIAGRAM

DESCRIBE CORNER MONUMENT FOUND  
3/4" Iron pipe, rock, old sq. stake in place. Fair condition. Stake rotted burned. Pipe 8" and rock 4" above ground.

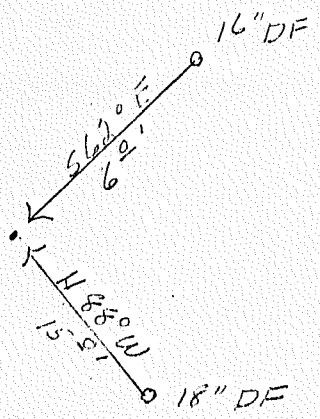
CORNER No. .... 44 .....

SECTION OR SUBDIVISION 1/4 33/34  
TWP. 2N, RANGE 9 E, W.M.

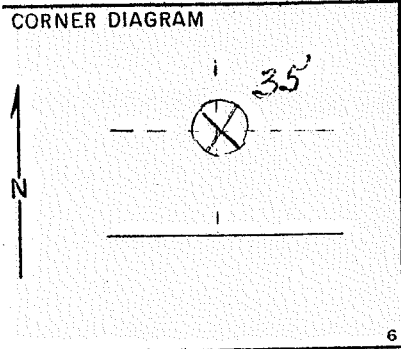
DESCRIBE CORNER MONUMENT FOUND  
Iron bar with rock pile. Good condition, 12" above ground.  
Mound of rock around bar.

DESCRIBE BEARING TREES OR OTHER OFFICIAL ACCESSORIES FOUND  
Faced D.F. 10" diameter bearing N49° E 8.4' distance; Faced D.F.  
10" diameter bearing N40° W distance 40.6'. Not believed to be a  
genuine corner. This placed this day by County Survey crew.

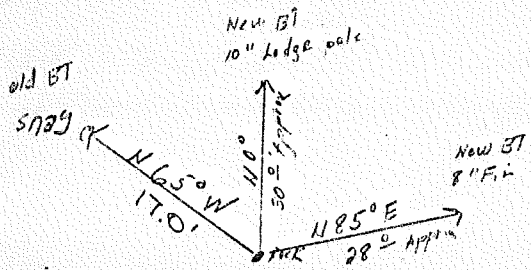
CORNER No. .... 75

- SW Cor 31 2 N 7
- SEC 36 2 N 8
- Large rock with cross
- 12" bare ground
- 2 original BT's
- 2 new BT's
- Found - A Hutson 9-27-68
- FD. A HUTSON 6-16-75
- ONE B.T.
- FD DLF - 9-22-76, Edge of cat
- fire trail, Stone 18" x 17" with
- X on top

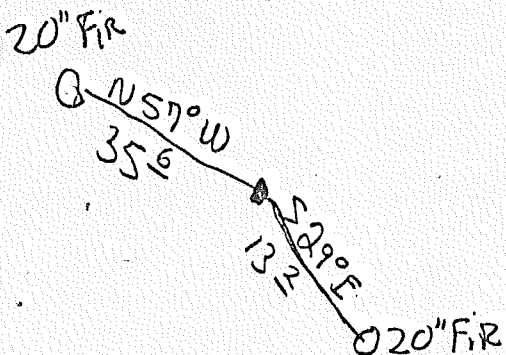
CORNER No. 806

BT's:

20" FIR N 57° W 35.6  
20" FIR S 29° E 13.12

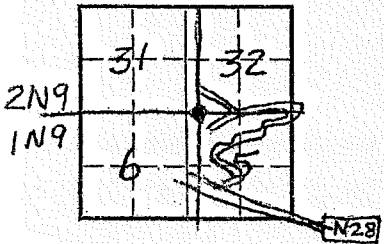
1. T. 2N R. 9E No. 2-5 Cor. Sec. Mer. Wm. State Oregon N. F. Mt. Hood Dist. Hood River

4. Description of Corners: Consists of 2 1/2" galv. iron pipe 10" above ground with brass Hood River County cap.

A Doug. Fir stump 24" dbh, 4' above ground. Faced. Burned out. at 14' distance and bearing N10°W.

A Doug. Fir stump 28" dbh, 5' above ground bearing S31°E. and 8' distance. Faced and burned out.

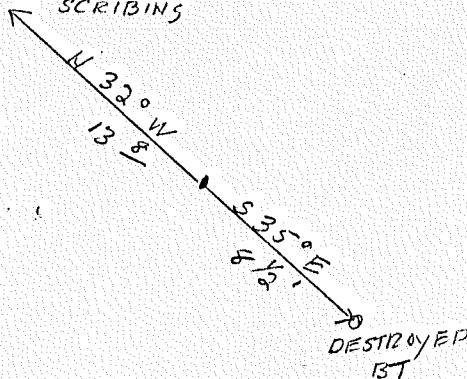
24" BT. NO LESIBLE SCRIBINS

RESET CORNER  
REMOVED 2" PIPE, 4  
SET 2" GAL PIPE W/  
BRASS CAP MKD  
TAN R9E  
S31 1532  
5 TIN

RESET 11-24-69  
HOOD RIVER COUNTY

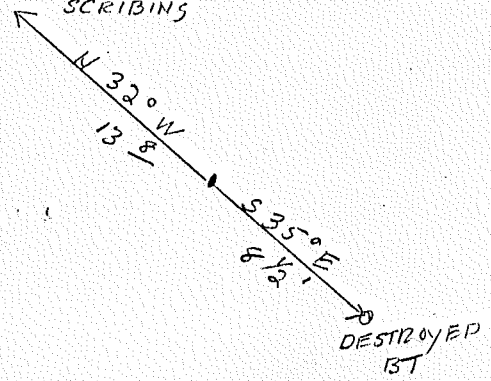
CORNER No. .... 460 .....

24" BT. NO LESIBLE SCRIBING

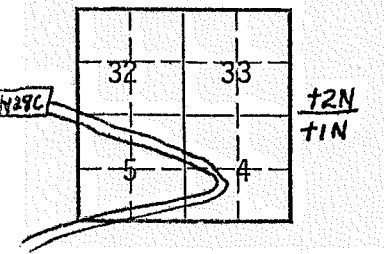
Consists of 2" Iron Pipe w/brass cap

BT's 10"DBH Grand Fir which bears 10'distance at E30°S.  
15"DBH Western Hemlock bears S16°E at 17'distance.  
22"DBH Western Hemlock-downed- due south at 12'distance as it lay from corner.

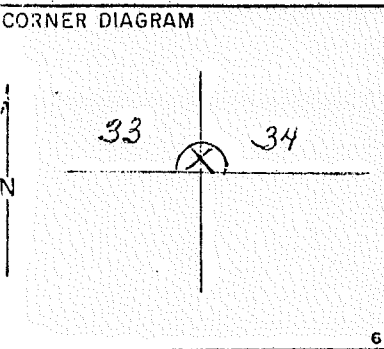
DESCRIBE CORNER MONUMENT FOUND  
 1! Iron pipe with disc top. By C.S. and G. Fry  
 3"x24" above ground RR pipe - seen by Eric S. Nance March 1960

DESCRIBE BEARING TREES OR OTHER OFFICIAL ACCESSORIES FOUND  
 2 B.T.'s.

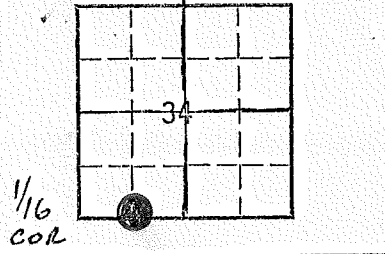
4. Description of Corners:  
Consists of two Iron Pipes with BLM caps. ?  
TWO CLOSING CORNERS?  
ARE THESE B. L. M. OR COUNTY?

Corner is located 65' west of N205. Trees are blazed on line and marked with orange paint to corner.

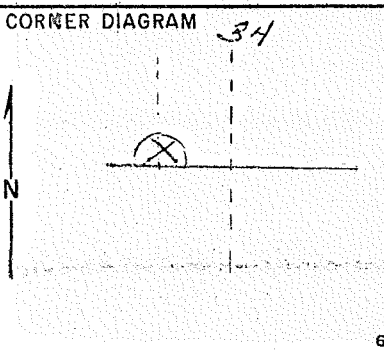
DESCRIBE CORNER MONUMENT FOUND  
Iron pipe with brass disc in place. Good condition. 24" above ground. Marked on top 1/16.

DESCRIBE BEARING TREES OR OTHER OFFICIAL ACCESSORIES FOUND  
Scribed 1/16 Cor. B.T. on W.F. 20" diameter bearing  $144^{\circ} 42\frac{1}{2}'$  distance. Not believed to be genuine corner. Placed by Geo. Frey & County Survey Crew.

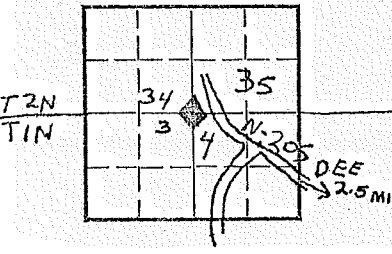
1. T 2N R 9E No. Z-17 Cor. Sec. Mer W State Oregon (Rectangular) N. F. Mt. Hood Dist. Hood River

4. Description of Corners: 2" galv. iron pipe, 24" above ground, small mound of rock. brass cap stamped

5. Investigation Notes:  
A D. fir snag 40" dbh, <sup>6. com</sup> S 48° E, 9' distant, standing, Broken off at a height of 50', Very old face, chopped out, blacked, pitched. ~~iron~~ faintly visible. marks

A D. fir 13" dbh, <sup>6. com</sup> S 9° E, 45' dist, Faced, grown over, yellow metal loc. tag. "1960 GP" Mistletoed, poor condition, original?  
A D. fir snag 26" dbh, <sup>6. com</sup> S 62° W, 22 ft. dist. standing full height. ~~iron~~ marks visible, illegible, very old, original?  
A D. fir 11" dbh, 24' dist. <sup>GP</sup> 1960, blazed, grown over, mistletoed, poor condition. Marked for cutting.

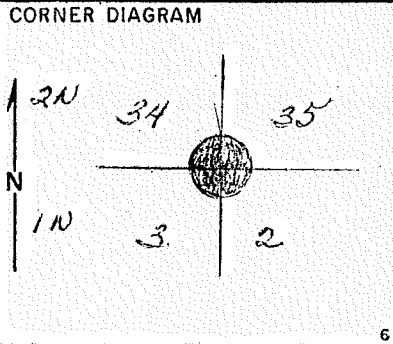
DESCRIBE CORNER MONUMENT FOUND  
Iron pipe with brass cap in place. Good condition, 24" above ground. Mound of rock is located around pipe. Marked 34 | 35  
3 | 2

DESCRIBE BEARING TREES OR OTHER OFFICIAL ACCESSORIES FOUND  
All new B.T.'s. 4 D.F. trees all 10" in diameter. Believed to be a genuine corner. Corner placed by George Frey with H.R. County survey. One possible old B.T. tree.
