Jarrative: As per O.R.S. 209.250 all required information is shown in its proper place. In Addition one could define Purpose of Survey as:

SURVEY ⁸⁶ ^{A.W.}
R-Bob Zeman, Tim Schechitel & Judy Cobb.
CATION-Parcels located in the
East 1/2 of Sec. 15, T. 1 N., R. 10 E.,
W. M.-
**WOOD RIVER COUNTY,
OREGON**

**DLC SURVEYING
DAN CRON 352-6574
34 TROUT CREEK ROAD
ORKDALE, OREGON 97041**

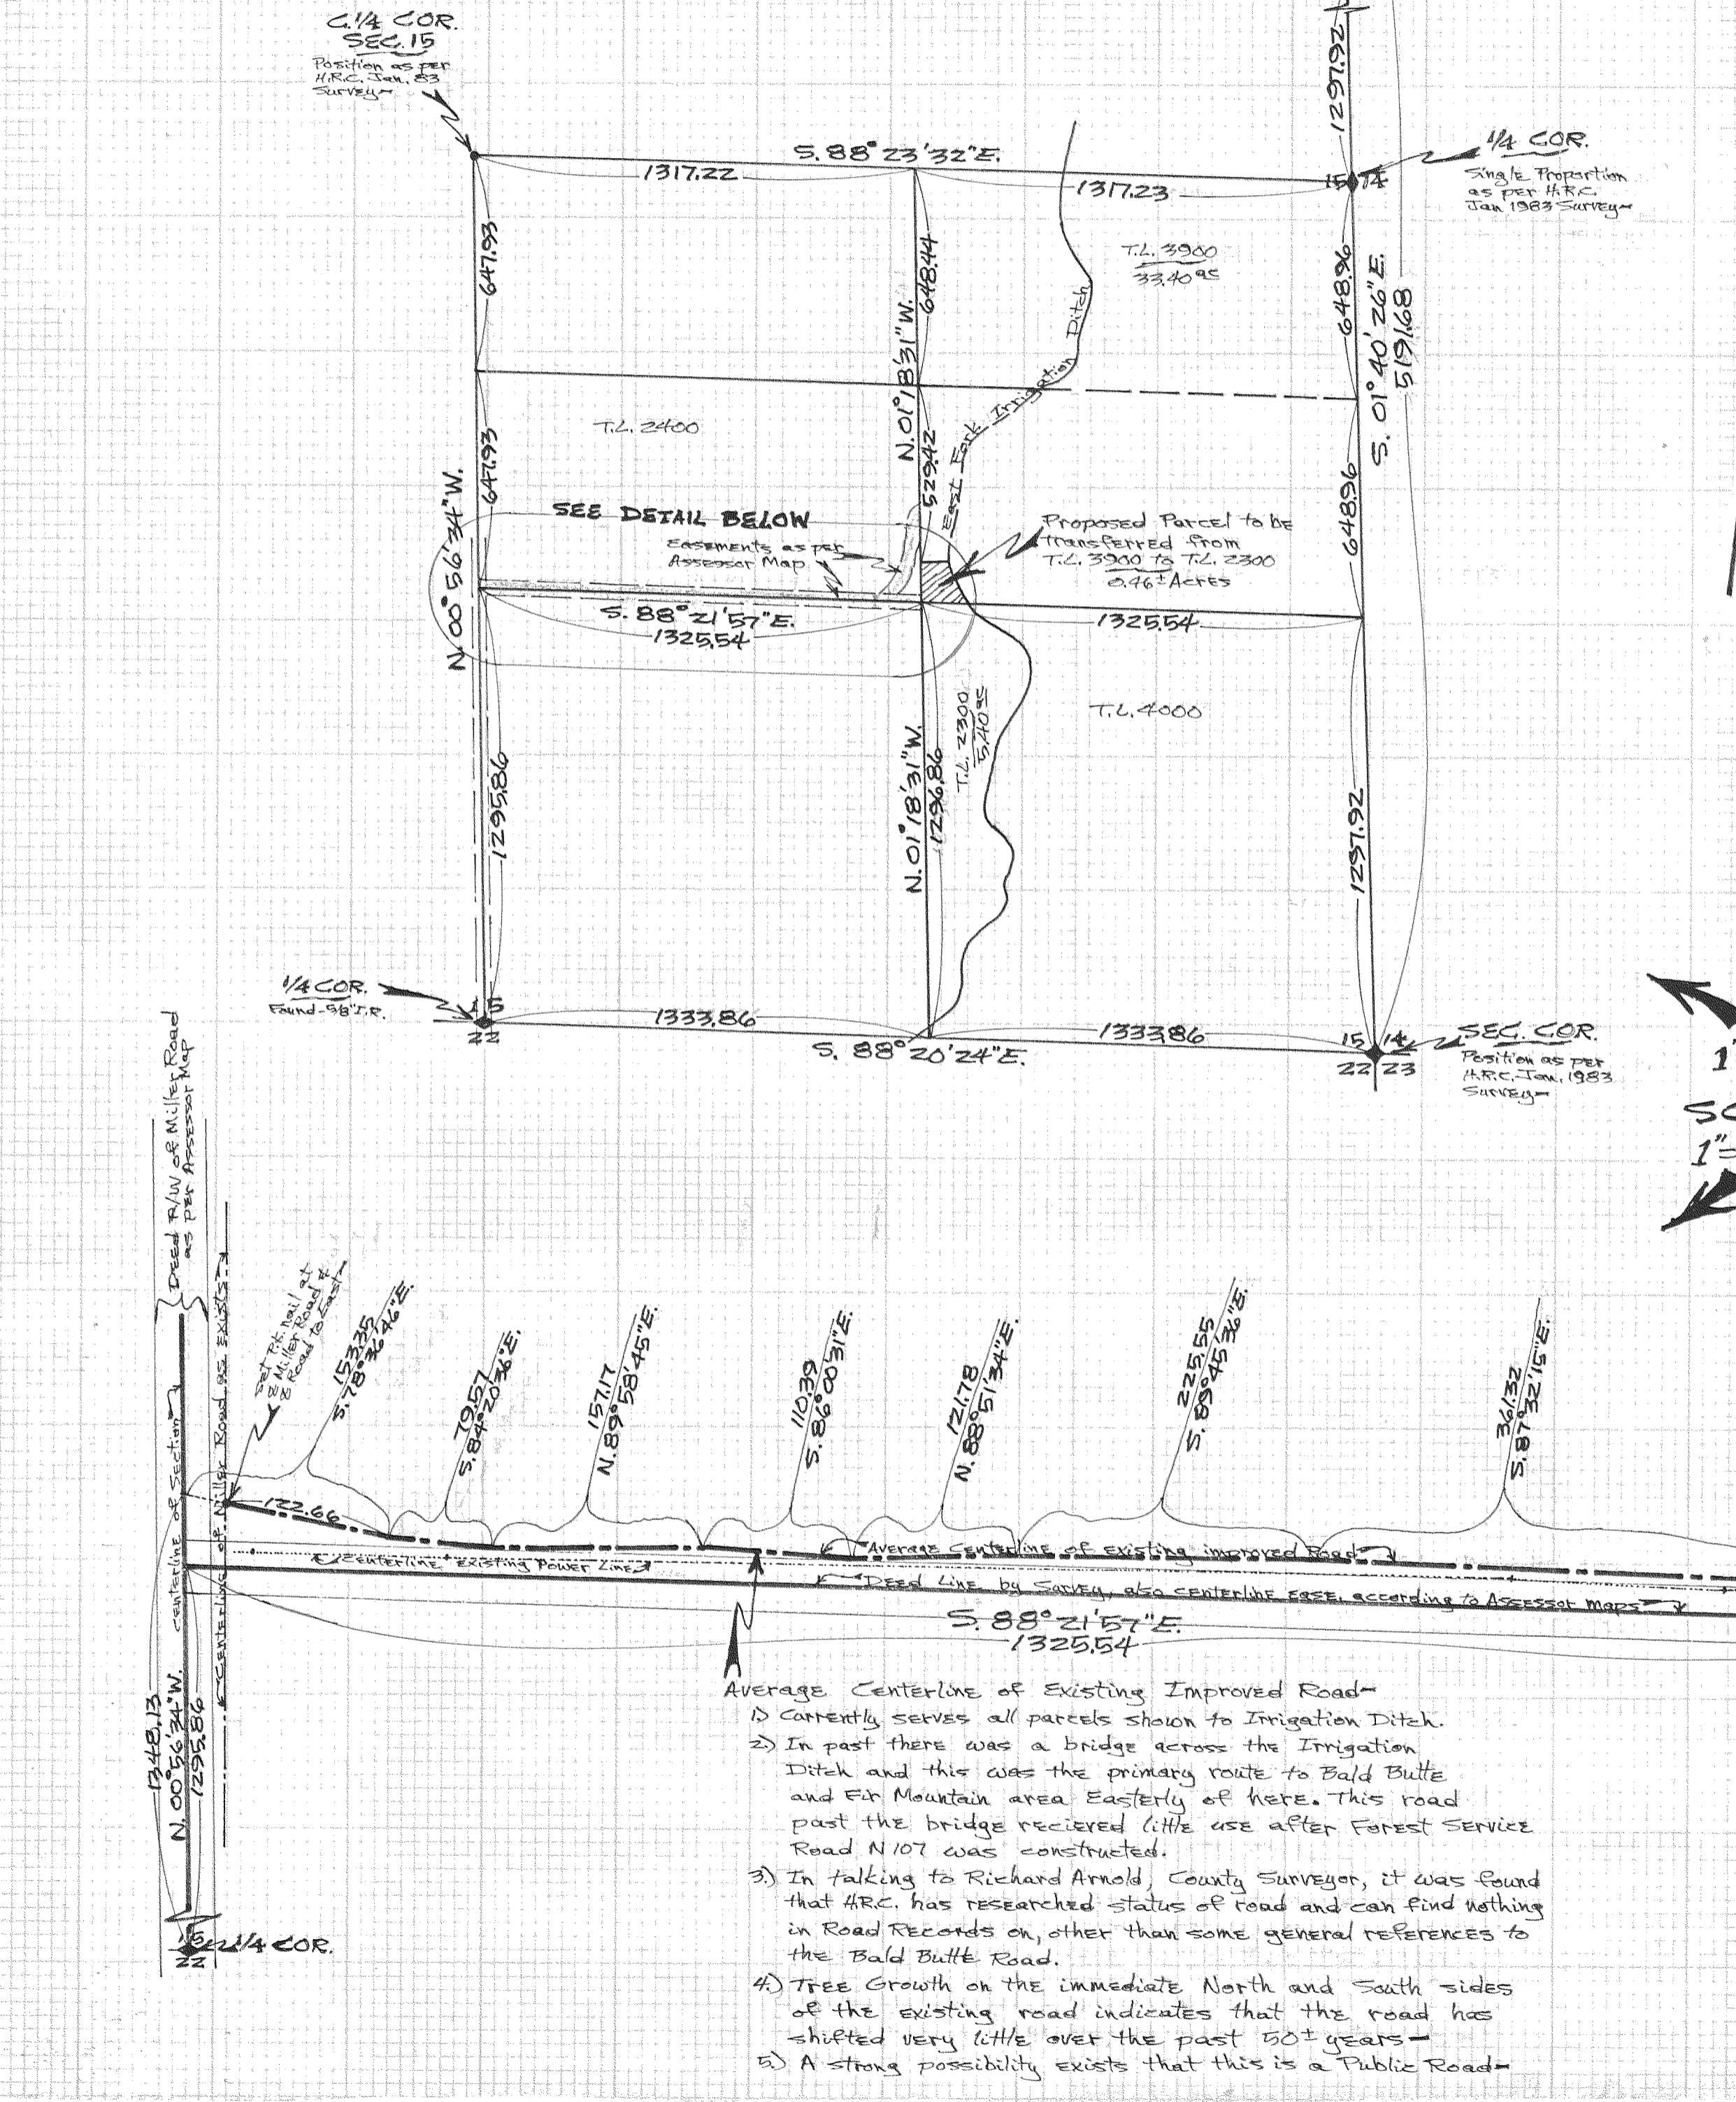
88002

- 1.) Locate existing road as shown.
 - 2.) Define Property Lines as shown.
 - 3.) Resolve Boundary Line problem as discovered by H.R.C. 79095 Survey -
 - 4.) Resolve conflict between D.L.C. 1/31/83 Survey 1/2" I.R. and H.R.C. 79095 Survey 5/8" I.R. as shown -

Proposed Boundary Adjustment
to correct possession line
problem involving improvement

Found H.R.C. 5/8" I.R.
AS PER H.R.C. 79005 SURVEY
44 South & 1° 22' East

Walking to H.R.C. it was
concluded that the said
5/8" I.R. is in error =

Average Centerline of Existing Improved Road -

- 1) Currently serves all parcels shown to Irrigation Ditch.
- 2) In past there was a bridge across the Irrigation Ditch and this was the primary route to Bald Butte and Elm Mountain area Easterly of here. This road past the bridge received little use after Forest Service Road N107 was constructed.
- 3) In talking to Richard Arnold, County Surveyor, it was found that H.R.C. has RESEARCHED status of road and can find nothing in Road Records on, other than some general references to the Bald Butte Road.
- 4) Tree Growth on the immediate North and South sides of the existing road indicates that the road has shifted very little over the past 50+ years -
- 5) A strong possibility exists that this is a Public Road -
