BOUNDARY ADJUSTMENT IN SE 1/4 SEC 11, T 1 N, R 10 E, WM COUNTY OF HOOD RIVER, STATE OF OREGON

SURVEY FOR
DON AND SHERRY
BALES

LAND SURVEYING
1109 Country Club Road
Hood River, Oregon 97031
Tele: (503)386-3322
DATE SURVEYED: DECEMBER 1993
JOB NO.: 93071

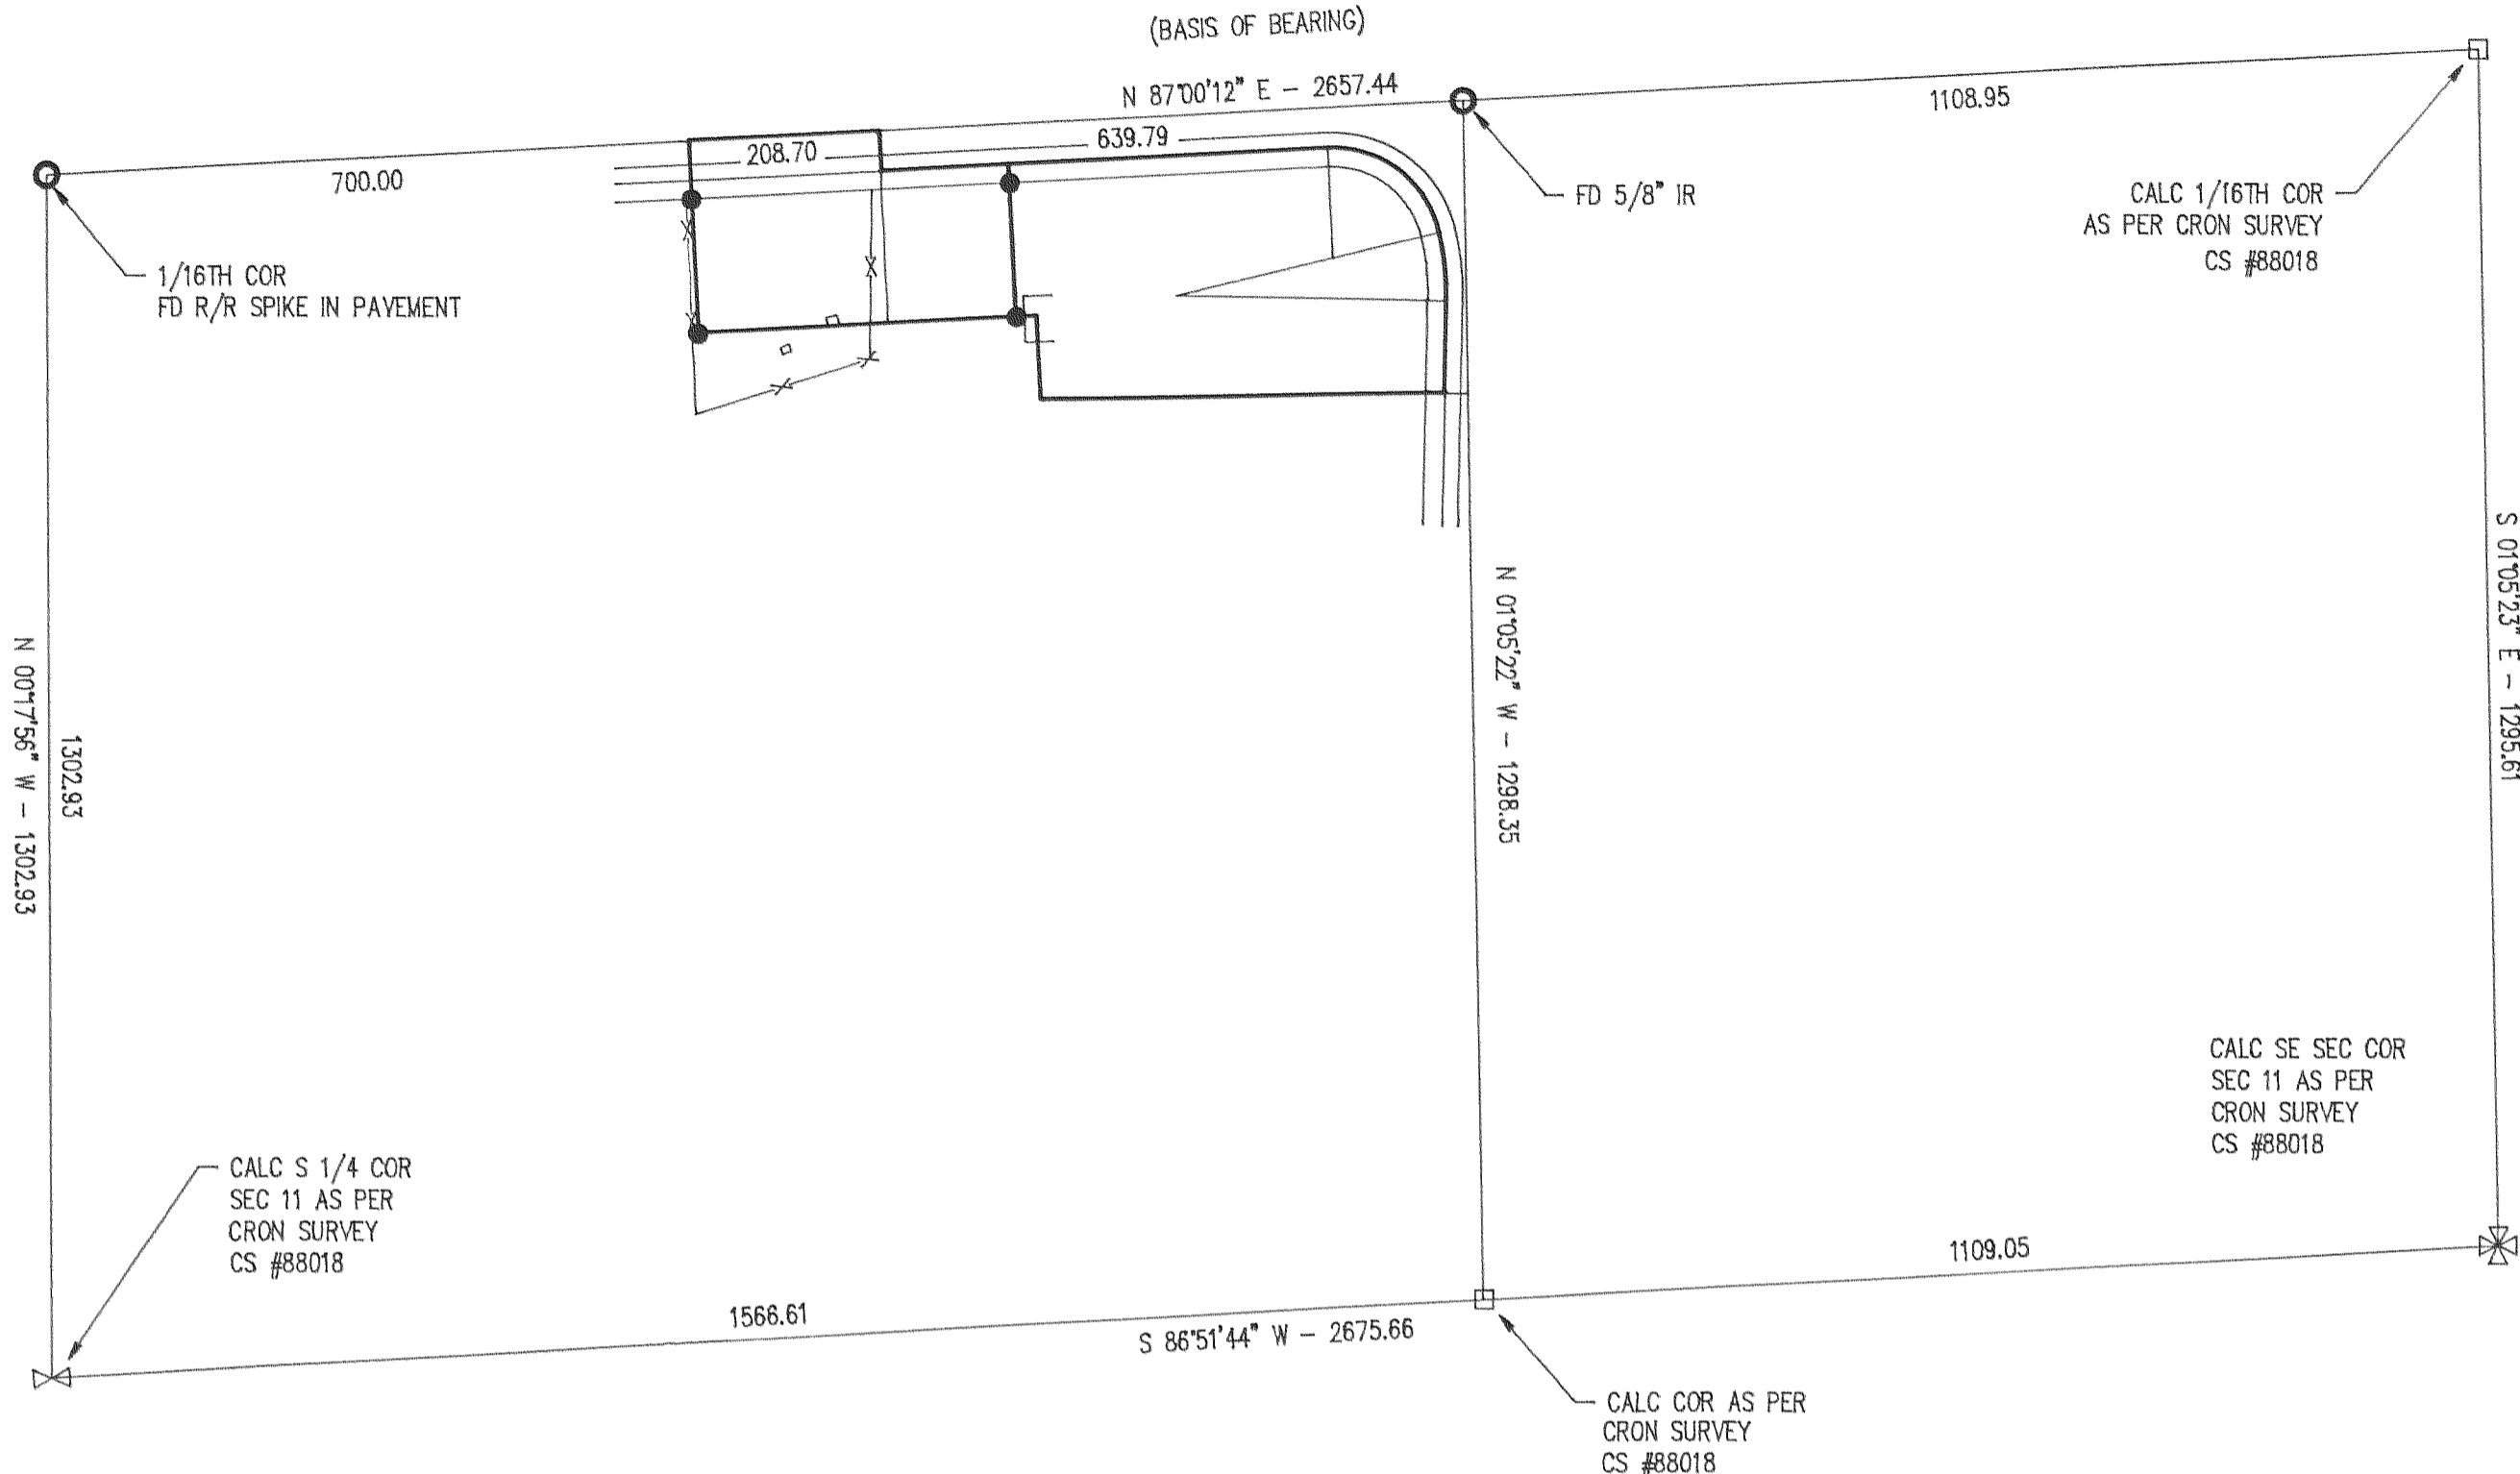
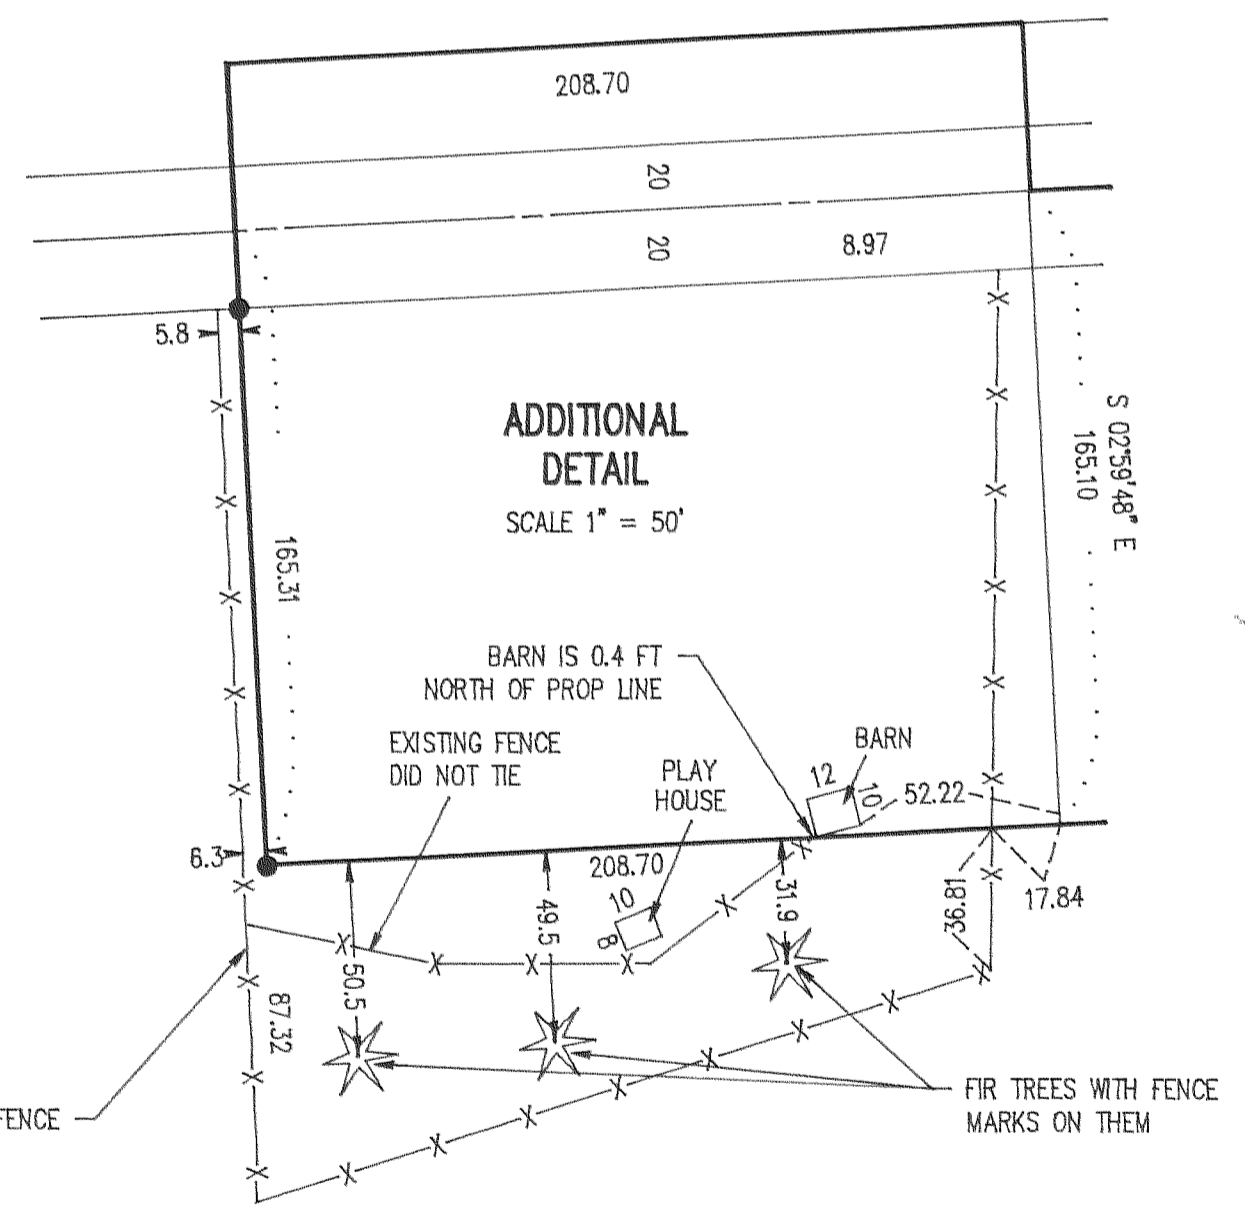
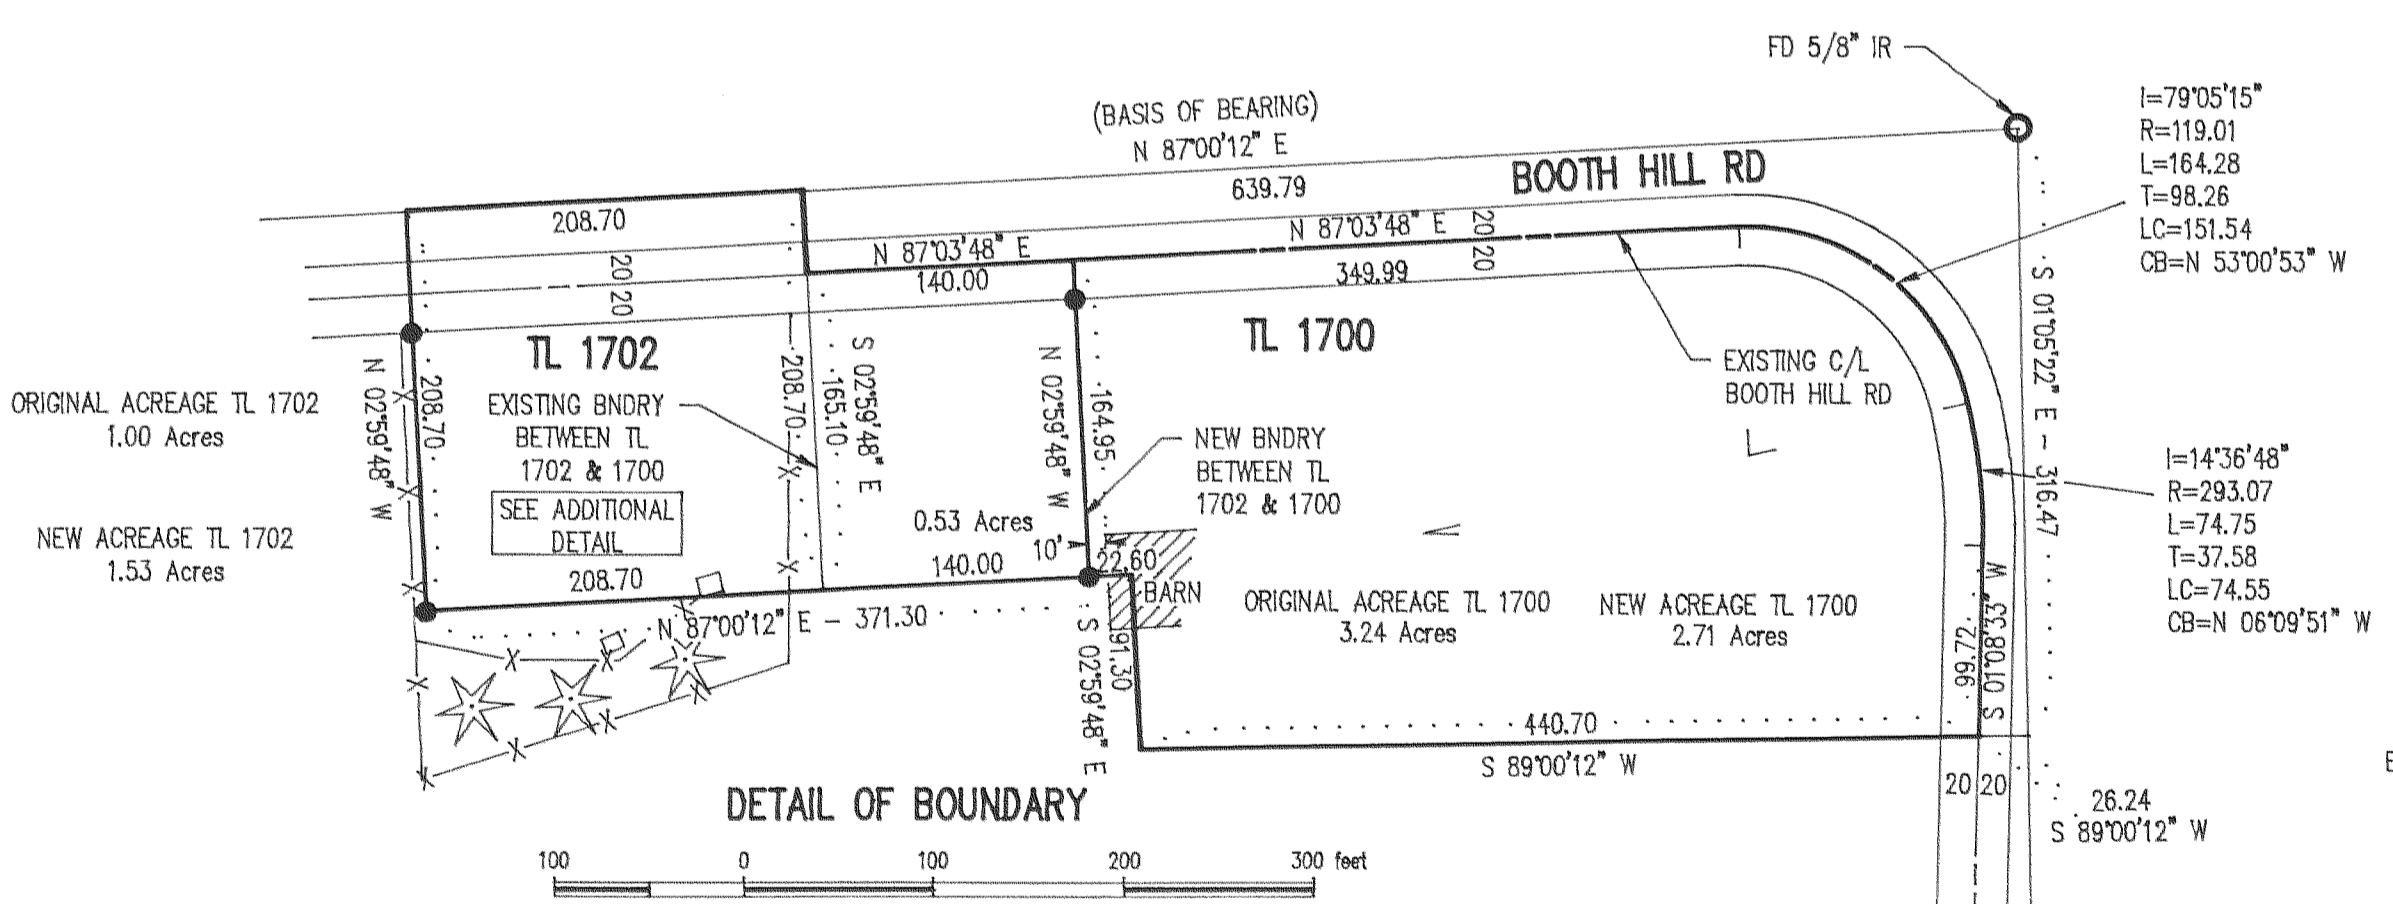
THE PURPOSE OF THE SURVEY WAS TO ADJUST THE BOUNDARY BETWEEN TAX LOT 1702 AND 1700. AS SHOWN ON THE PLAT, BOOTH HILL ROAD DOES NOT FOLLOW THE 1/16TH LINE AS WAS THE ORIGINAL INTENTION. AS PER JUDGEMENT IN HOOD RIVER CIRCUIT COURT (DECREE NO. 7414) FILED DECEMBER 16, 1976, HOOD RIVER COUNTY RECORDS, THE LAND NORTH OF TAX LOT 1700 WAS IN THE POSSESSION OF OWNERS TO THE NORTH. THE ACREAGE FOR TAX LOT 1700 WAS CALCULATED TO THE CENTER OF THE EXISTING ROAD. THE ACREAGE FOR TAX LOT 1702 WAS CALCULATED AS DESCRIBED IN THEIR DEED. ALL MONUMENTS FOUND AND ESTABLISHED, ALONG WITH THE MEASURED BEARINGS AND DISTANCES ARE SHOWN HEREIN. ALSO THE REMAINDER OF TAX LOT 1702 WAS SURVEYED AND IT WAS FOUND THAT THE BOUNDARIES DID NOT FIT THE EXISTING POSSESSION LINES. THAT INFORMATION IS SHOWN ON THE PLAT.
